UPRT Preliminary Thoughts on Sriwijaya 182

ICAO Regional Workshop on Loss of
Control in-Flight and UPRT
November 10-11, 2021

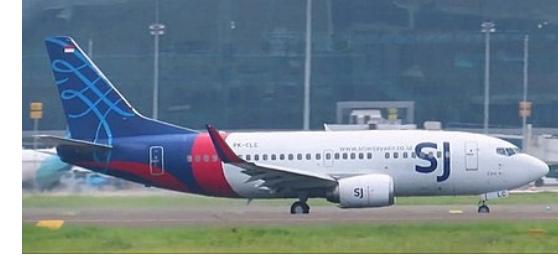
- Jan. 9, 2021
- 737-500
- Sea impact five minutes after departure from Jakarta
- 62 fatalities
- During climb, throttle split (left throttle reduced, right did not)
- A/P disengagement at 10,000 ft, left roll > 45 degs, then A/T disengage
- Resulting sideslip will cause airplane to roll
- Other factors
 - Experienced crew (18,000 and 5,000 hrs in two seats)
 - Recent and recurring autothrottle maintenance
 - Poor weather in area
