**Twentieth Meeting of Directors of Civil Aviation of the Eastern Caribbean
(20th E/CAR DCA)**

20th E/CAR DCA-WP/25

**PROPOSAL TO RECTIFY REPORTED DEFICIENCIES
RUNWAY STRIPS AND RUNWAY END SAFETY AREAS (RESA)**

(Presented by the United States of America)

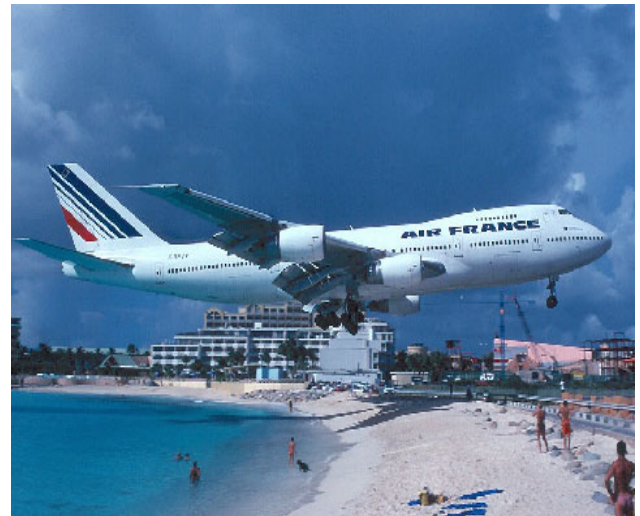
Figure 3 - Flight deck view of the RESA and a beach view of the landing aircraft on final approach to St. Marteen International Airport.

1.4 Recognizing the extent of non-compliance with RESA SARPs and the greater difficulties imposed by the proposed safety enhancement (see figures 3 and 4), ICAO Montreal accepted the position that Member State/Territories may use *alternative means* to achieve the safety benefits of RESA. ICAO further acknowledged a proven method to arrest overruns, known as the Engineered Materials Arresting Systems (EMAS). EMAS first appeared in the United States and is gaining acceptance worldwide (figures 5 and 6 and IP# E/CAT/DCA/20, *Status Of Engineered Materials Arresting System Installations in the United States*). However, ICAO and ADWG recognized the substantial costs associated with the installation of EMAS, and are therefore seeking other alternative means of compliance. Another alternative means used by various Member States is the application of declared distances to readjust the reported runway field lengths.

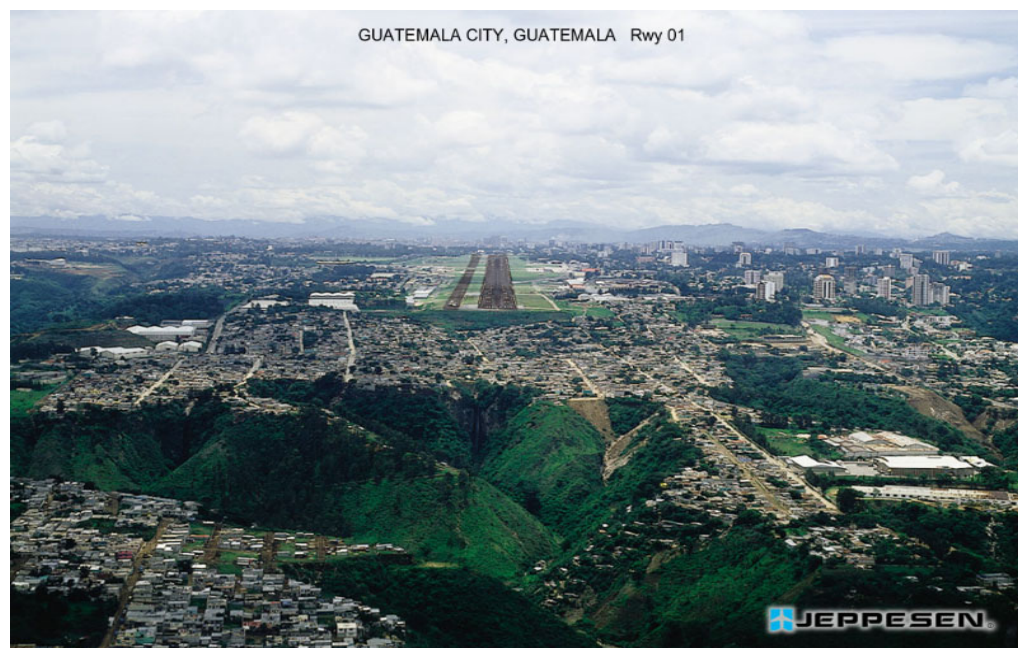
Figure 4 - Steep terrain off Runway 01 at Guatemala City La Aurora International Airport.

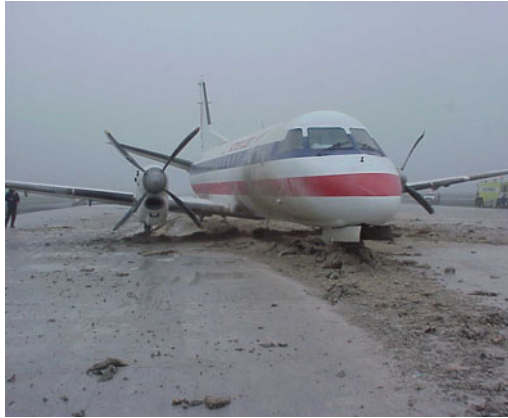
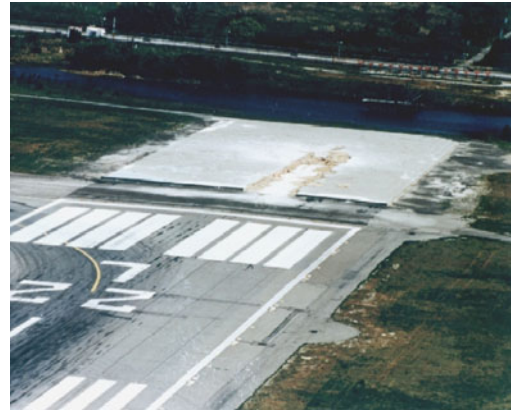
Figure 5 - Photos of EMAS off Runway 22L at JFK taken the day after the safe arrestment of a SAAB-340 overrun in June 1999 (note the surface area removed to extract the aircraft)

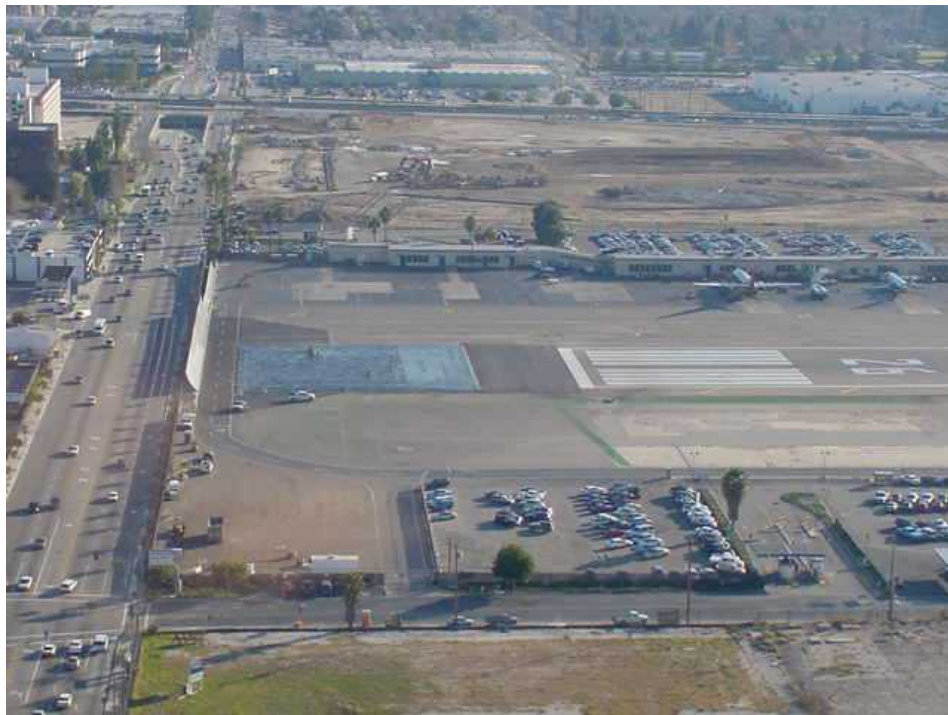
Figure 6 - Aerial photo showing (a) relationship of Hollywood Blvd. off Runway 26 at Burbank Airport, Burbank, California and (b) EMAS installation awaiting chevron-markings
