The Second Meeting of the Asia/Pacific Aerodrome Design and Operations Task Force (AP-ADO/TF/2)

**CHALLENGES AND SAFETY MANAGEMENT DURING EXTENSION OF RUNWAY AND CONSTRUCTION OF RESA IN THE VICINITY OF OPERATIONAL RUNWAY: A CASE OF TRIBHUVAN INTERNATIONAL AIRPORT, KATHMANDU, NEPAL**

(Presented by Nepal)

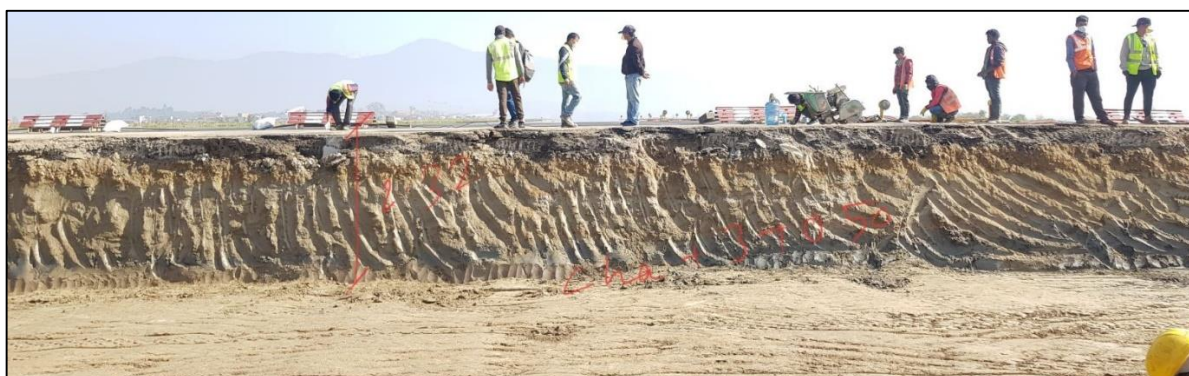
2.6. The subsoil was composed of heavy clay that needs very careful handling because it cannot be compacted by normal methods. So, the design demands for replacement of this clayey soil with better quality material. For constructing the runway extension pavement, the clayey soil was to be removed up to a depth of 2 to 2.5 m from the existing ground level, covered with a layer of geo-composite materials, and then a 150 cm thick CBR 35 (minimum) material is laid before the 1.5 m thick good soil is placed and compacted in layers. Each layer is required to be compacted, tested and followed by another layer of soil before the actual pavement can be constructed. This takes considerable amount of time and initial 300 m of the existing approach lights are in this construction area and are obstructions to carrying out the works.

2.7. Pavement Layers (As-built):

a) Asphalt Concrete Surface Course	t=60 mm
b) Asphalt Concrete Binder Course	t=80 mm
c) Asphalt Treated Base Course	t=150 mm (CBR>=5%)
d) Well Graded Crushed Aggregate Base Course	t=237 mm (CBR>=80%)
e) Geogrid 4.75m wide across the runway width	Only at new and old connection
f) Crushed Aggregate Subbase Course	t=150 mm (CBR>=35%)
g) Geogrid 4.75m wide across the runway width	Only at new and old connection
h) Replacement of unsuitable clay (Subgrade)	t=1500 mm (CBR>=5%)
i) Crushed Aggregate Subbase Course	t=150 mm (CBR>=35%)
j) <u>Geo-Composite</u>	At whole area
<b>Total top to bottom thickness</b>	<b>t=2327 mm</b>

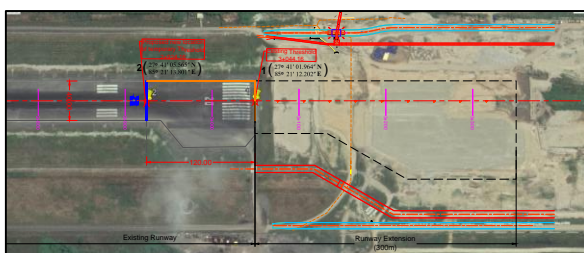
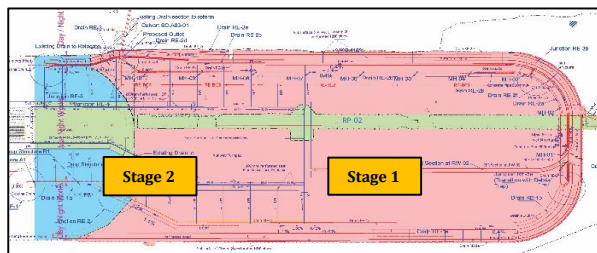
2.14. The runway extension works commenced in January 2019 through a local contractor. In the first Stage, a following NOTAM was issued about the work in the runway extension area in the south and the contractor had commenced the work from a point approximately 120 m from the existing threshold towards south (away from the operational runway). The work was being progressed in various stages keeping in mind the rather tight workspace and short window of time.

2.15. By the end of September 2019, the work of replacing the poor-quality natural soil with better quality soil had been taken up from 120 m from the existing threshold up to the end of extension (Stage-1 Area). Granular subbase course had been laid in some areas of the extension portion. The existing approach lights were still functioning, as they had not been removed yet.

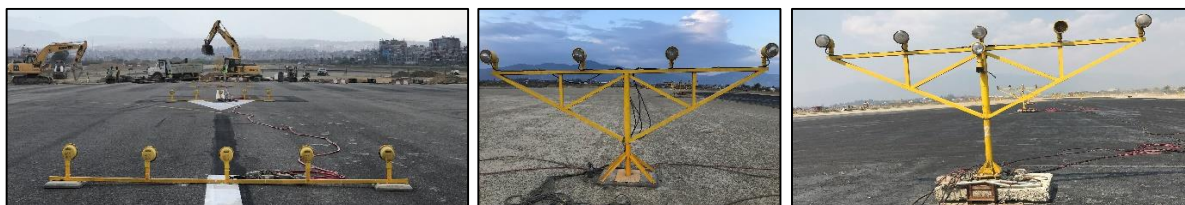
2.17. Meanwhile, during the period from October 2019 to March 2020, the construction work at the available site had been progressed and a *local arrangement* was made to continue provision of existing full-length approach lights. The arrangement was to mount the frame containing the approach lights on concrete blocks (alternative to fixing them on poles on normal foundations). During the construction period, these lights would be lifted away and removed beyond the runway shoulder area and relocated at the end of the work shift in the morning.

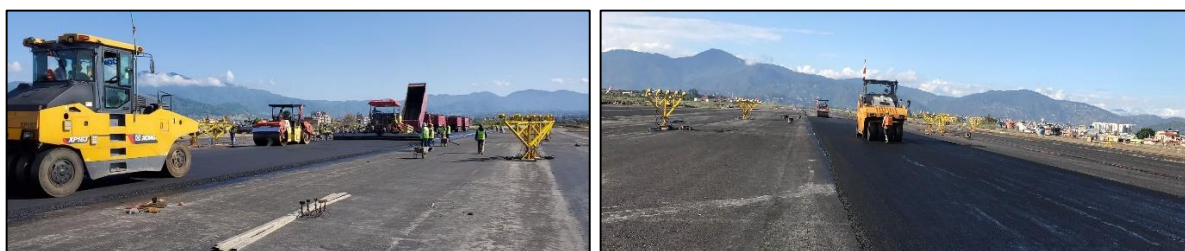
2.20. To tackle this problem, the availability of full-length approach lights was considered more appropriate from the safety point of view and hence, it was accepted that the *local temporary arrangement* (as in Paragraph 2.17) of mounting the approach lights in the runway extension area on concrete blocks that can be lifted and moved easily, was used during the temporary threshold displacement period.

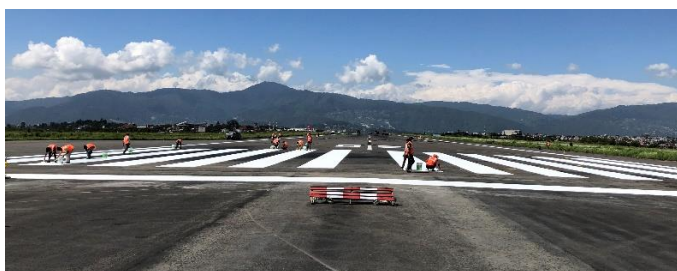
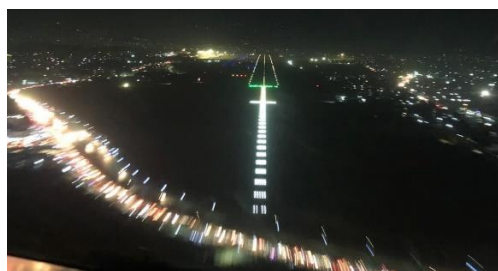
2.29. The runway pavement works was completed by the end of May 2020. After the completion of pavement works, threshold 02 and the associated visual aids were reinstated to its original position on first week of June, 2020 and the NOTAMs and AIP Supplements were issued accordingly. The airfield lighting works were delayed due to importation of the goods and its installations were completed by mid-December 2020.

2.30. The whole of the runway extension and RESA construction works was completed successfully by the end of December 2020 without any accident or incident during the construction period.
