Tenth Meeting of the FANS Interoperability Team – Asia
(FIT-Asia/10)

FANS INTEROPERABILITY TEAM (FIT) CENTRAL REPORTING AGENCY (CRA) PROBLEM REPORT (PR) BRIEFING

This paper describes investigation and disposition of submitted Air Traffic Services (ATS) data link problem reports (PRs) that are relevant to the Asia Region.

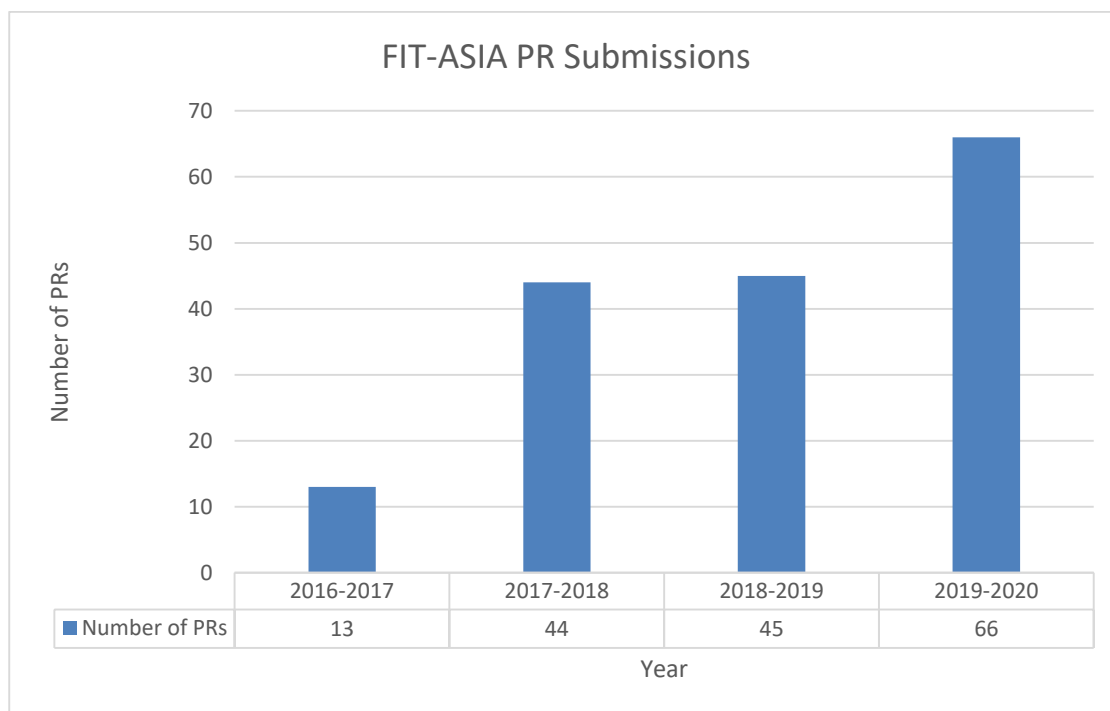
FIGURE 1

1.3 **Figure 1** illustrates the number of PRs submitted per calendar year for the Asia region, starting in 2016.
