Eleventh Meeting of the FANS Interoperability Team – Asia  
(FIT-Asia/11)

### FANS INTEROPERABILITY TEAM (FIT) CENTRAL REPORTING AGENCY (CRA) PROBLEM REPORT (PR) BRIEFING

*This paper describes investigation and disposition of submitted Air Traffic Services (ATS) data link problem reports (PRs) that are relevant to the Asia Region.*

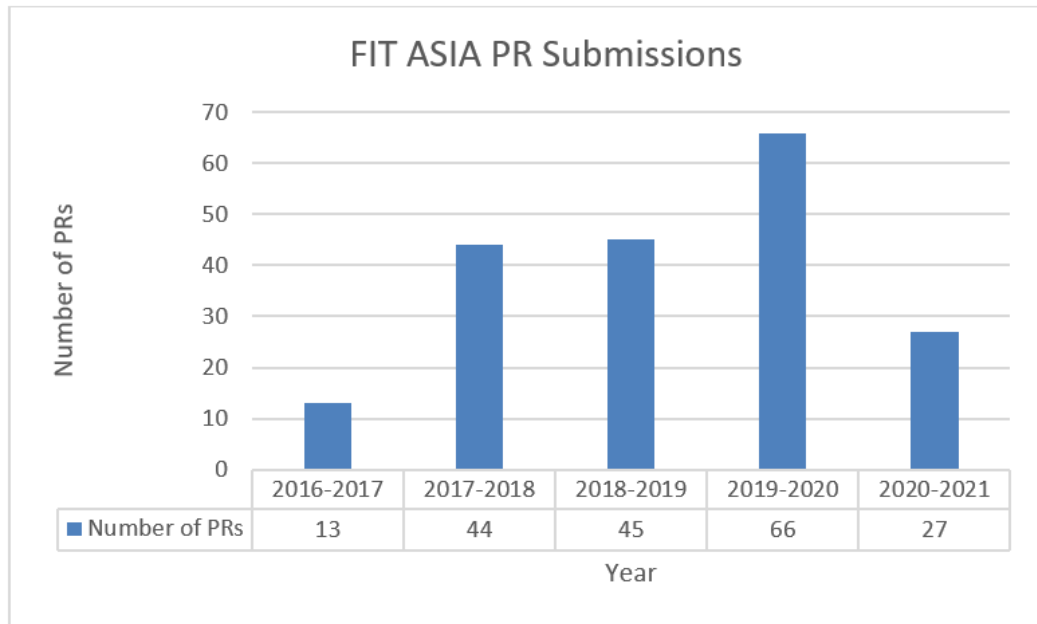
**Figure 1**

1.3 Figure 1 illustrates the number of PRs submitted per calendar year for the Asia region, starting in 2016.

1.4 The lower number of PRs submitted in the last 12 months is not surprising as there has been a dramatic decrease in air traffic, particularly international air traffic, due to the impact of the COVID-19 pandemic.
