FIT ASIA Central Reporting Agency –Problem Report Briefing

Agenda

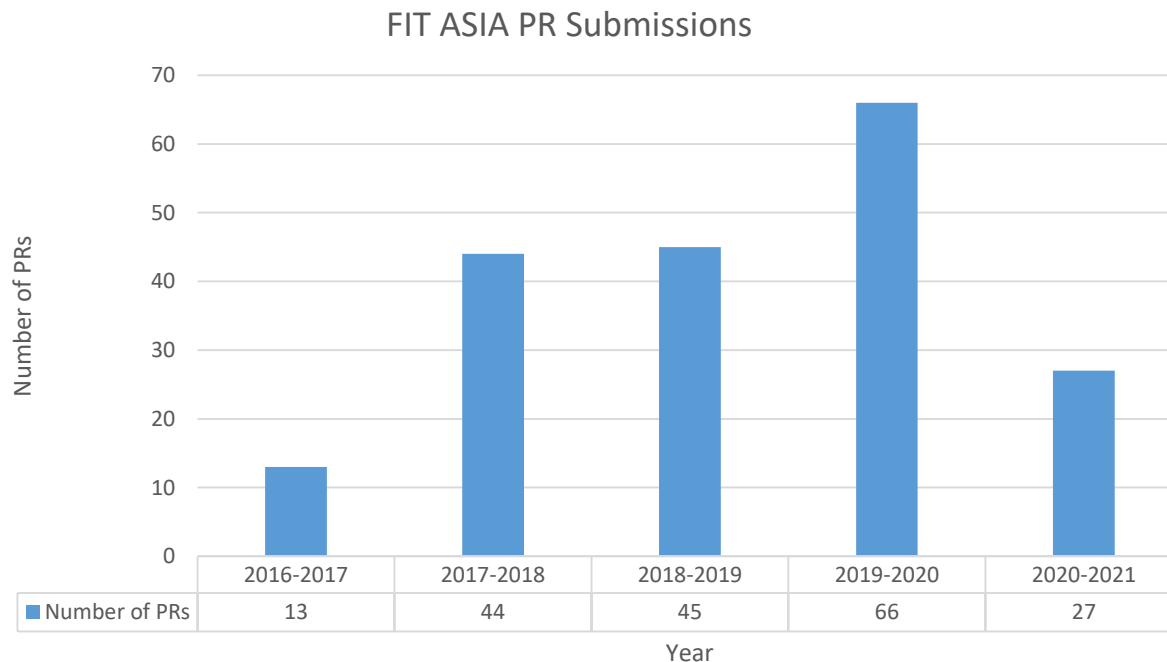
- Between August 2020 and August 2021 27 PRs have been filed for the Asia region.
- This is a noticeable decrease compared to the 66 PRs filed during the one year period leading up to FIT ASIA/10. However, this is not surprising due to the dramatic decrease in international air traffic due to Covid-19.
