Runway Condition Report

Requirement stated in ICAO Doc 9981

Airport Authority Hong Kong has invited HKO
(1) to develop an automatic system monitoring rainfall; and
(2) to suggest real-time Runway Condition Report (RCR) for HKIA.

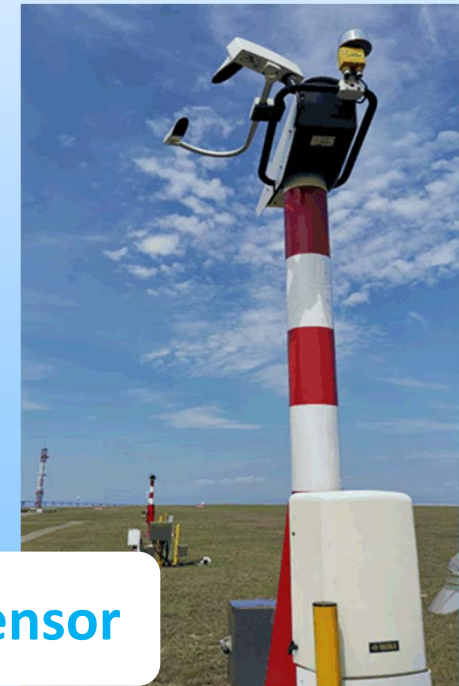
Radar

Present Weather Sensor

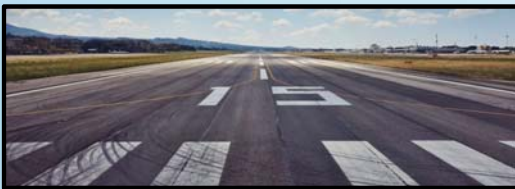
RCR on ATIS

Report on each of
the runway thirds

Hong Kong International Airport (HKIA)
Automatic Terminal Information Service (ATIS)

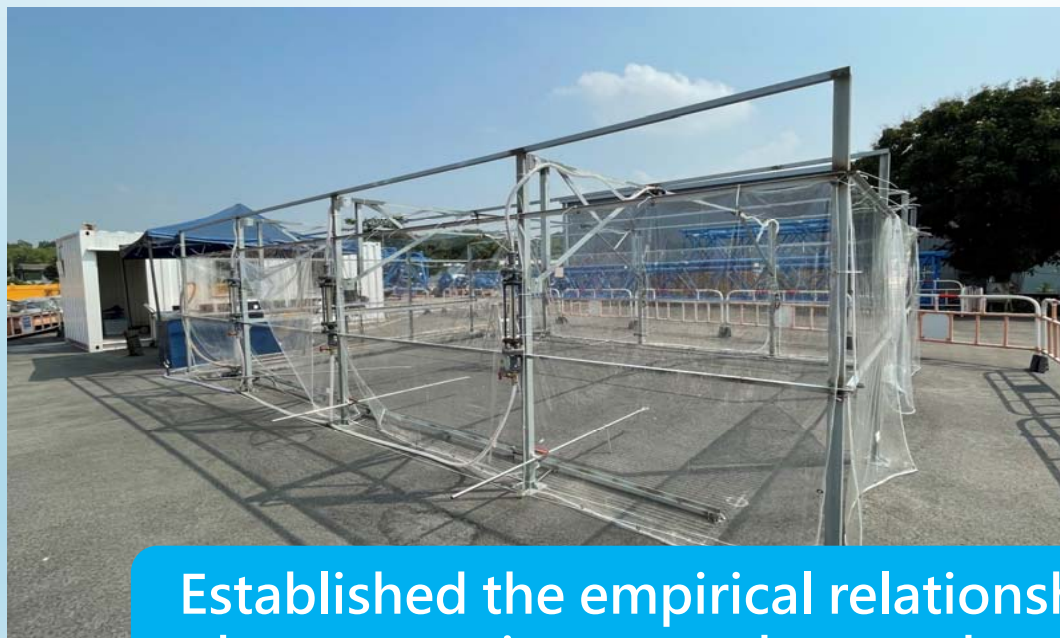
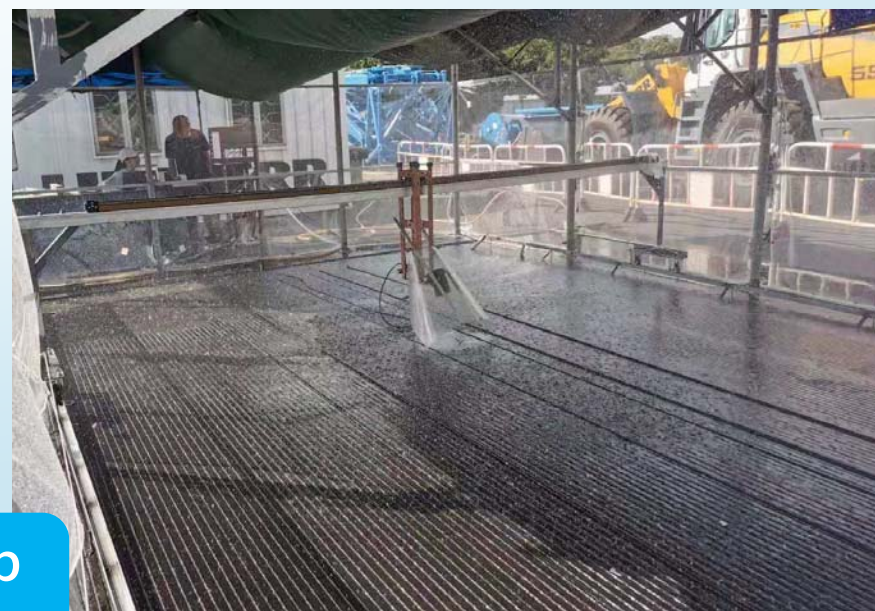
Simulation of standing water

conducted a field experiment using a mocked runway surface with same grooving, inclination and material of the HKIA runway

Established the empirical relationship between rain rate and water depth

>100mm/hr rain rate could produce water depths of >3mm

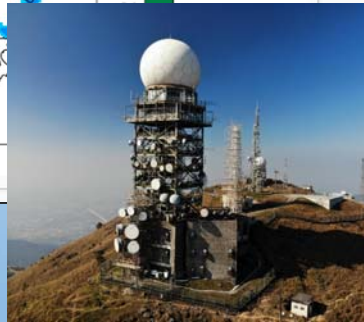
Radar Animation of Past 3 Hours

Radar data: TCR

2022-06-06 04:36 UTC
2022-06-06 12:36 HKT

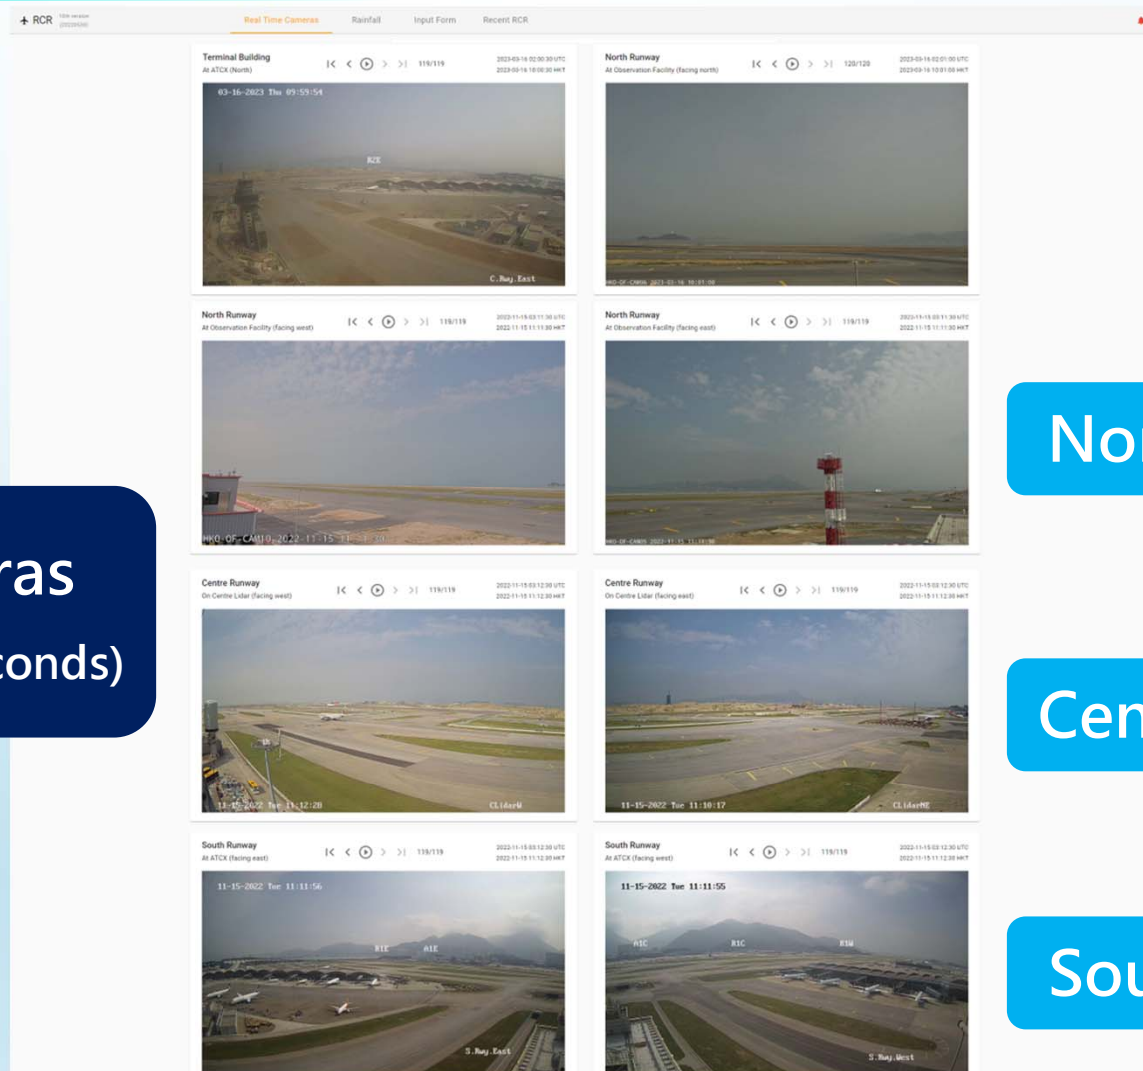
All-in-one rainfall monitoring platform

Weather cameras
(Update at every 30 seconds)

North Runway

Centre Runway

South Runway

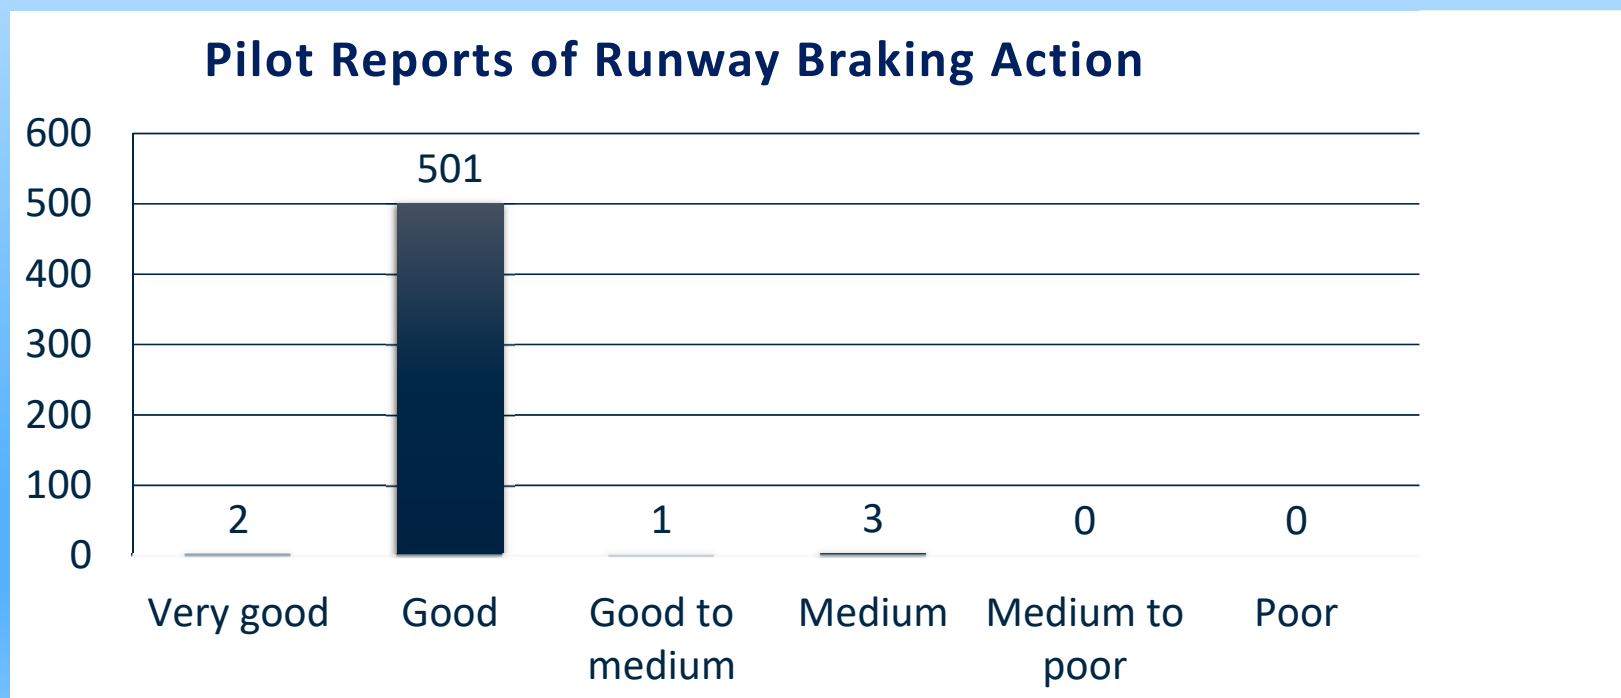
Pilot reports of runway braking action

- Pilot Braking Action Reports were received from June 2022
- 507 Pilot Reports were received

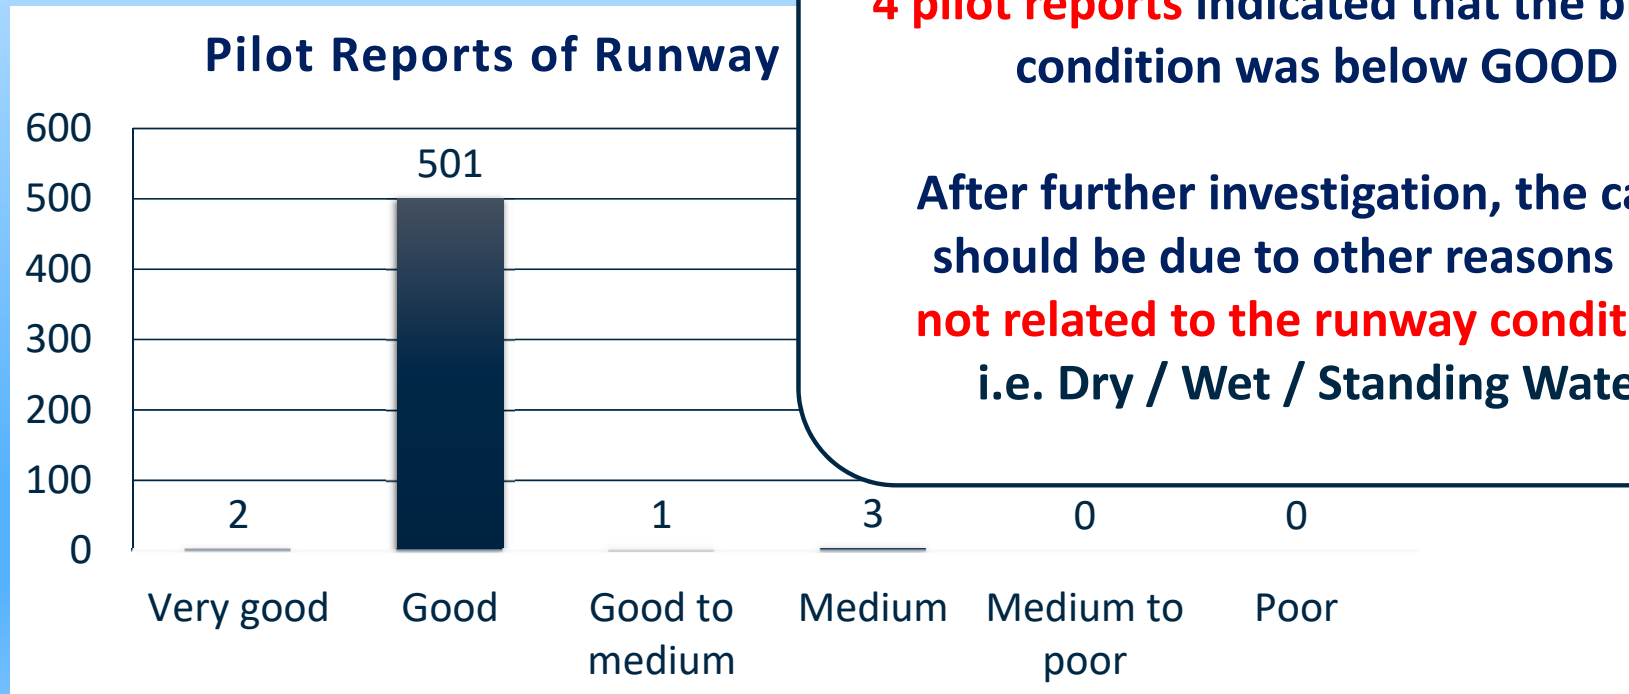
Pilot reports of runway braking action

- Pilot Braking Action Reports were received from June 2022
- 507 Pilot Reports were received

4 pilot reports indicated that the braking condition was below GOOD

After further investigation, the cases should be due to other reasons but **not related to the runway conditions** i.e. Dry / Wet / Standing Water
