MODE-S DAPS DATA - New Zealand

MODE-S ADDRESS AND FLIGHT IDENTIFICATION

ICAO APAC - SURICG8 SEMINAR - BANGKOK

ANDY ALFORD AIRWAYS NEW ZEALAND

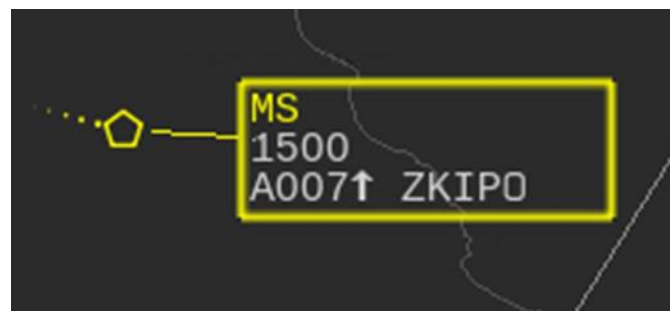
MODE-S ALERT

SOFTWARE USED TO IDENTIFY DUPLICATE MODE-S ADDRESSES

- **New Software together with HMI functionality was required to help identify the issue to ATC**
 - **Duplicate MODE-S alert indicated by Yellow MS in Line 1 of track Label (correlated or uncorrelated)**
 - **Identified by 2 (or more) tracks with MS Alerting**

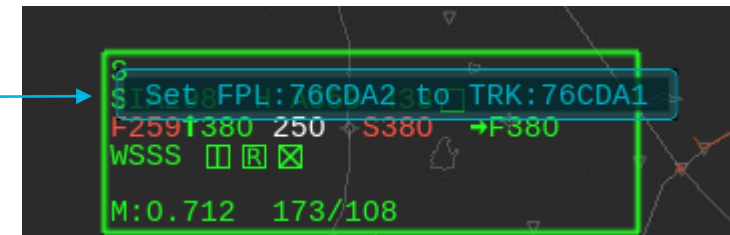
NEW SOFTWARE SOLUTION

➤ A new software solution was implemented to indicate an incorrect MODE-S between Aircraft and FPL

- Indicated with Yellow S in Line 1 of Track Label
- Resolved by right clicking on Yellow **S**
- Corrects FPL details to show code being transmitted by aircraft

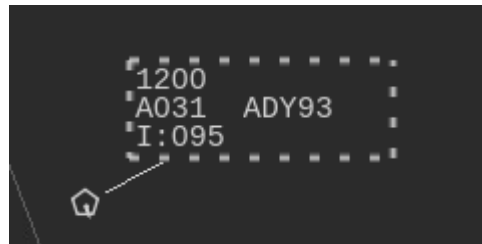
Uncorrelated VFR

- Squitted or obtained from register BDS 2.0;
- Can be used as a method for correlation/coupling between the surveillance track and flight plan – **especially for DO260 ADS-B systems in ADSB NRA**
- Useful to help identify uncorrelated/coupled flights (VFR or IFR)

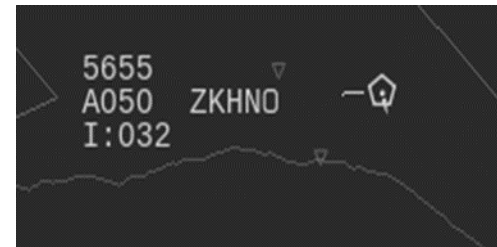
Uncorrelated IFR
