FIT-Asia 15 Seminar Workshop

Boeing CRA

PBCS Overview

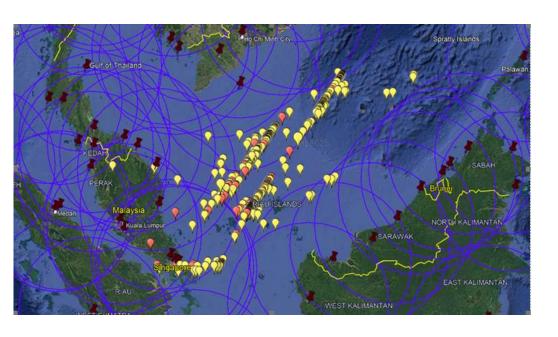
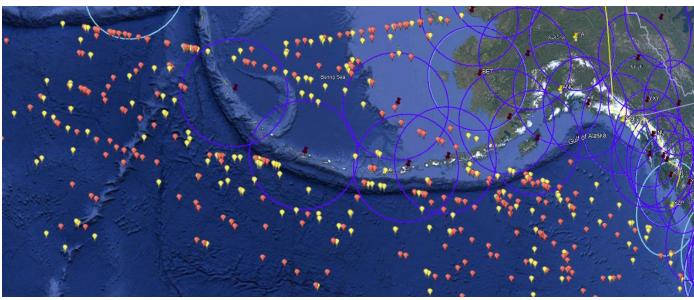
VHF – SATCOM Link Transitions

- Avionics generally designed to minimize costs to operators where possible (preferring less expensive VHF links over SATCOM links)
- Avionics attempt to deliver a downlink through a VHF link a certain number of defined times at a defined interval before considering the VHF link to be unavailable
- This can cause delays when the aircraft is on the edge of VHF coverage causing time performance to seem poor via SATCOM, when the avionics are actually attempting (but failing) to deliver the downlink via VHF
- RAT1 timer (reference FIT-Asia/13 IP/2) intended to address this issue, but implementation is not yet universal

South China Sea North Pacific
