To Promote continuous safety with systematic thinking

—Thinking and Strategy Sharing of Loong Airlines System to Prevent CFIT

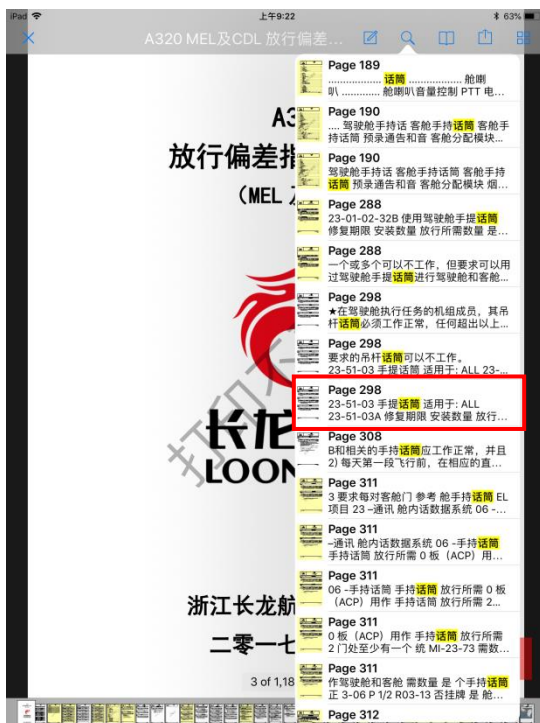
EFB's quick search function

On March 16th, 2018, during the stop-over in Chongqing of our company's flight, the front Handset failed suddenly. During the troubleshooting process, the release engineer of Chongqing Airport and our company's technical supporting engineers incorrectly followed the "A320 release deviation guide (DDG -MEL and CDL)" MEL23-51-03A" project to release the aircraft, resulting in the fact that the aircraft did not meet the MEL release conditions.

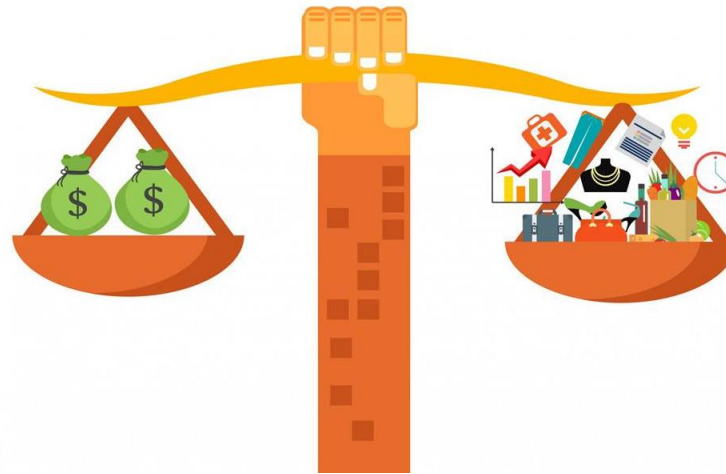
Modified :

- The cost is about 700,000 \$
- **950-foot warning trigger logic**

- What safety management manages is the safety risk itself, and it's not just about managing warnings!
- 1250-foot trigger warning has a **higher safety margin** than 950-foot trigger warning.
