International Civil Aviation Organization
CAR/SAM REGIONAL PLANNING IMPLEMENTATION GROUP (GREPECAS)
**Fifth Meeting of the GREPECAS Aerodromes and Ground Aids /
Aerodrome Operational Planning Subgroup (AGA/AOP/SG/5)**
Montevideo, Uruguay, 20 to 24 November 2006

Agenda Item 5: Review of Task Force Activities
5.1 Runway Strips & Runway End Safety Areas Task Force

**PROPOSAL TO RECTIFY REPORTED DEFICIENCIES
RUNWAY STRIPS AND RUNWAY END SAFETY AREAS (RESA)**

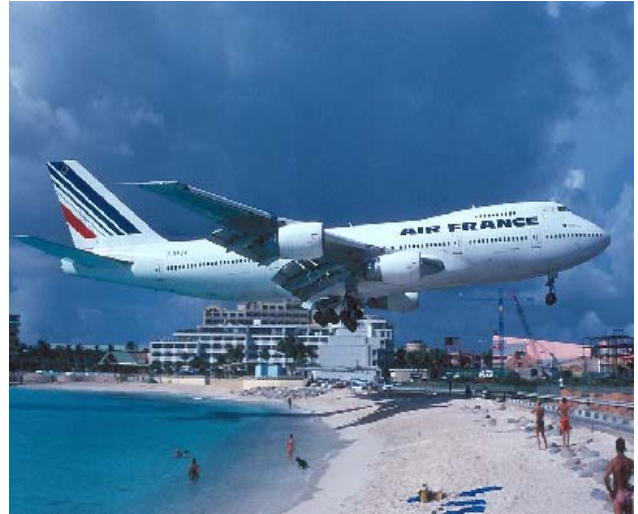
Figure 3 - Flight deck view of the RESA and a beach view of the landing aircraft on final approach to St. Marteen International Airport.

1.4 Recognizing the extent of non-compliance with RESA SARPs and the greater difficulties imposed by the proposed safety enhancement (see figures 3 and 4), ICAO Montreal accepted the position that Member State/Territories may use *alternatives means* to achieve the safety benefits of RESA. ICAO further acknowledged a proven method to arrest overruns known as Engineered Materials Arresting Systems (EMAS). EMAS first appeared in the United States and is gaining acceptance worldwide (figures 5 and 6 and IP/08 AGA/AOP/SG/5, *Status Of Engineered Materials Arresting System Installations In The United States*). However, ICAO and ADWG recognized the substantial costs associated with the installation of EMAS, and are therefore seeking other alternative means of compliance. Another alternative means used by various Member States is the application of *declared distances* to readjust the reported runway field lengths.

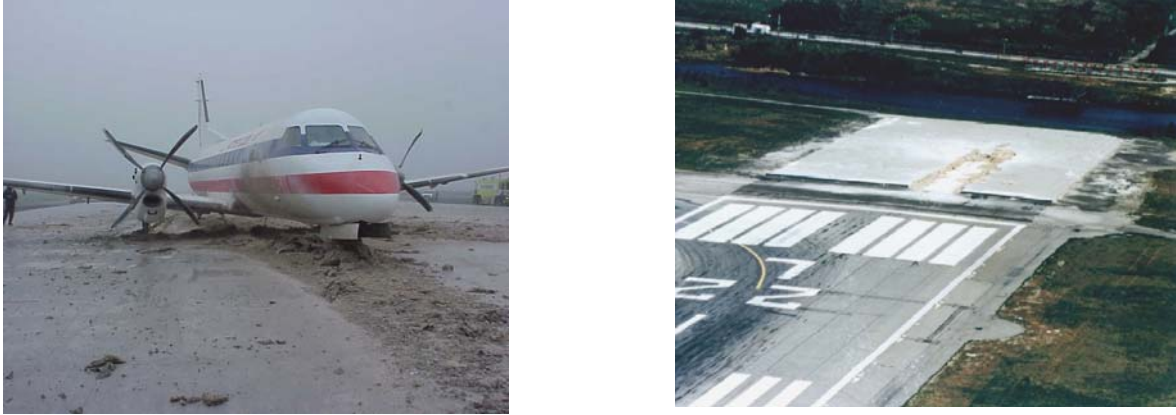
Figure 5 - Photos of EMAS off Runway 22L at JFK taken the day after the safe arrestment of a SAAB-340 overrun in June 1999 (note the surface area removed to extract the aircraft)

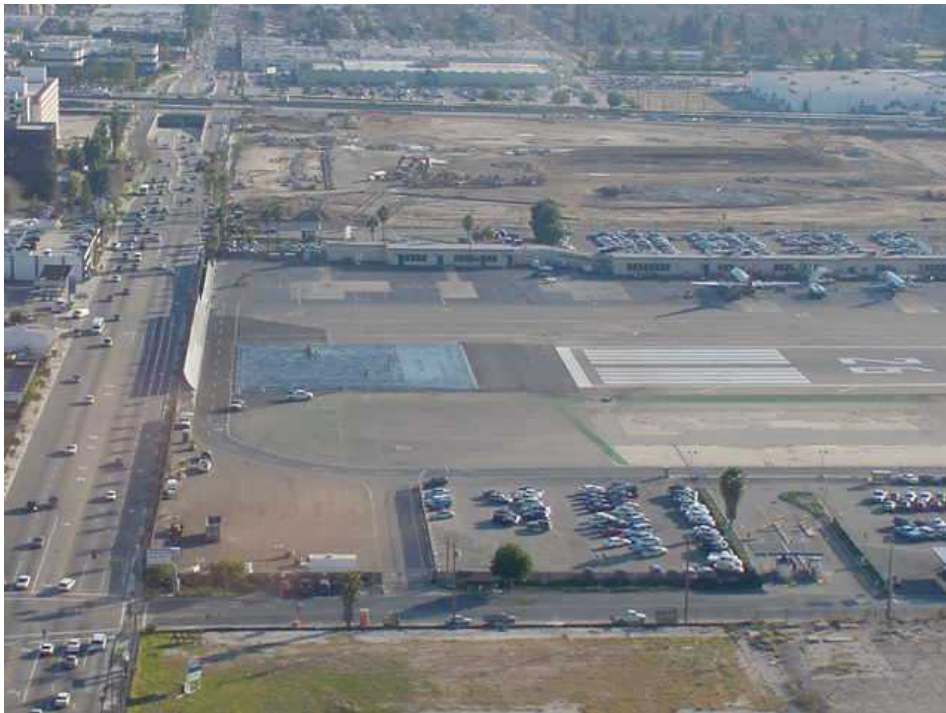
Figure 6 - Aerial photo showing (a) relationship of Hollywood Blvd. off Runway 26 at Burbank Airport, Burbank, California and (b) EMAS installation awaiting chevron-markings

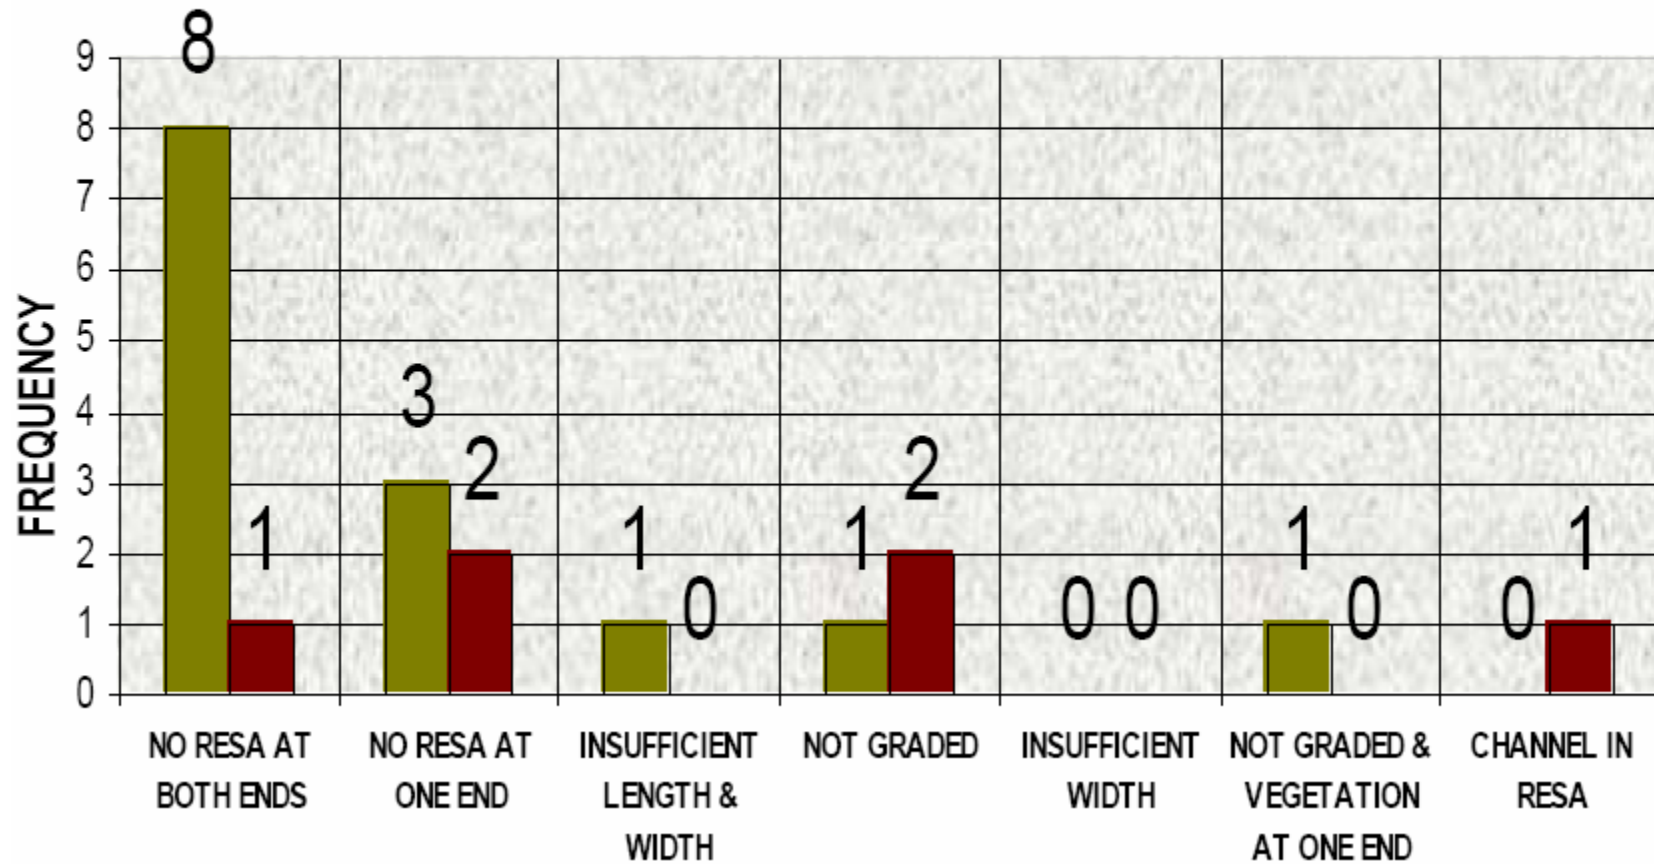
Figure A5

**COMPARISON of RESA DEFICIENCIES FOR
CAR (///) & SAM (\\) REGIONS (10/2004)**

Figures A5 and A6 illustrated the differences between the CAR Region and the SAM Region for each SARPS. For RESAs, figure A5 showed that *both regions share similar types of deficiencies*, with the exception of the much higher rate within the CAR Region for runways lacking RESAs at both ends; *a rate of 8 to 1*. For runway strips, figure A6 showed a *dichotomy of the problem*. That is,

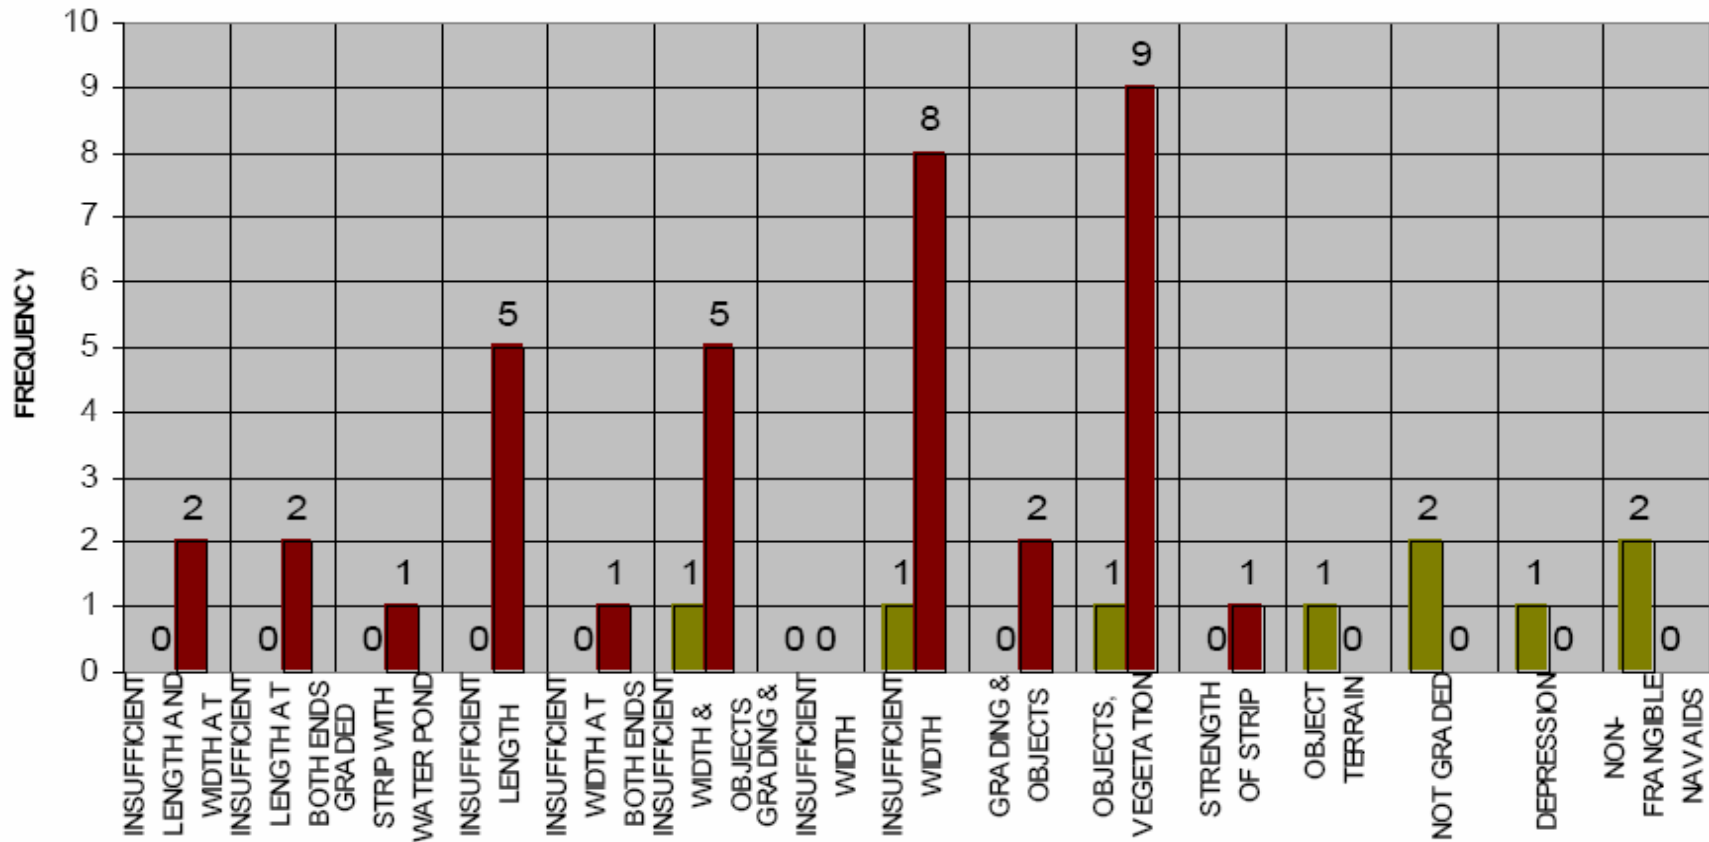
Figure A6

COMPARISON OF RWY STRIP DEFICIENCIES FOR CAR (///) & SAM (\\) REGIONS (10/2004)

the CAR Region faces a dimensional challenge as compared to the SAM Region, which faces a clearing of objects and improved grading conditions.
