Fourteenth Meeting of the CAR/SAM Regional Planning and Implementation Group  
(GREPECAS)

GREPECAS/14-WP/29

**PROPOSAL TO ASSIST IN THE RECTIFICATION OF RUNWAY STRIPS AND RUNWAY  
END SAFETY AREAS (RESA) DEFICIENCIES**

(Presented by the United States of America)

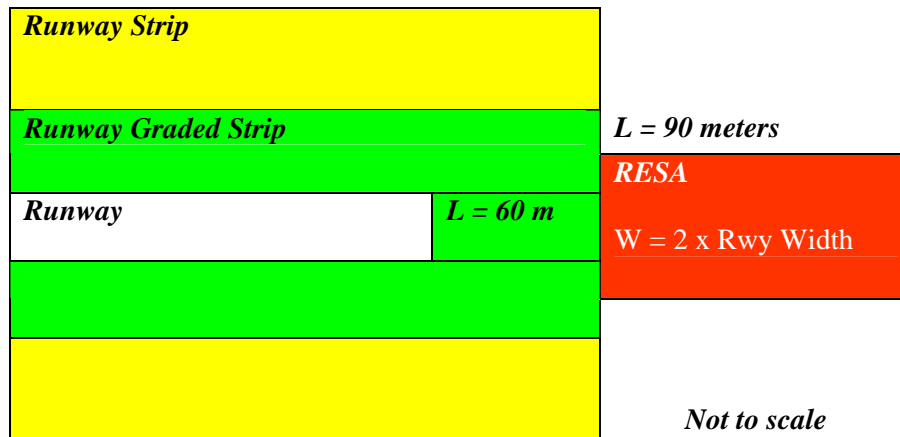
Figure 1 - Schematic of a runway and its runway strip, graded portion of the runway strip, and the runway end safety area (RESA).

- Notes:*
- #1 - Paragraphs 3.4 and 3.5, Annex 14, Volume I provide the dimensional and surface standards and recommended practices.
  - #2 - The length of the runway strip off the runway end for Code 1, non-instrumented runways is 30 meters.
  - #3 - Code 1 and 2 non-instrumented runways are not required to have RESAs.

1.1 ICAO concentrates its efforts for reducing the risk of damage to an airplane that undershoots, veer-offs, or overruns the runway by requiring prepared protective areas that surround the runway. To achieve this safety goal, Annex 14, Volume I defines the protective areas as the runway strip, the “graded portion” of the runway strip, and the runway end safety area (RESA). Figure 1 illustrates the relationship among these ICAO protective areas which are categorized as *standards*.

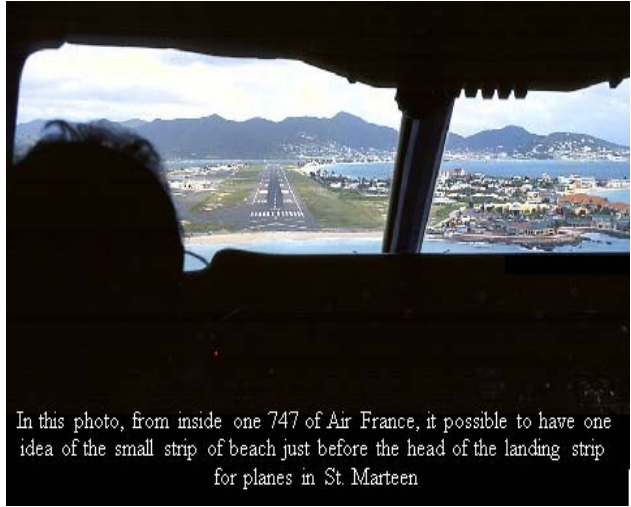
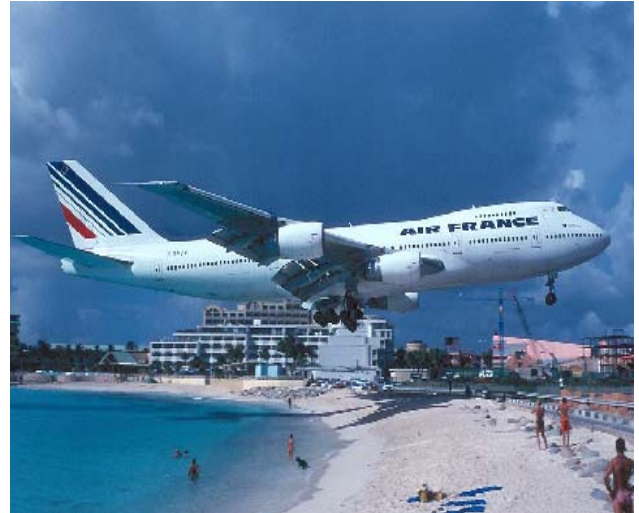
In this photo, from inside one 747 of Air France, it possible to have one idea of the small strip of beach just before the head of the landing strip for planes in St. Marteen

Figure 3 - Flight deck view of the beach view of the landing aircraft on final approach to Runway 09/27 at Saint. Maarten/Philipsburg International Airport of Netherlands Antilles.

1.5 Recognizing the extent of non-compliant RESAs and the greater difficulties imposed by the proposed safety enhancement (see figures 3 and 4), ICAO Montreal accepted the position that Member State/Territories could use *alternatives means* to achieve the safety benefits of RESA. Furthermore, ICAO acknowledged the concept of *Engineered Materials Arresting Systems (EMAS)* as a proven method to arrest overruns. Historically, EMAS first appeared in the United States and is now gaining acceptance worldwide (see figures 5 and 6 and IP/###/GREPECAS/14, *Status Of Engineered Materials Arresting Systems Installations In The United States*). However, ICAO and ADWG recognized the substantial costs associated with the installation of EMAS and, are therefore, seeking other *alternative means of compliance*. One alternative in use is the application of *declared distances* to readjust reported runway field lengths, principally ASDA [accelerated-stop distance available] and LDA [landing distance available].

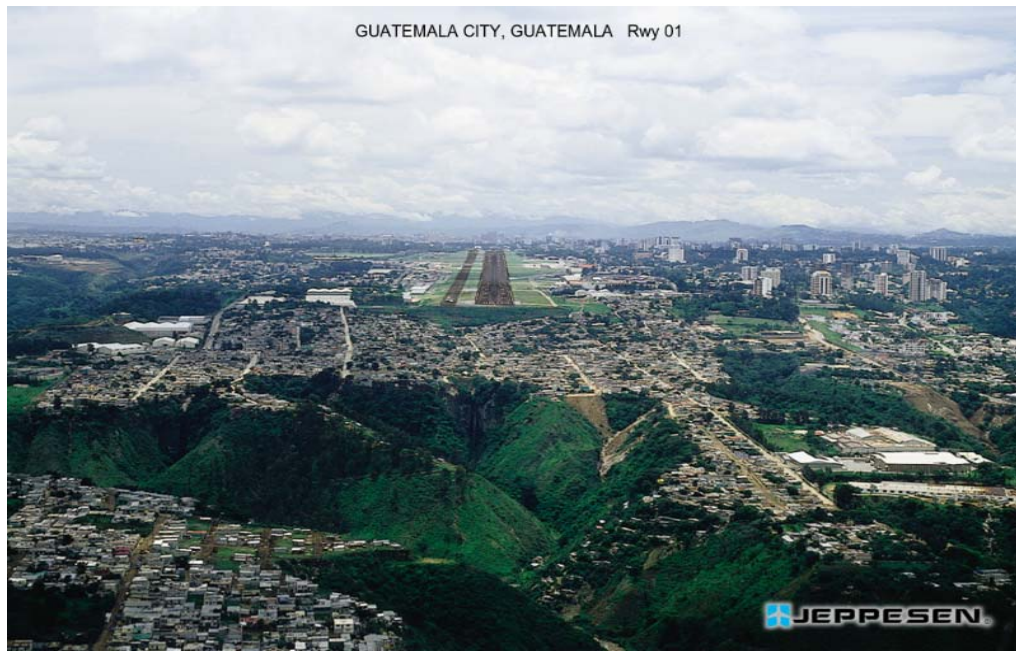
Figure 4 – Steep terrain off Runway 01 at Guatemala City La Aurora International Airport at 1,510 meters above MSL

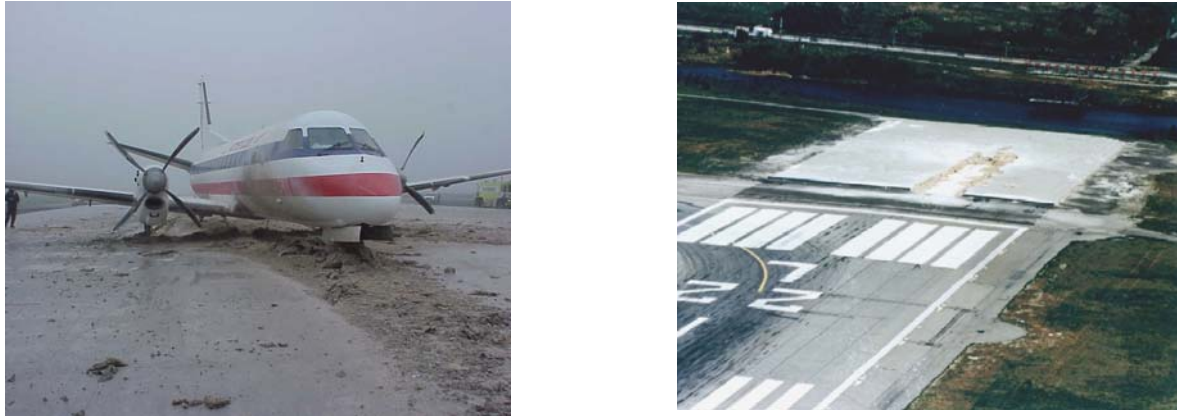
Figure 5 - Photos of EMAS off Runway 22L at JFK taken the day after the safe arrestment of a SAAB-340 overrun in June 1999 (note the surface area removed to extract the aircraft)

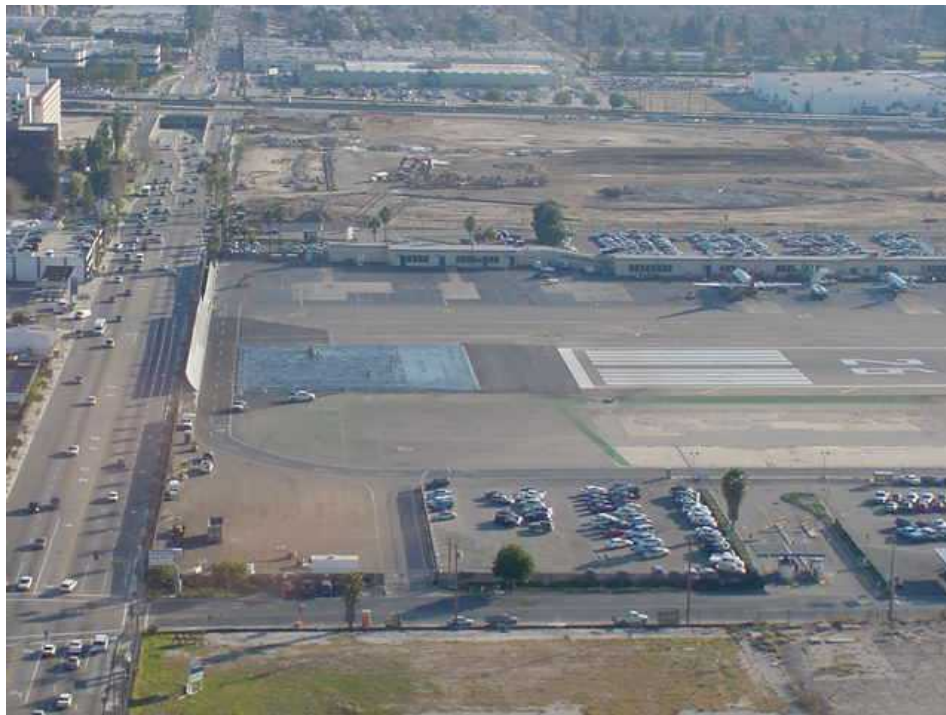
Figure 6 - Aerial photo showing (a) relationship of Hollywood Blvd. off Runway 26 at Burbank Airport, Burbank, California and (b) EMAS installation awaiting chevron-markings

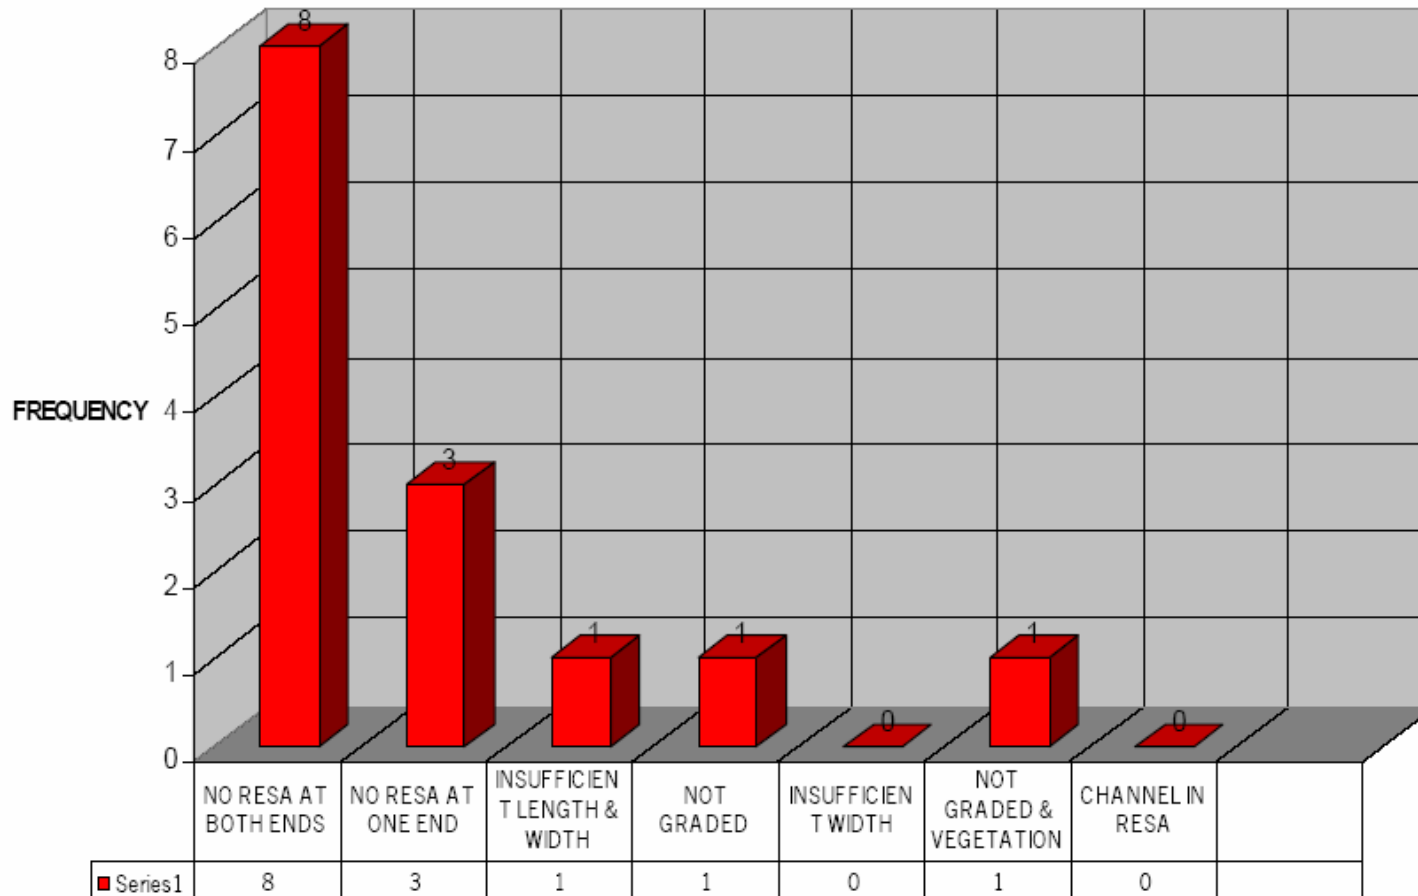
**CAR REGION - RESA DEFICIENCIES BY CATEGORY (10/2004)**

A.1.1 **CAR Region**, column No. 3 recorded 22 reported cases (or 22 runways) in 2003 that were deficient in some characteristic. Of these cases, 8 runways were corrected and are now fully compliant for this particular SARP. The positive trend, 8 of 22 runways, demonstrated a significant improvement of 36% from the 2003 WP/3 of AGA/AOP/SG/3 (27/06/03.). In response to the remaining substandard runways, figure B1 of Appendix A was developed to *categorize the causes of non-compliance*. Figure B1 clearly showed the problem to be a *lack of RESAs* as compared to problems *within existing RESAs*. To illustrate this point, of the 14 non-compliant RESA deficiencies, 11 reported no RESA at both ends or at one end, a significantly high rate of 79% (11/14). The category with the predominant deficiency at 57% (8/14) was the category “lack of RESA at both ends.”

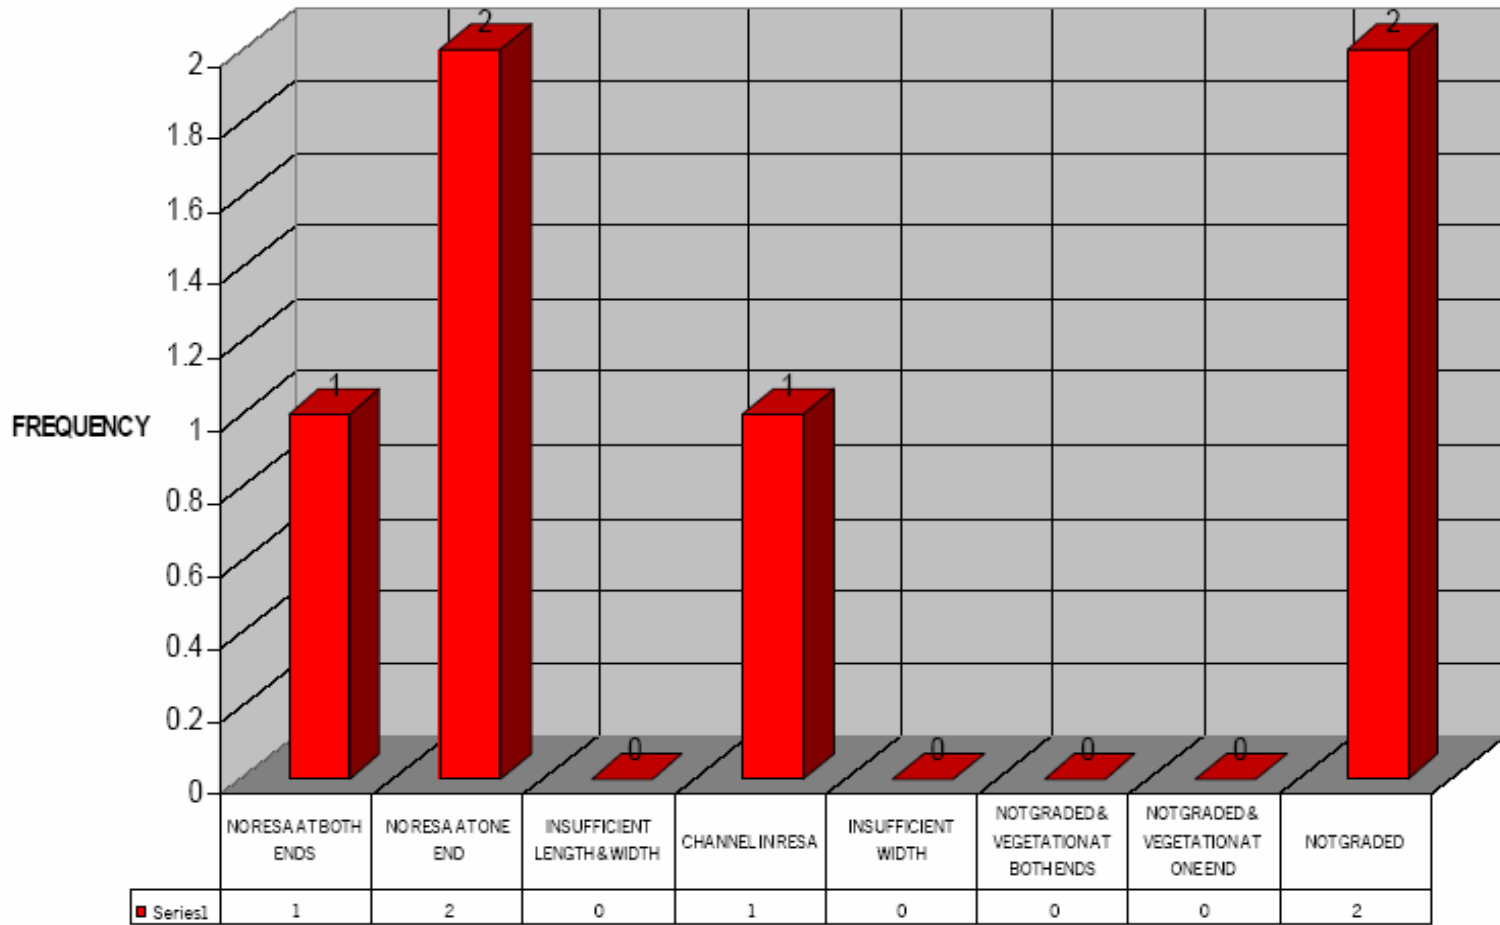
Figure B2

**SAM REGION - RESA DEFICIENCIES BY CATEGORY (10/2004)**

A.1.2 **SAM Region**, column No. 7, recorded 7 reported cases (or 7 runways) in 2003 that were deficient in some characteristic. Of these cases, 1 runway was corrected and is now fully compliant for this particular SARP. The positive trend, 1 of 7 runways, demonstrated an improvement of 14% from the 2003 WP/3 of AGA/AOP/SG/3 (27/06/03.) For the SAM Region, figure B2 clearly showed the problem to be a *combination* of the lack or existence of RESAs and problems within existing RESAs. To illustrate the point, of the 6 non-compliant RESA deficiencies, 3 reported no RESA at both ends or at one end, or a rate of 50% (3/6) while 3 reported problems within existing RESAs, or a rate of 50% (3/6).

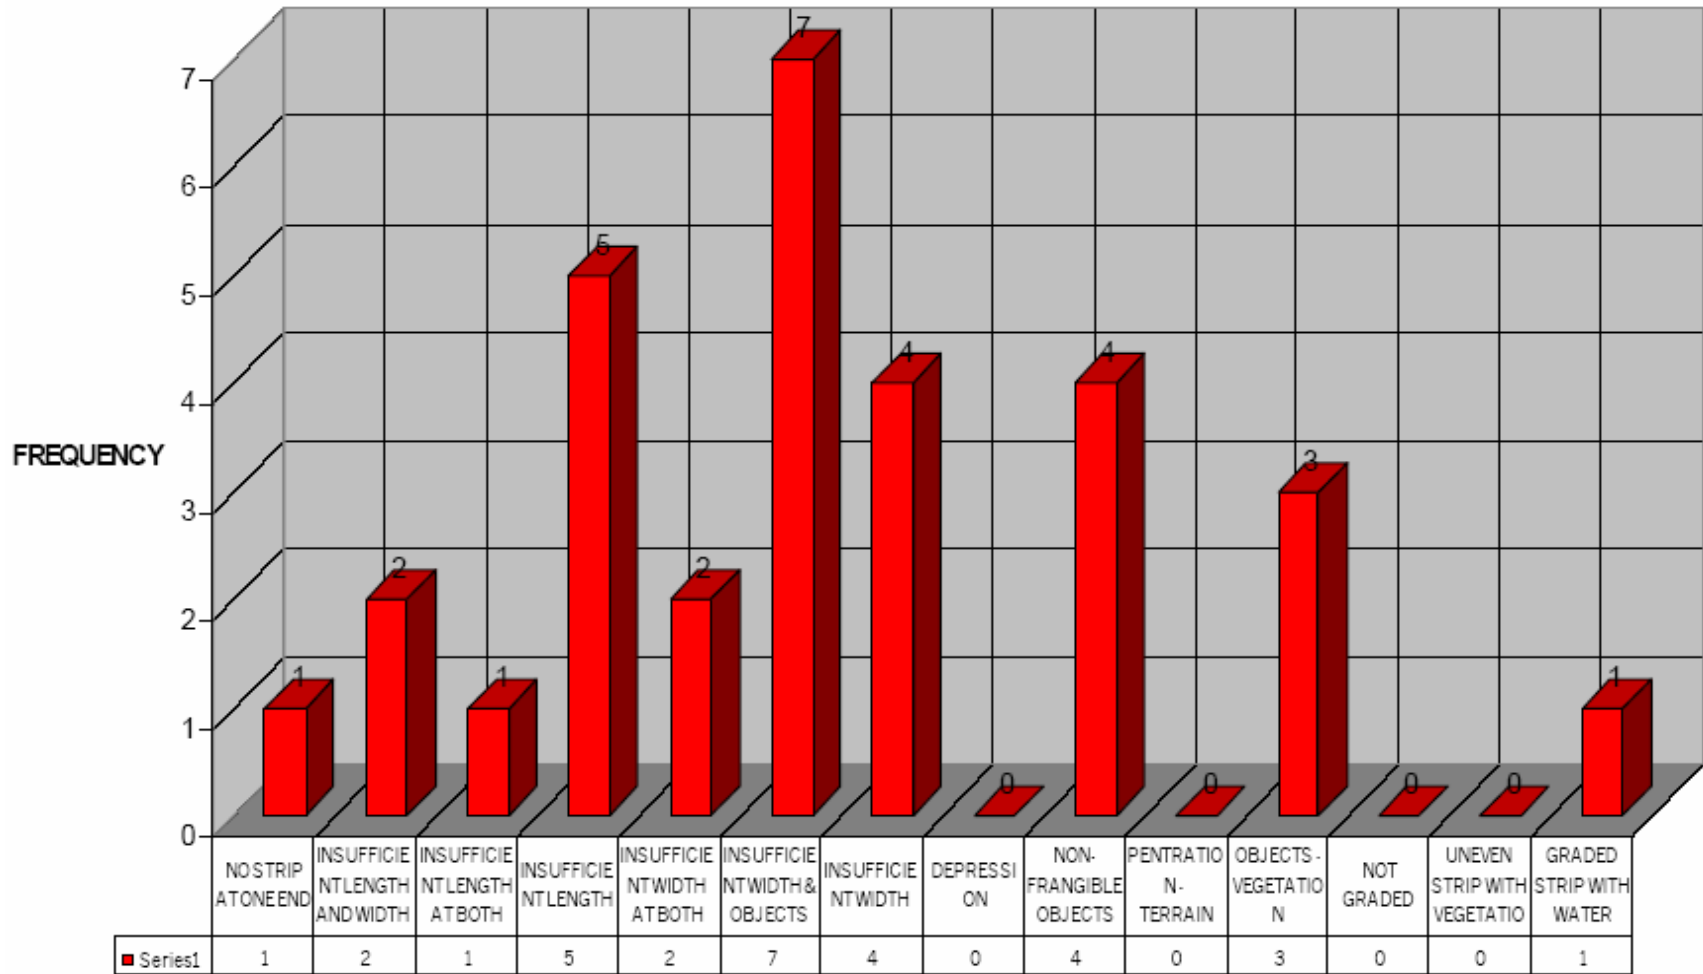
Figure B3

**CAR REGION - RWY STRIP DEFICIENCIES BY CATEGORY (10/2004)**

A.2.1 **CAR Region**, column No. 4, recorded 43 reported cases or 43 runways. Of these, 12 runways were corrected and are now fully compliant for this particular SARPS. The positive trend, 12 of 43 runways, demonstrated a significant improvement of 28% from the 2003 WP/3 of AGA/AOP/SG/3 (27/06/03.) For the CAR Region, figure B3 clearly showed the problem of *physical size* as compared to problems within existing runway strips. To illustrate the point, of the 30 non-compliant runway strip deficiencies, 22 reported substandard dimensions for a significantly high rate of 73% (22/30). The predominant deficiency was width rather than length.

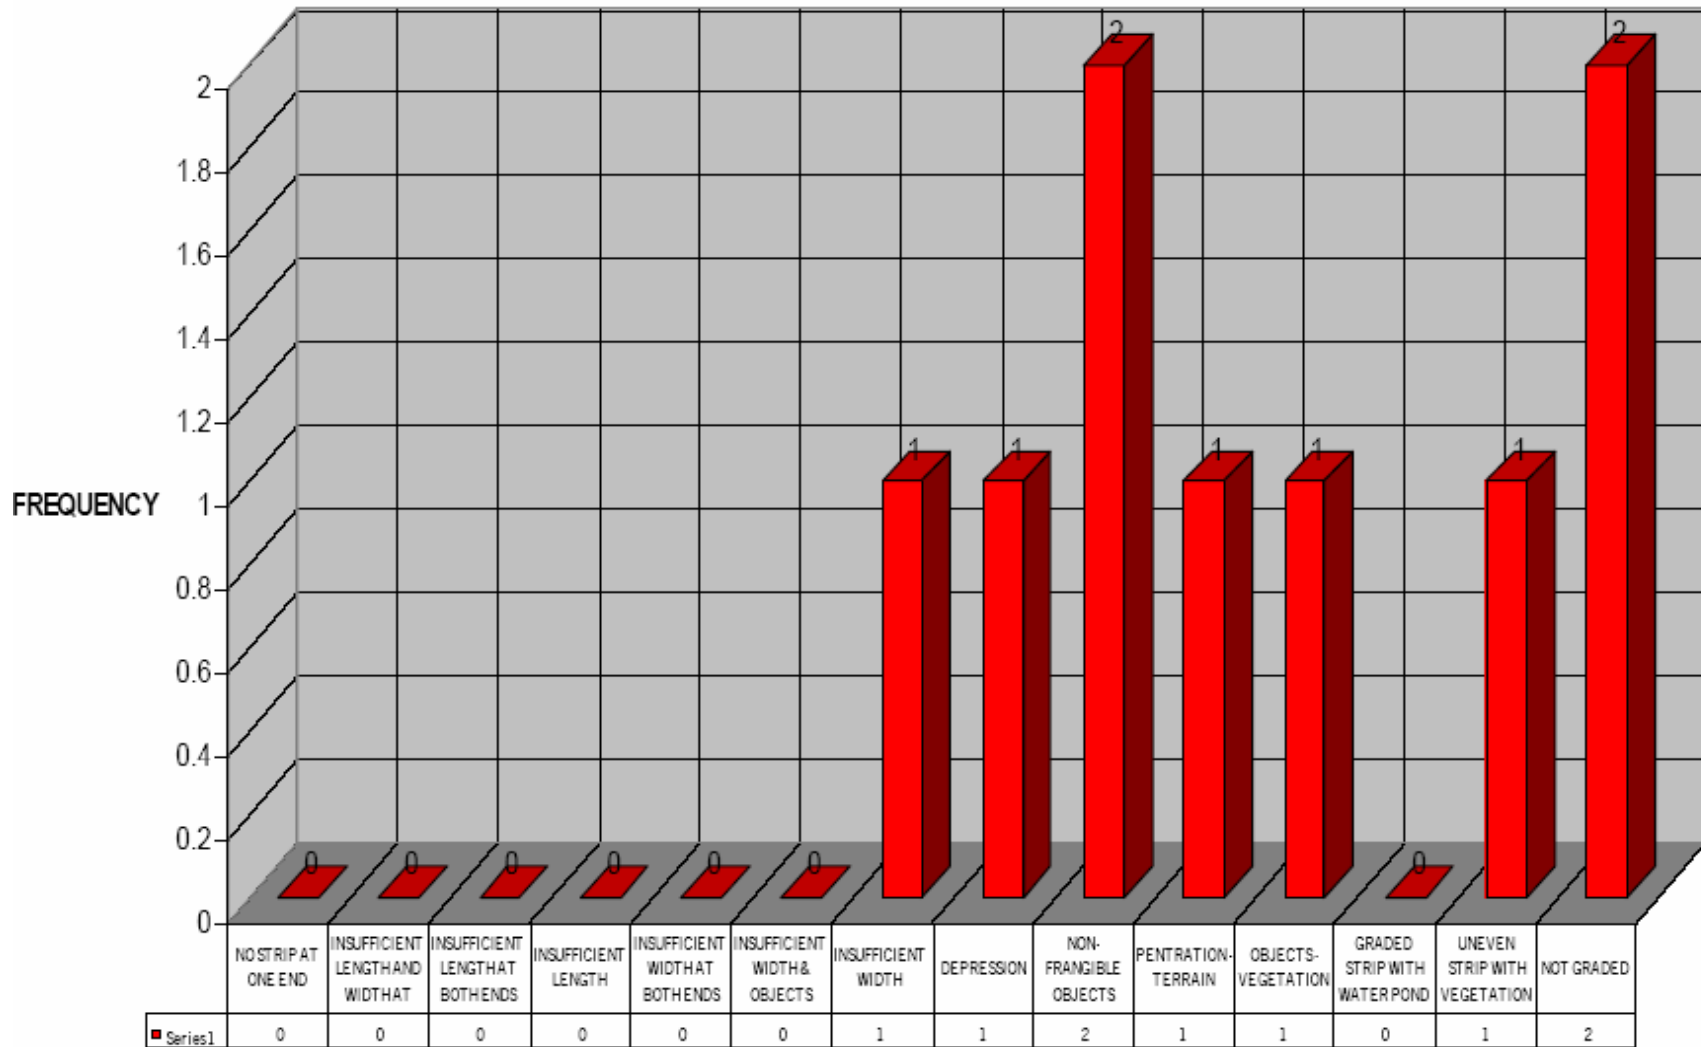
Figure B4

**SAM REGION - RWY STRIP DEFICIENCIES BY CATEGORY (10/2004)**

A.2.2 **SAM Region**, column No. 8, recorded 12 reported cases (or 12 runways.) Of these, 3 runways were corrected and are now fully compliant for this particular SARPS. The positive trend, 3 of 12 runways, demonstrated a significant improvement of 25% from the 2003 WP/3 of AGA/AOP/SG/3 (27/06/03.) For the SAM Region, figure B4 clearly showed the problem to be *within existing runway strips*. To illustrate the point, of the 9 non-compliant runway strip deficiencies, 8 reported no-dimensional problems at a rate of 89% (8/9). Objects, vegetation and/or solid structures, account for 50% (4/8) of the reported deficiencies.

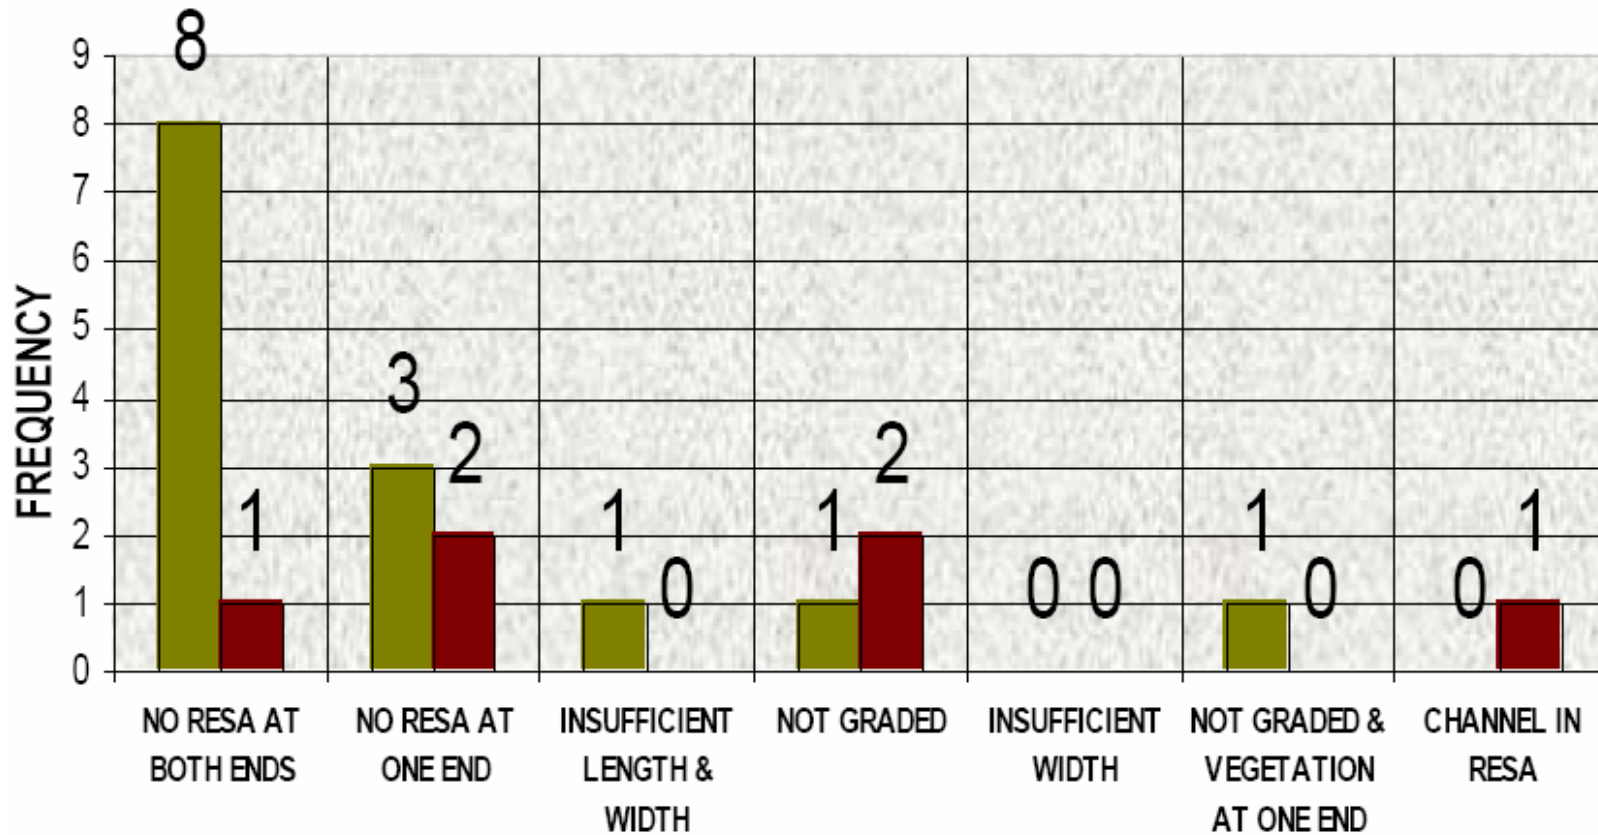
Figure B5

**COMPARISON of RESA DEFICIENCIES FOR  
CAR (///) & SAM (\\) REGIONS (10/2004)**

### A.3 **Summary Comparison for CAR/SAM Regions** (figures A5 and A6)

Figures A5 and A6 illustrated the differences between the CAR Region and the SAM Region for each SARPS. For RESAs, figure B5 showed that *both regions share similar types of deficiencies*, with the exception of the much higher rate within the CAR Region for runways lacking RESAs at both ends; *a rate of 8 to 1*. For runway strips, figure B6 showed a *dichotomy of the problem*. That is, the CAR Region faces a dimensional challenge as compared to the SAM Region, which faces a clearing of objects and improved grading conditions.

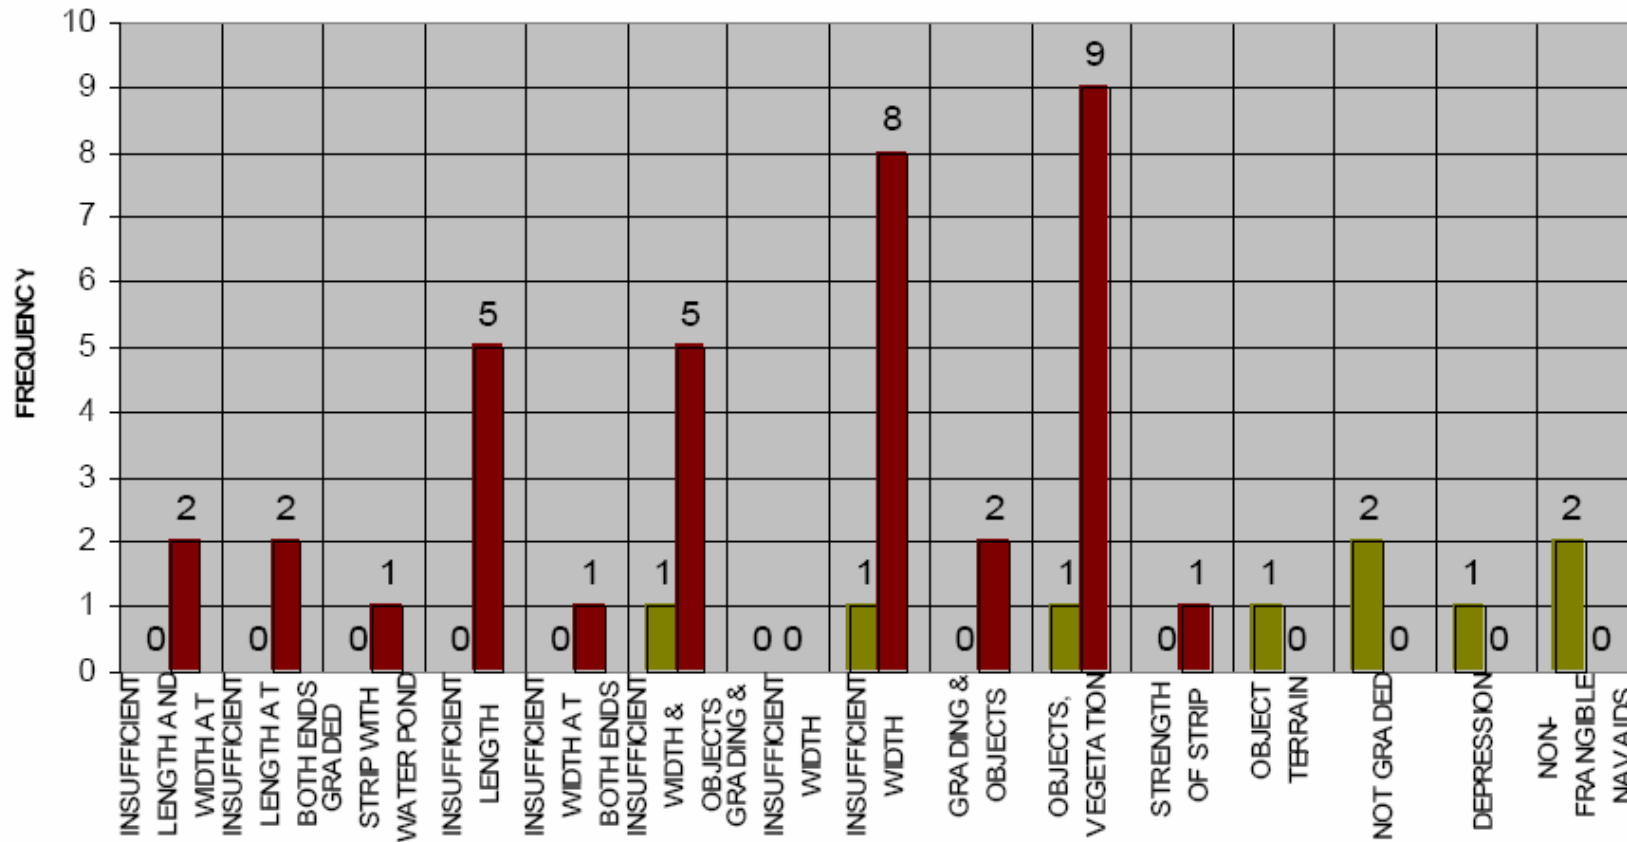
Figure B6

## COMPARISON OF RWY STRIP DEFICIENCIES FOR CAR (///) & SAM (\\) REGIONS (10/2004)
