ICAO-COSCAP Cabin Safety Seminar - Singapore 2013

Addressing Cabin Safety Threats

Addressing Cabin Safety Threats – Risk Exposure

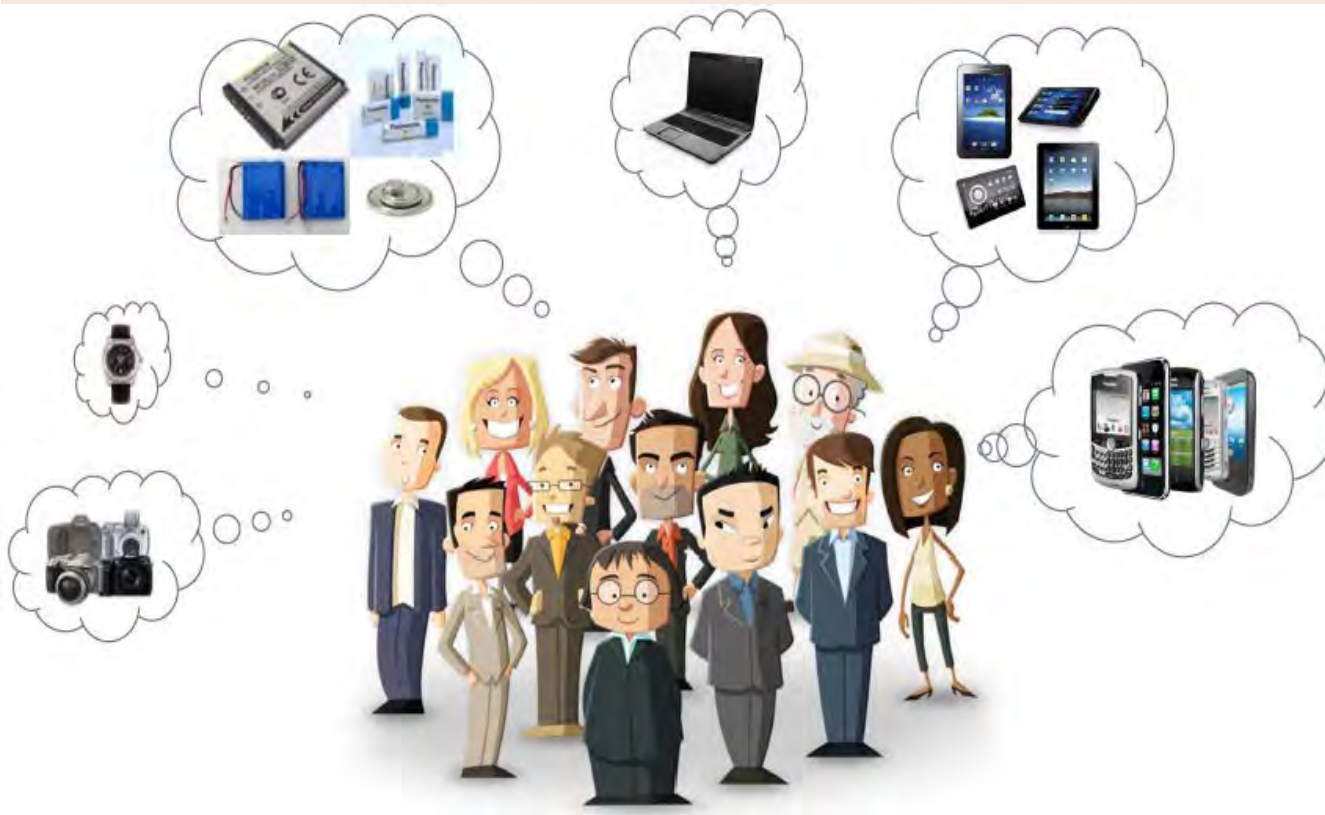
Lithium Batteries – Cabin Threat

- **Mitigation:** Cargo Safety Review Group initiated to review carriage of Dangerous Goods, with particular focus on Lithium Batteries transportation
- **Major milestones so far:**
 - Embargo on Lithium-metal batteries shipment on PAX a/c
 - Loading segregation between Lithium-Batteries and DG
 - Lithium-Batteries info on NOTOC

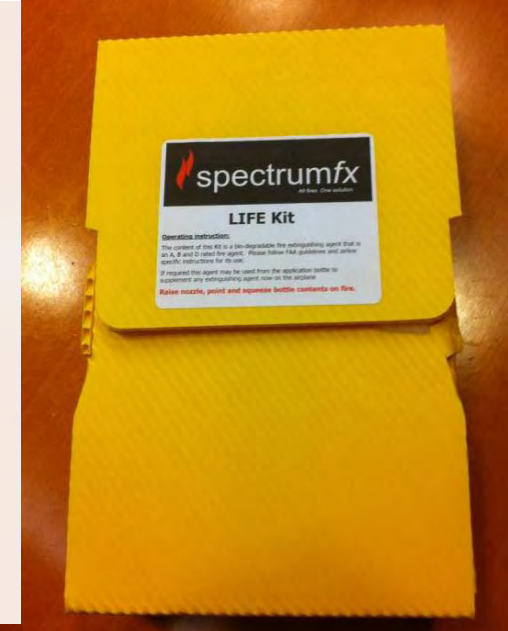
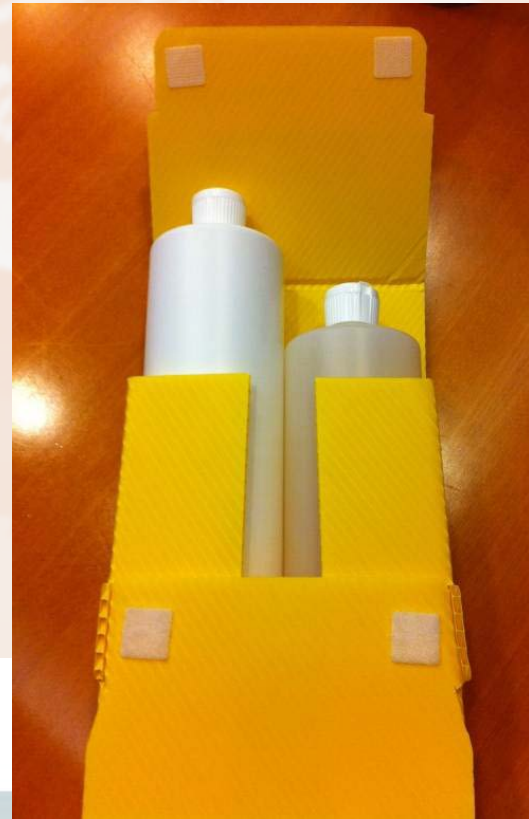
Dealing with Lithium Battery Fires in Cabin

Product “Firebane”

- Class D rated extinguishing agent,
- Designed for molten metal fires,
- Safe for people,
- A **GREEN** extinguishing agent .

Firebane can be used to douse the burnt P.E.D containing lithium battery to prevent re-ignition

Firebane are onboard all KA aircraft

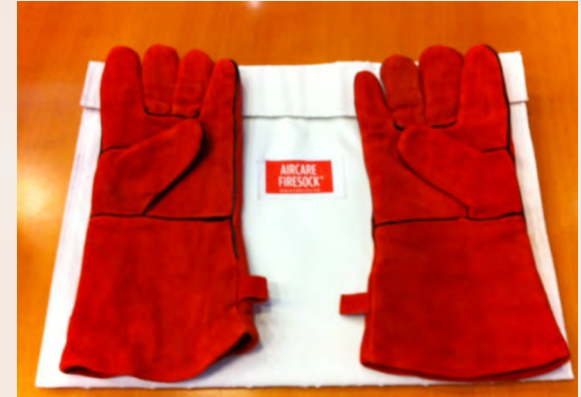
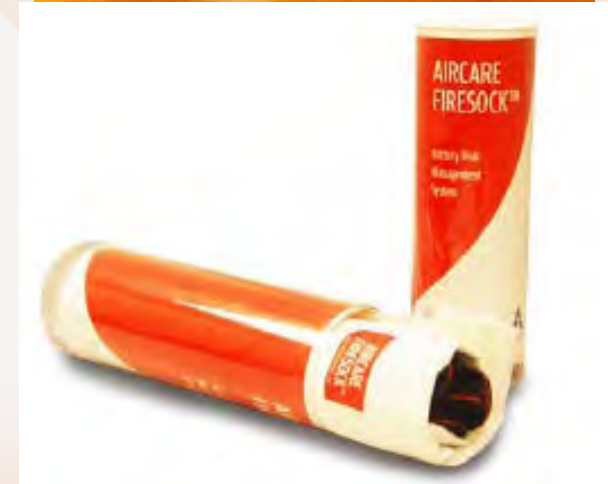
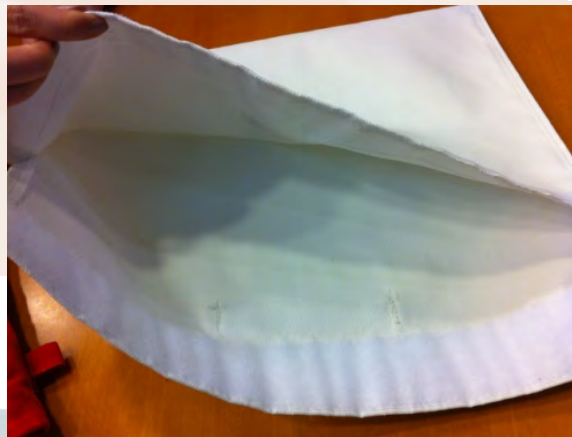
- Designed to contain fire in single or multiple cell lithium battery packs during a lithium battery fire.

FireSock kit includes :

- A pair of heat resistance gloves,
- A re-sealable storage tube,
- A re-sealable FireSock bag to contain the burnt P.E.D. after an incident.

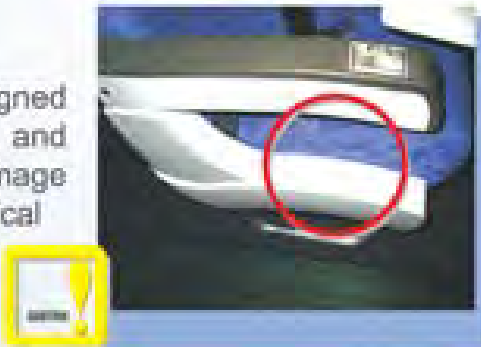
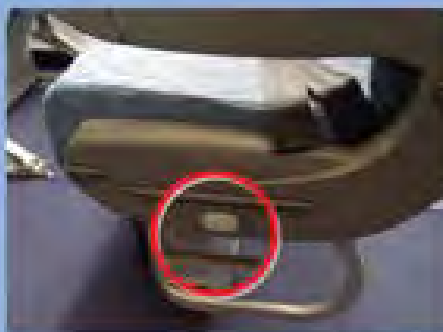
Using footstep

• This surface is not designed for people to step on, and doing so may cause damage to cabin facilities or physical injuries when you lose your balance and fall.

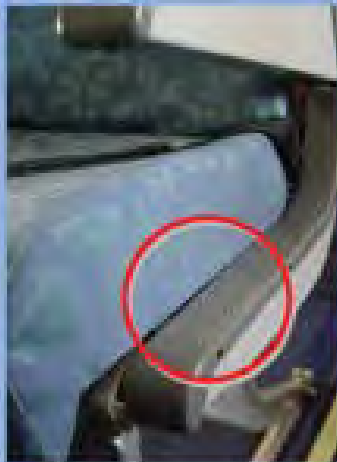
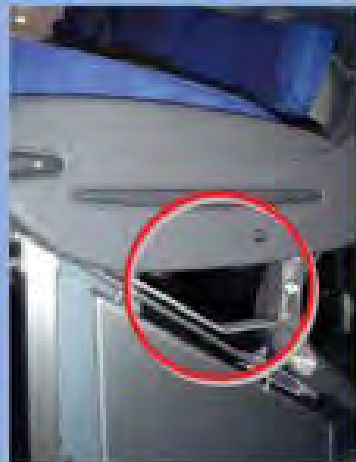
• These are proper foot steps in the cabin

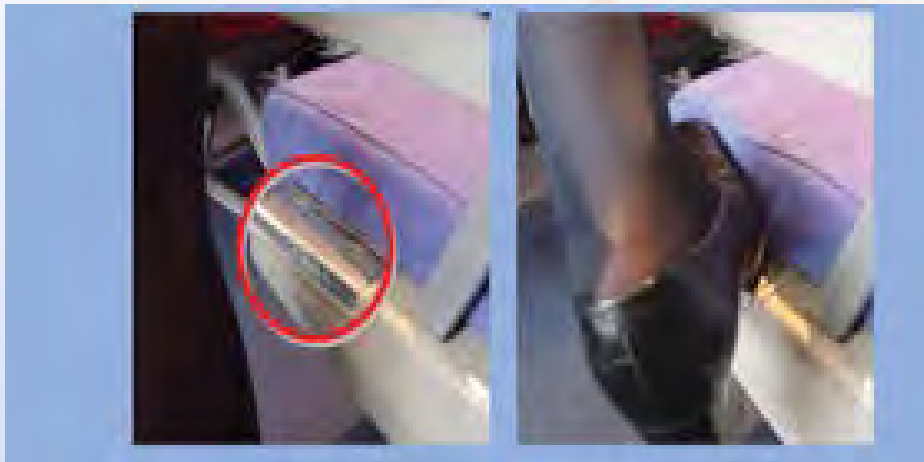
Hazard :

- Cabin crew injuries while stepping on the side of pax's seat without footstep/ non-skid pad.

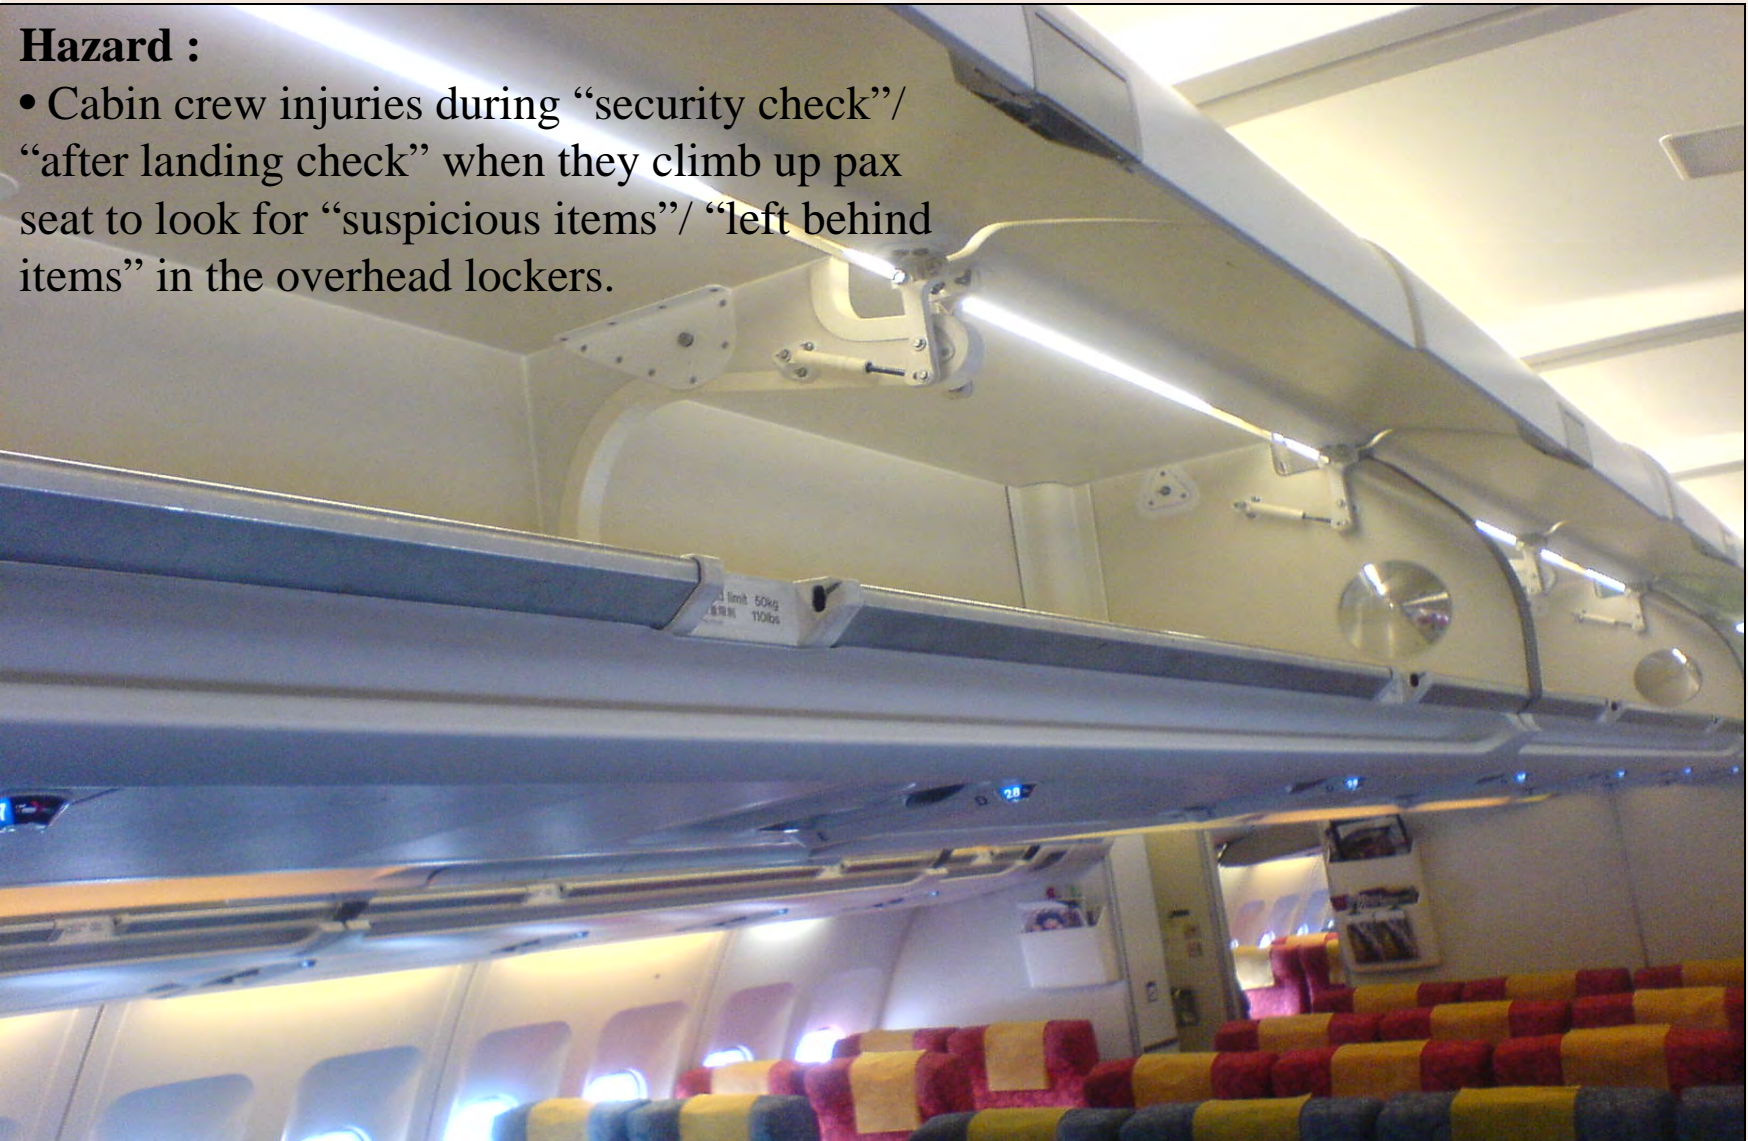
To Assist with Overhead Locker Security Check

- Cabin crew injuries during “security check”/ “after landing check” when they climb up pax seat to look for “suspicious items”/ “left behind items” in the overhead lockers.

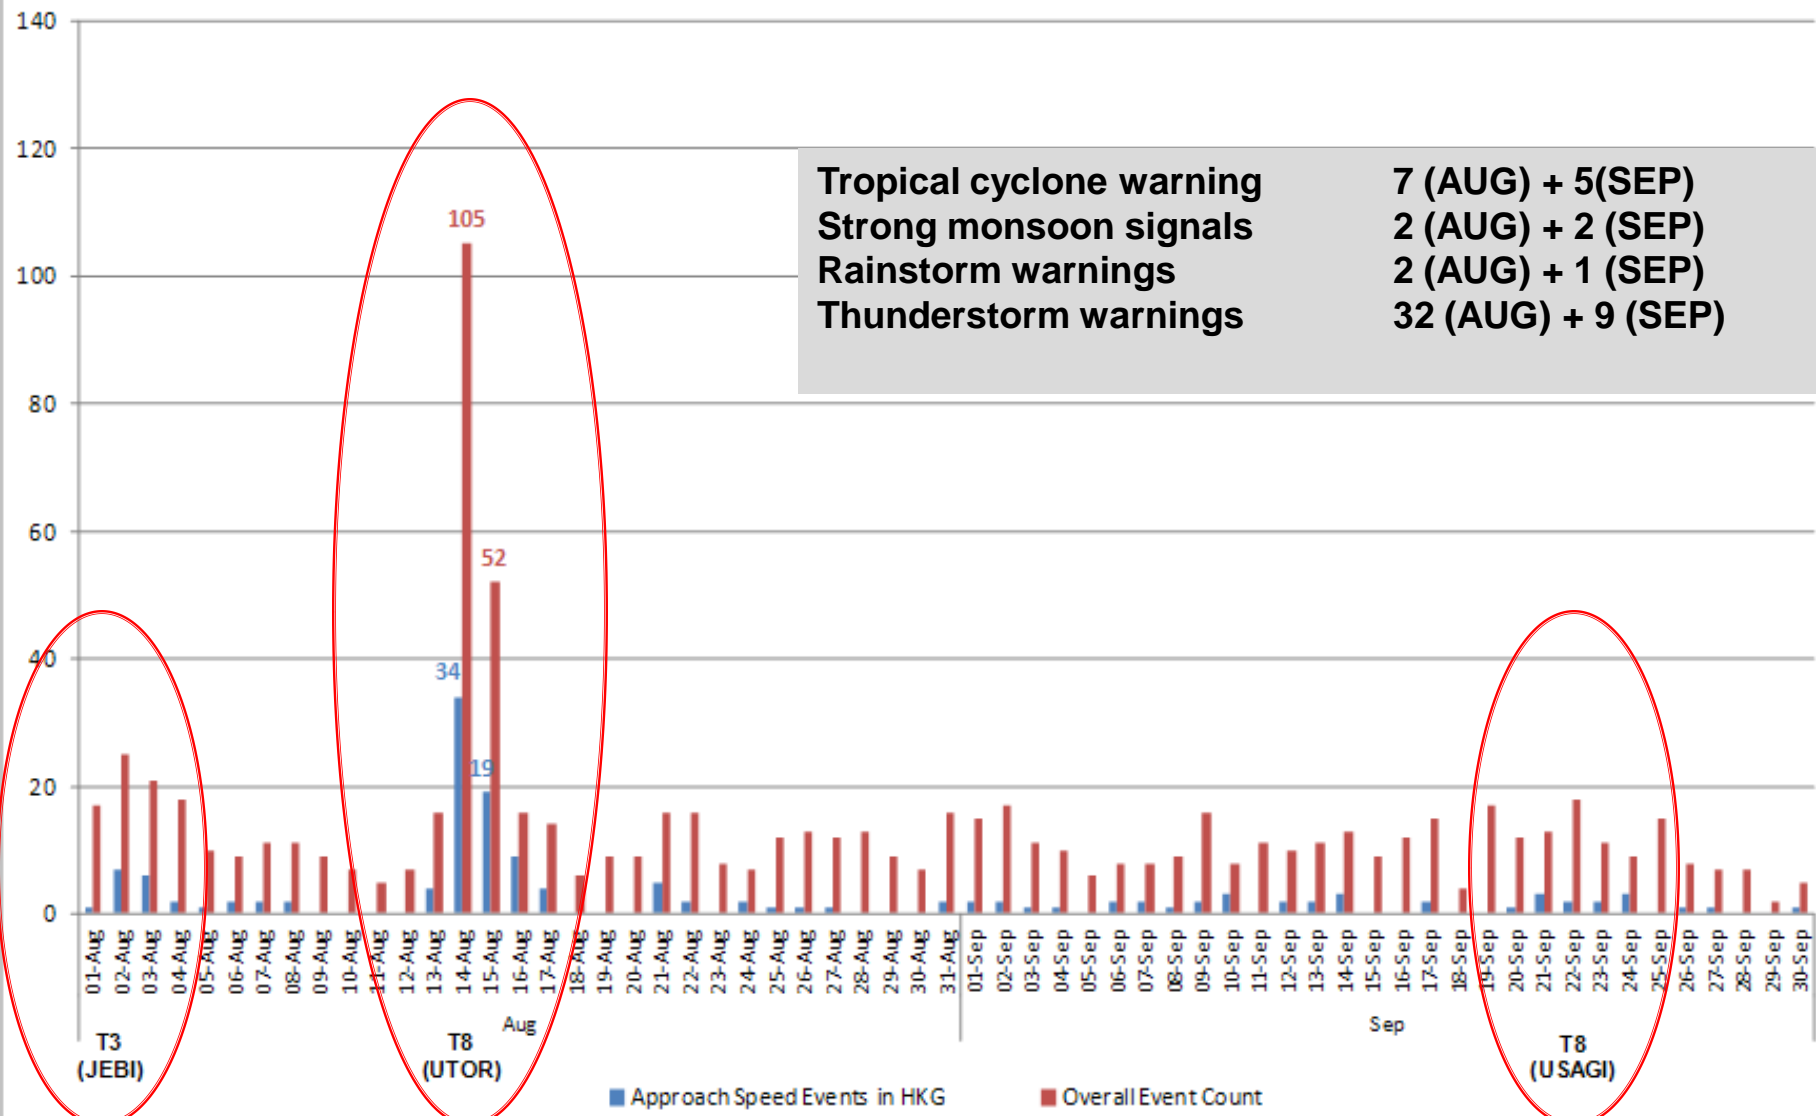
Daily Count of Events in HKG (Aug to Sep 2013)

Tropical cyclone warning 7 (AUG) + 5 (SEP)
Strong monsoon signals 2 (AUG) + 2 (SEP)
Rainstorm warnings 2 (AUG) + 1 (SEP)
Thunderstorm warnings 32 (AUG) + 9 (SEP)

■ Approach Speed Events in HKG ■ Overall Event Count

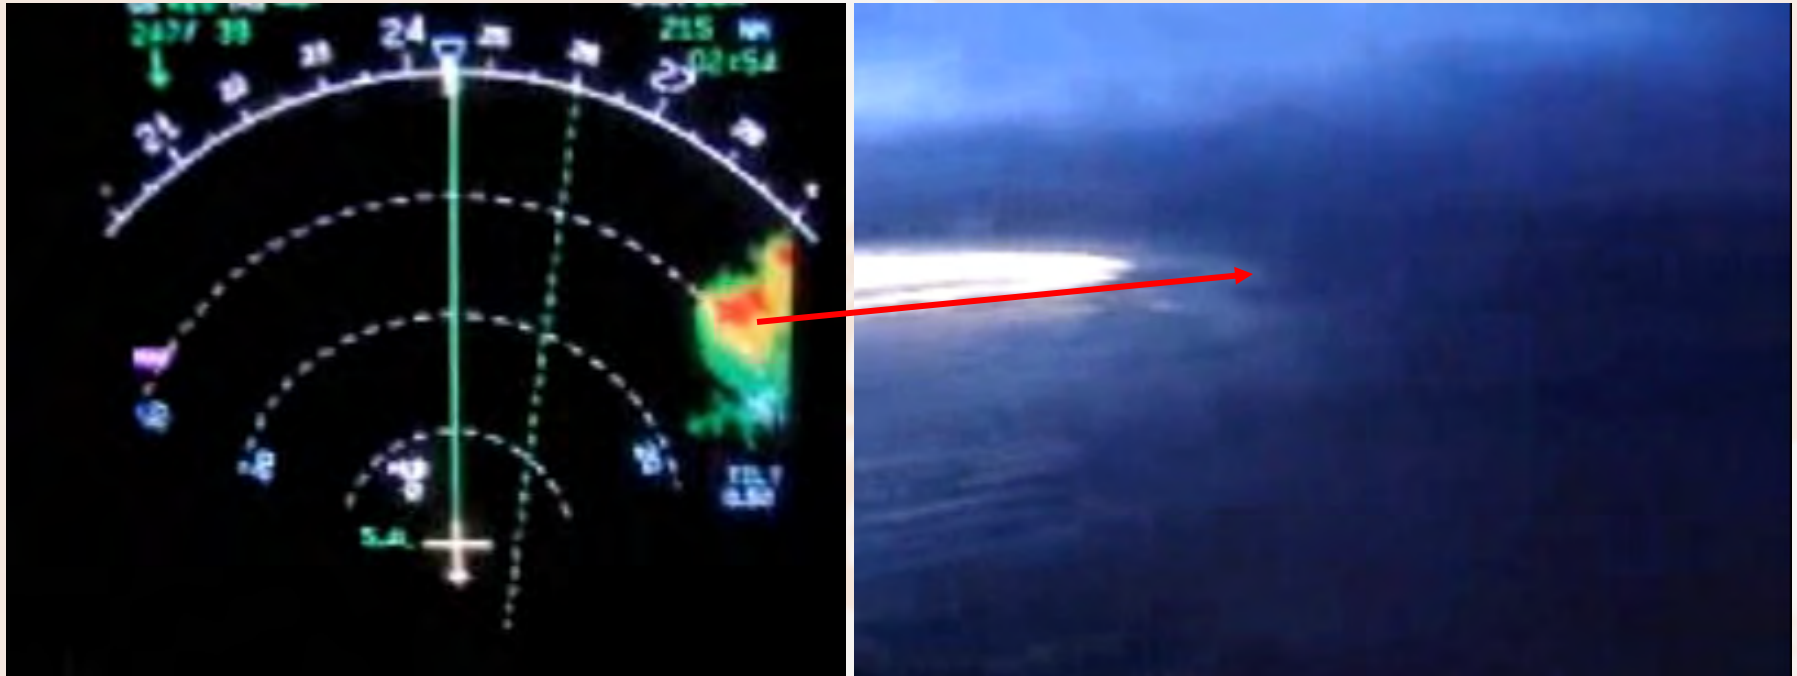
Flight Crew extensive use of the Onboard Weather Radar

- The flight crew community receive and tested on the use of the onboard weather radar annually
- Declare “Pan” for weather avoidance in congested routes, mainly in the PRC
- Employ new technology when available

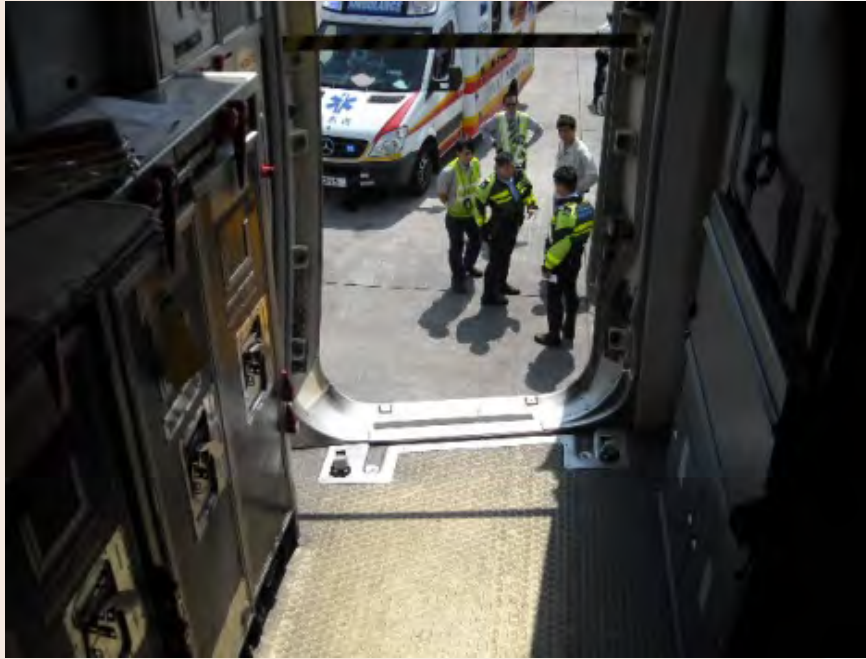
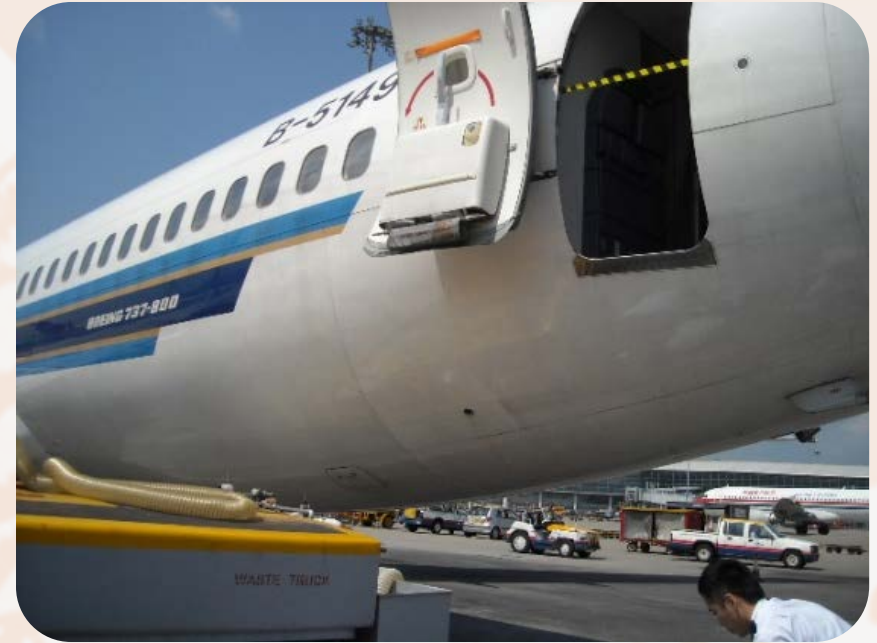
Unsecured Doors – A Death Trap!

- For this operator it is was normal procedure for the cabin crew to close an open cabin door from inside without any platform connection outside.
- The ramp vehicle did not wait till the aft left door was closed before retracting from the door.

- The likelihood of having left open cabin doors by ramp vehicles is 'POSSIBLE', particularly at outstations.
- The severity of injury to crew is 'MAJOR'.
- The risk level associated with this hazard is 'HIGH'. (*significant risks that require immediate attention*)

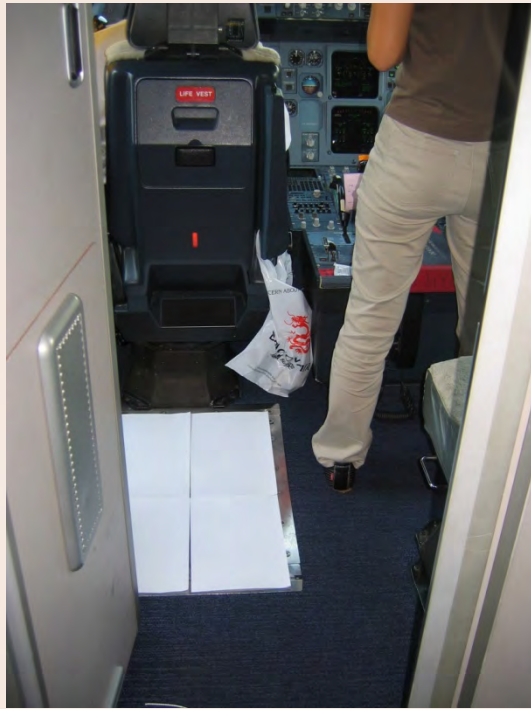
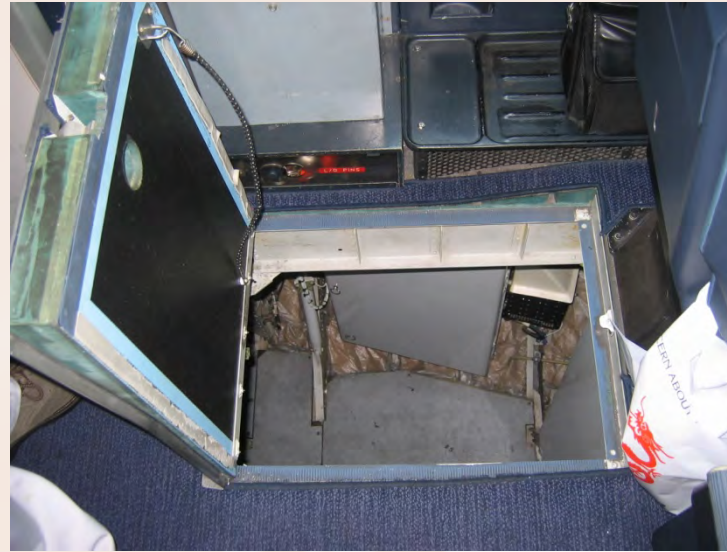
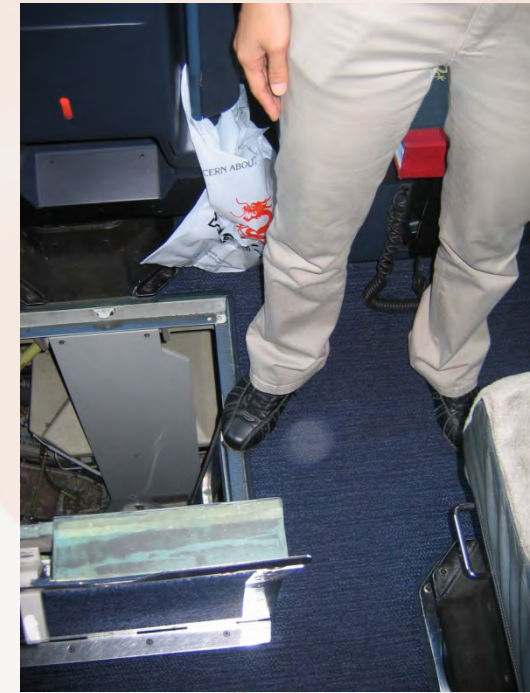
Unsecure Doors – Avionics Bay Access Door in Cockpit

The mix of cabin crew and ground engineers entering the flight deck is perhaps unavoidable during line operations.

A number of incidents where cabin crew have fallen into the open void while carrying pre-flight duties in the cockpit.

- Procedural; suspend pre-flight C/C duties and lock the Flight deck door (to be kept locked until hatch is closed)
- Technical (long term mitigation); change the hatch hinge orientation to be side opening (adopted on new production A350)

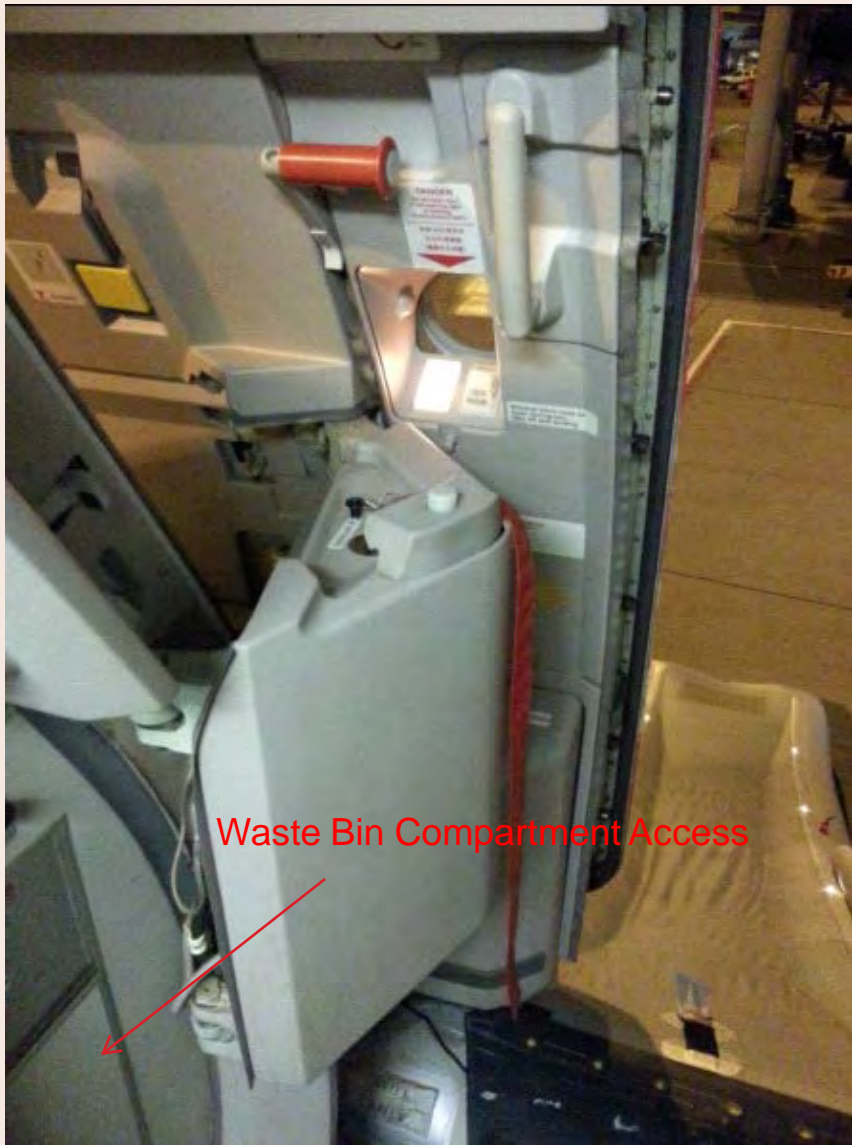
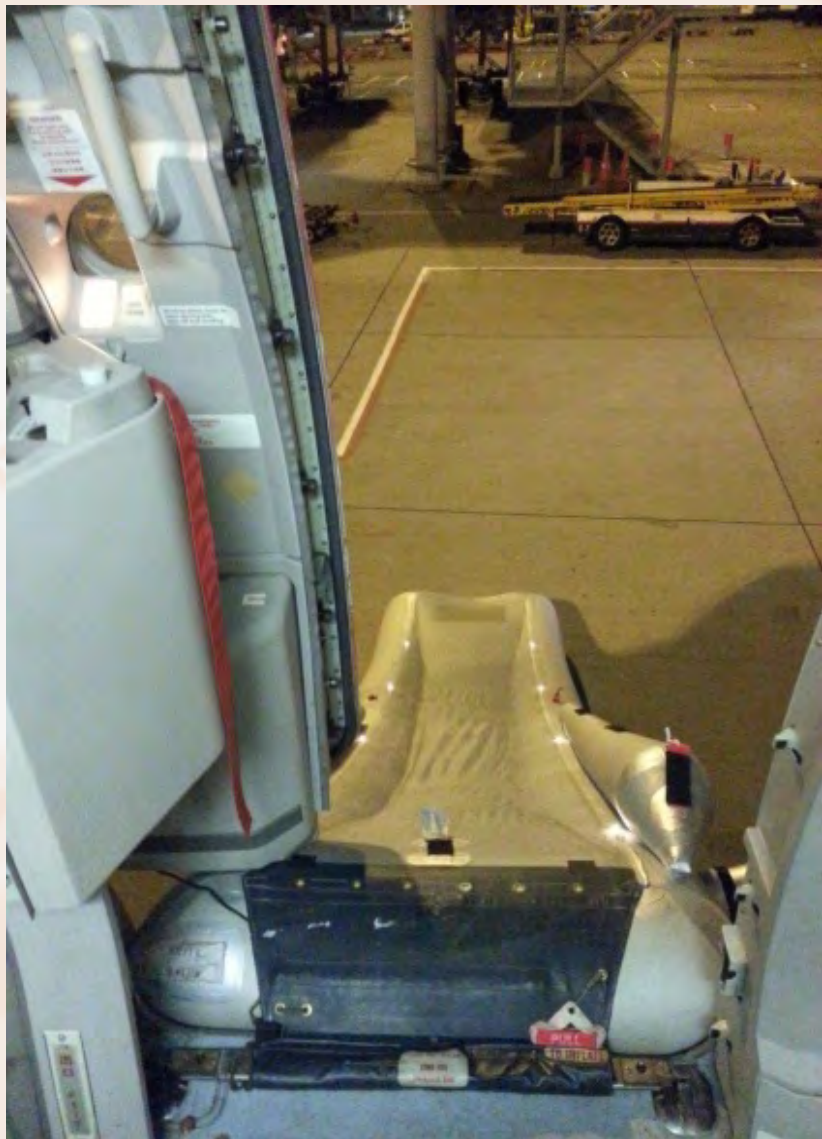
Doors – Oops, I didn't Know it was Armed !

Cleaning supervisor opened the R1 door from inside while the door was armed which resulted in the inflation of evacuation slide

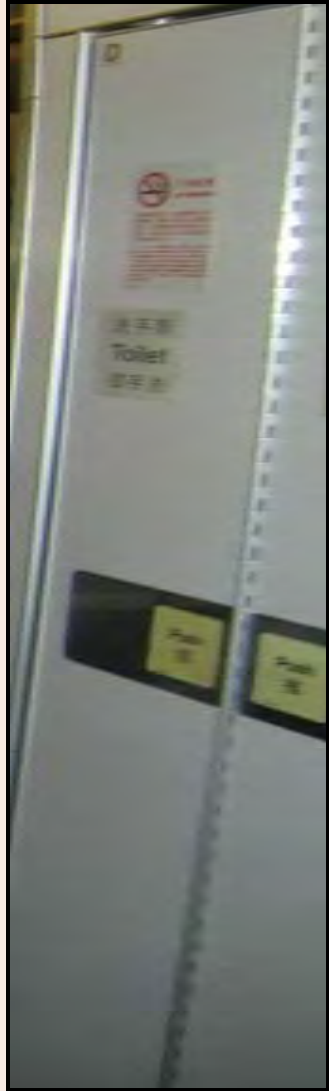
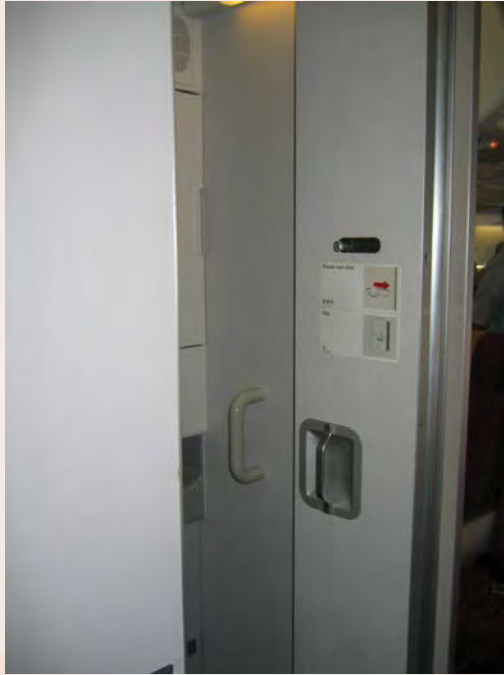
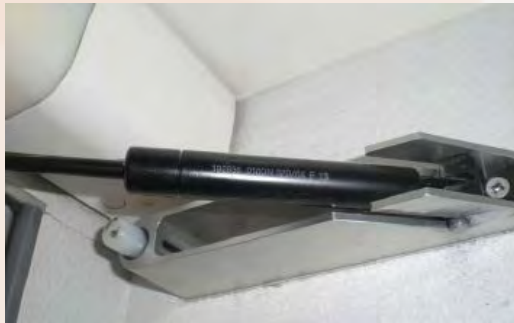
Lavatory Doors : Bi-Folding Type !

- The bi-folding doors close automatically and fold inside the lav. Compartment
- “Push” stickers are close to the fold-in line of the door
- Quick automatic release & closing mechanism
- The doors are attached with a gas spring to keep the door always in a closed condition plus there is no adjustment
- Injuries are often minor and not reported ;
 - Hand/ finger injury while pushing the door open due to stiffness of the door.
 - Hand/ finger trapped at the fold-in line while pushing-in the door for entry.
 - Hand/ finger trapped during the quick automatic closing action

- Cabin crew are to tech-log lavatory doors that has caused injury for engineering follow-up.
- Routine checks on the opening & closing mechanism of all bi-folding doors on whole fleet.

- Engineering to ensure the bi-folding lavatory door mechanism on new aircraft can be adjusted.
- Engineering to review lavatory door type/design with new cabin retrofit.

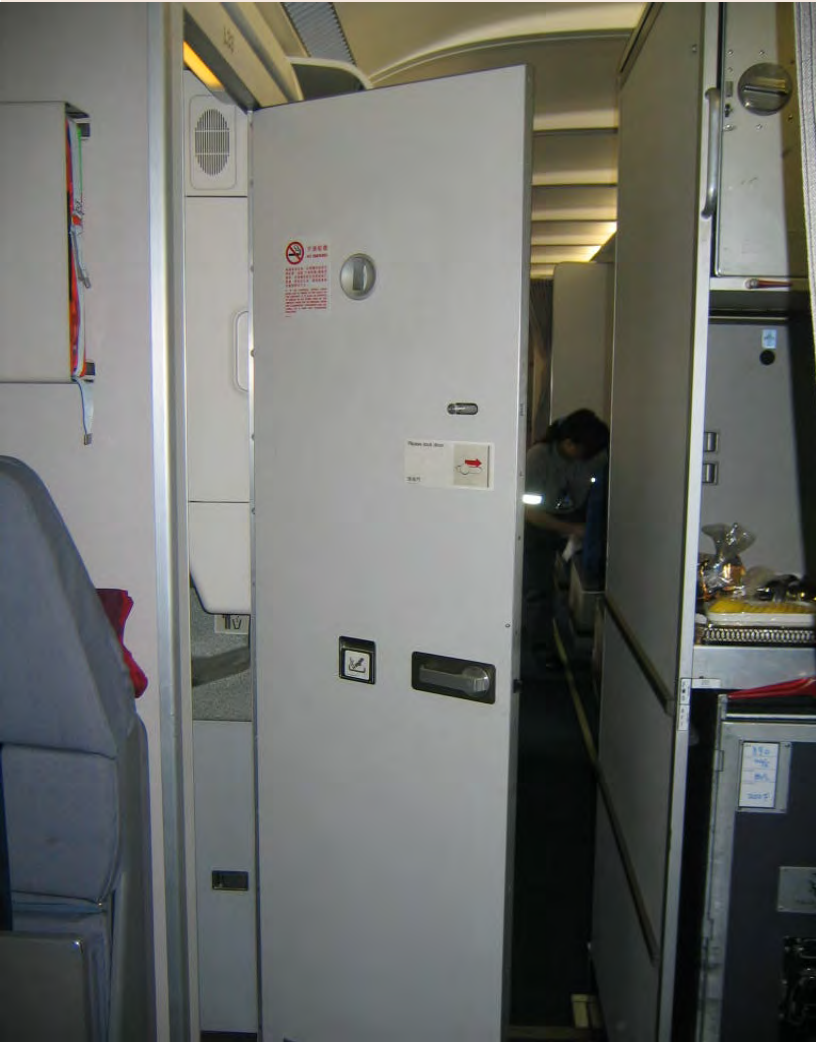
Lavatory Doors : Single Blade Type

- ▶ The larger lavatory has a single blade door which does not close automatically.
- ▶ The opening action is outwards and in certain locations, into the aisle (causing injury to pax or crew)
- ▶ Requirement to have certain number of such doors for disable pax access

Engineering propose modification to reduce the opening speed and reduce the possibility of inadvertent opening of the existing doors, e.g, use of a damper

A warning sticker (inside) door to exercise caution when opening

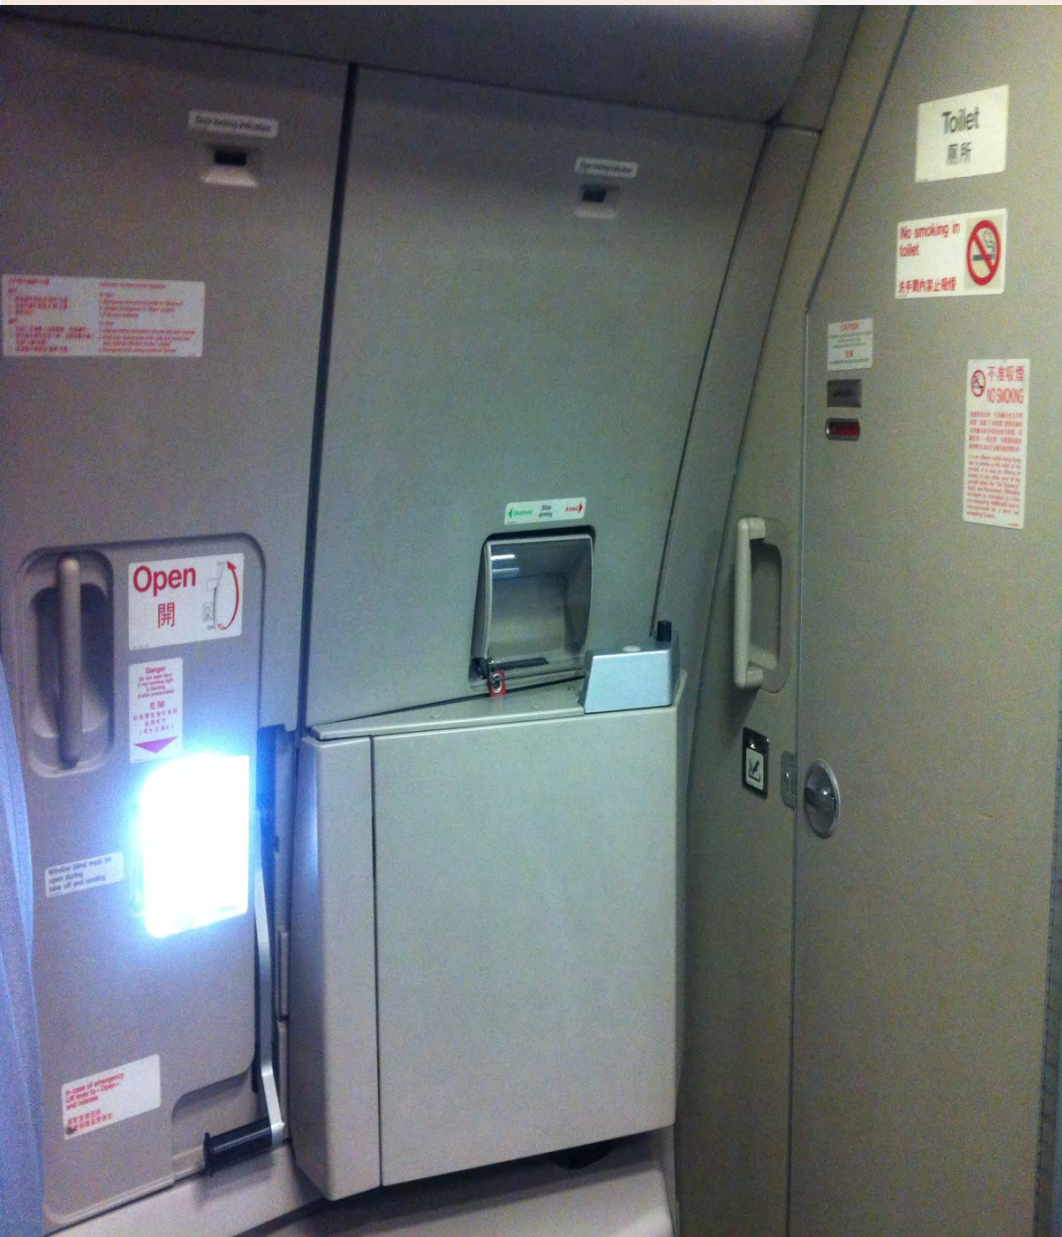
Doors : Where is the Toilet ?

- At around 1200LT, Captain informed CP L4 door was not locked.
- CP went to check the door and saw the door control handle was lifted slightly up.
- CP put the handle down immediately to lock the door.
- None of the crew in EY had witnessed anyone attempting to lift the door handle as they were all busy for meal service.
- Aircraft was cruising at 31000 ft.

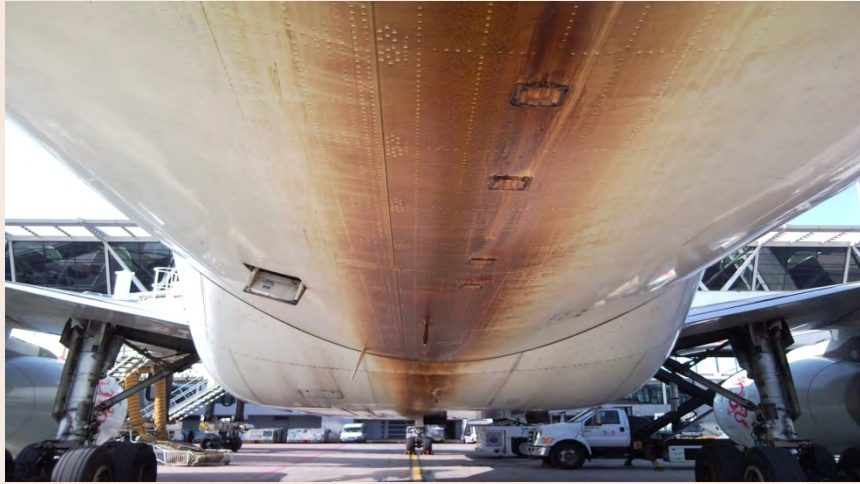
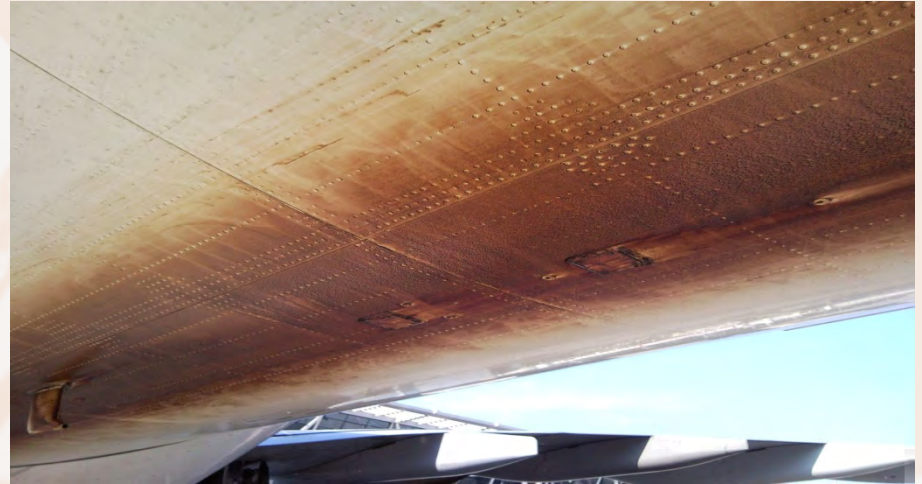
Safety over Service

- A technical solution is preferred to avoid the direct contamination of the RA's from the galley drains
- In the absence of a technical solution , the pouring of certain liquids (grey water only) is prohibited

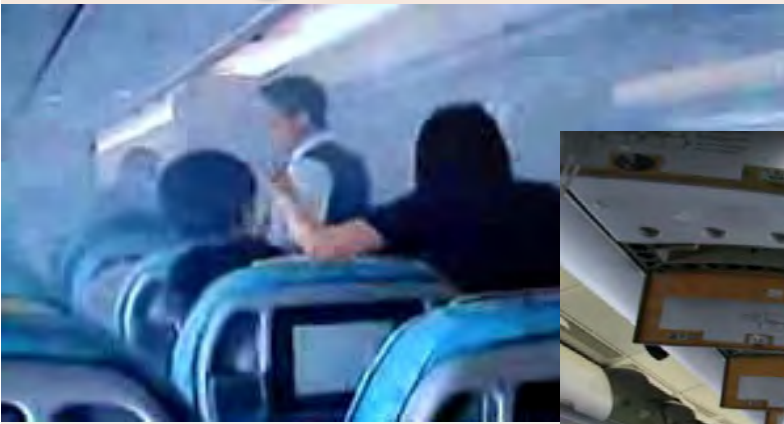
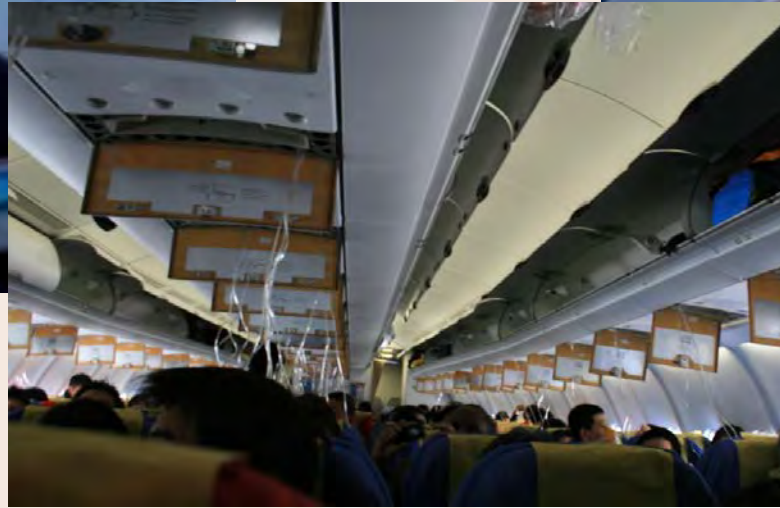
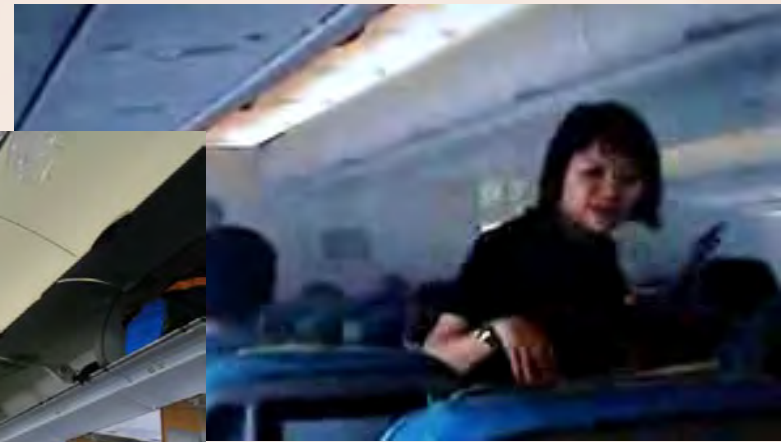
Dealing with an real emergency- smoke in the Cabin

- White dense smoke with strong burning plastic smell emitted from mid cabin, spreading to fwd & aft cabin.
- Oxygen masks were deployed in the smoke-filled cabin to provide oxygen for passengers
- P.A was made by cabin crew to instruct passengers how to activate oxygen and don mask as the oxygen masks were deploying in the cabin
- Passengers put on the mask as instructed and cabin crews were checking that passengers had donned masks correctly
- The majority of oxygen masks' reservoir bag did not inflate, but with green indication and weak oxygen flow (This phenomenon was subsequently confirmed as normal by the Engineering Department)
- Smoke eventually dissipated during descent into PEK. It lasted approx.10 minutes.
- Cabin was prepared for a normal landing following Captain's PA prior to landing

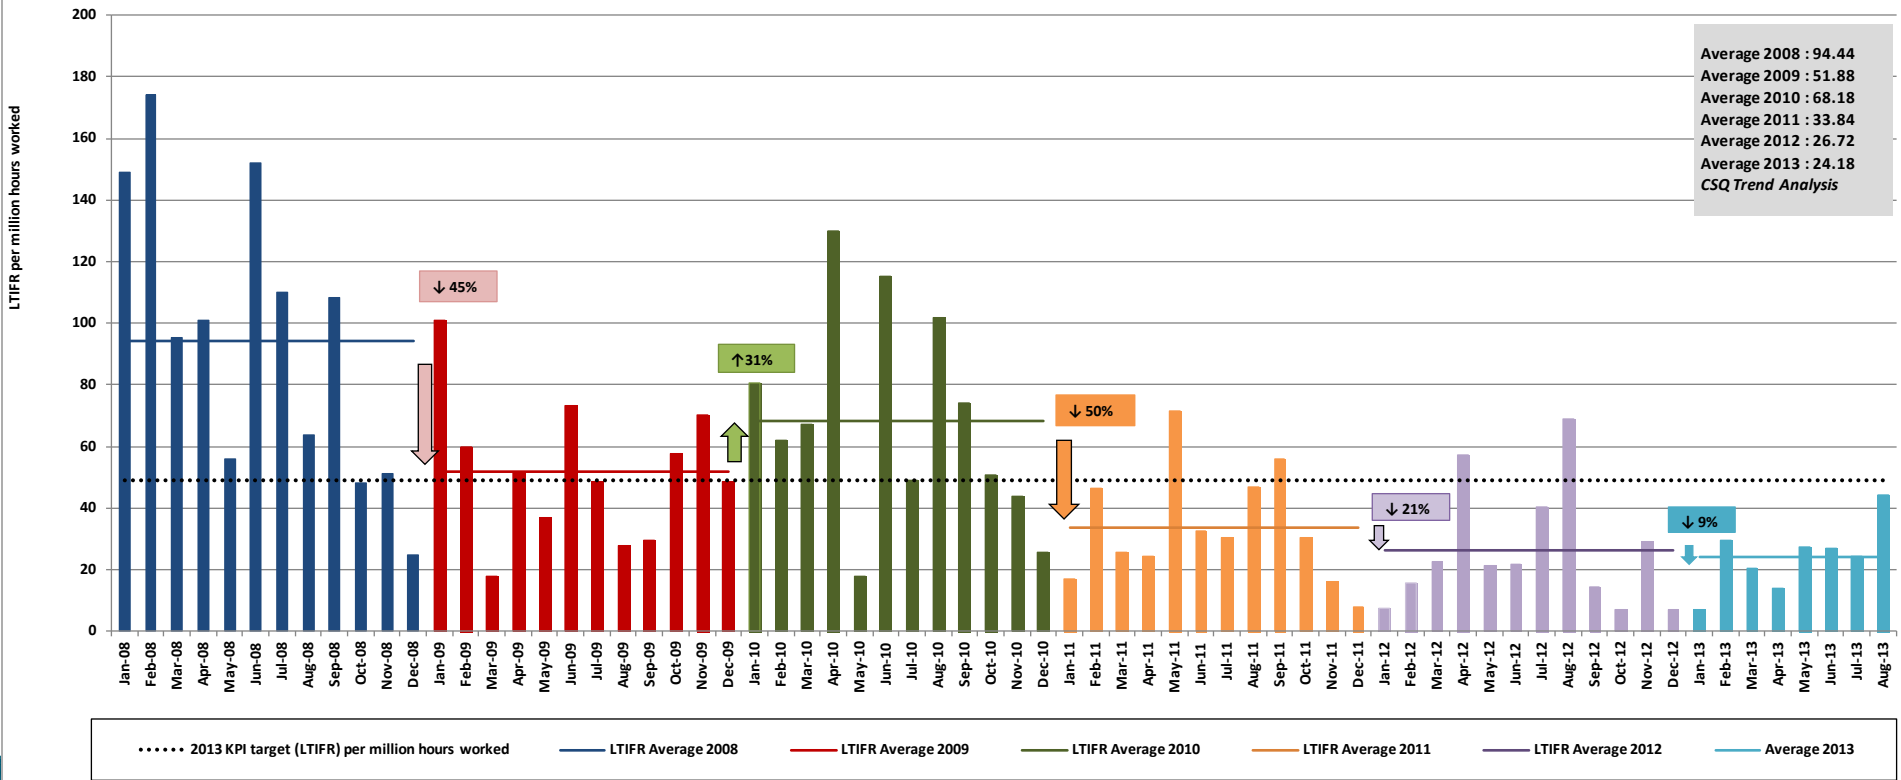
Lost Time Injury Frequency Rate

Average 2008 : 94.44
 Average 2009 : 51.88
 Average 2010 : 68.18
 Average 2011 : 33.84
 Average 2012 : 26.72
 Average 2013 : 24.18
 CSQ Trend Analysis

Consistent On Going Reduction in Cabin Safety Injuries
