**Guaraní International Airport**

**Aeronautical (Safety) Study of  
Airfield Items for the 747-8  
Operations**

**24 January 2013**

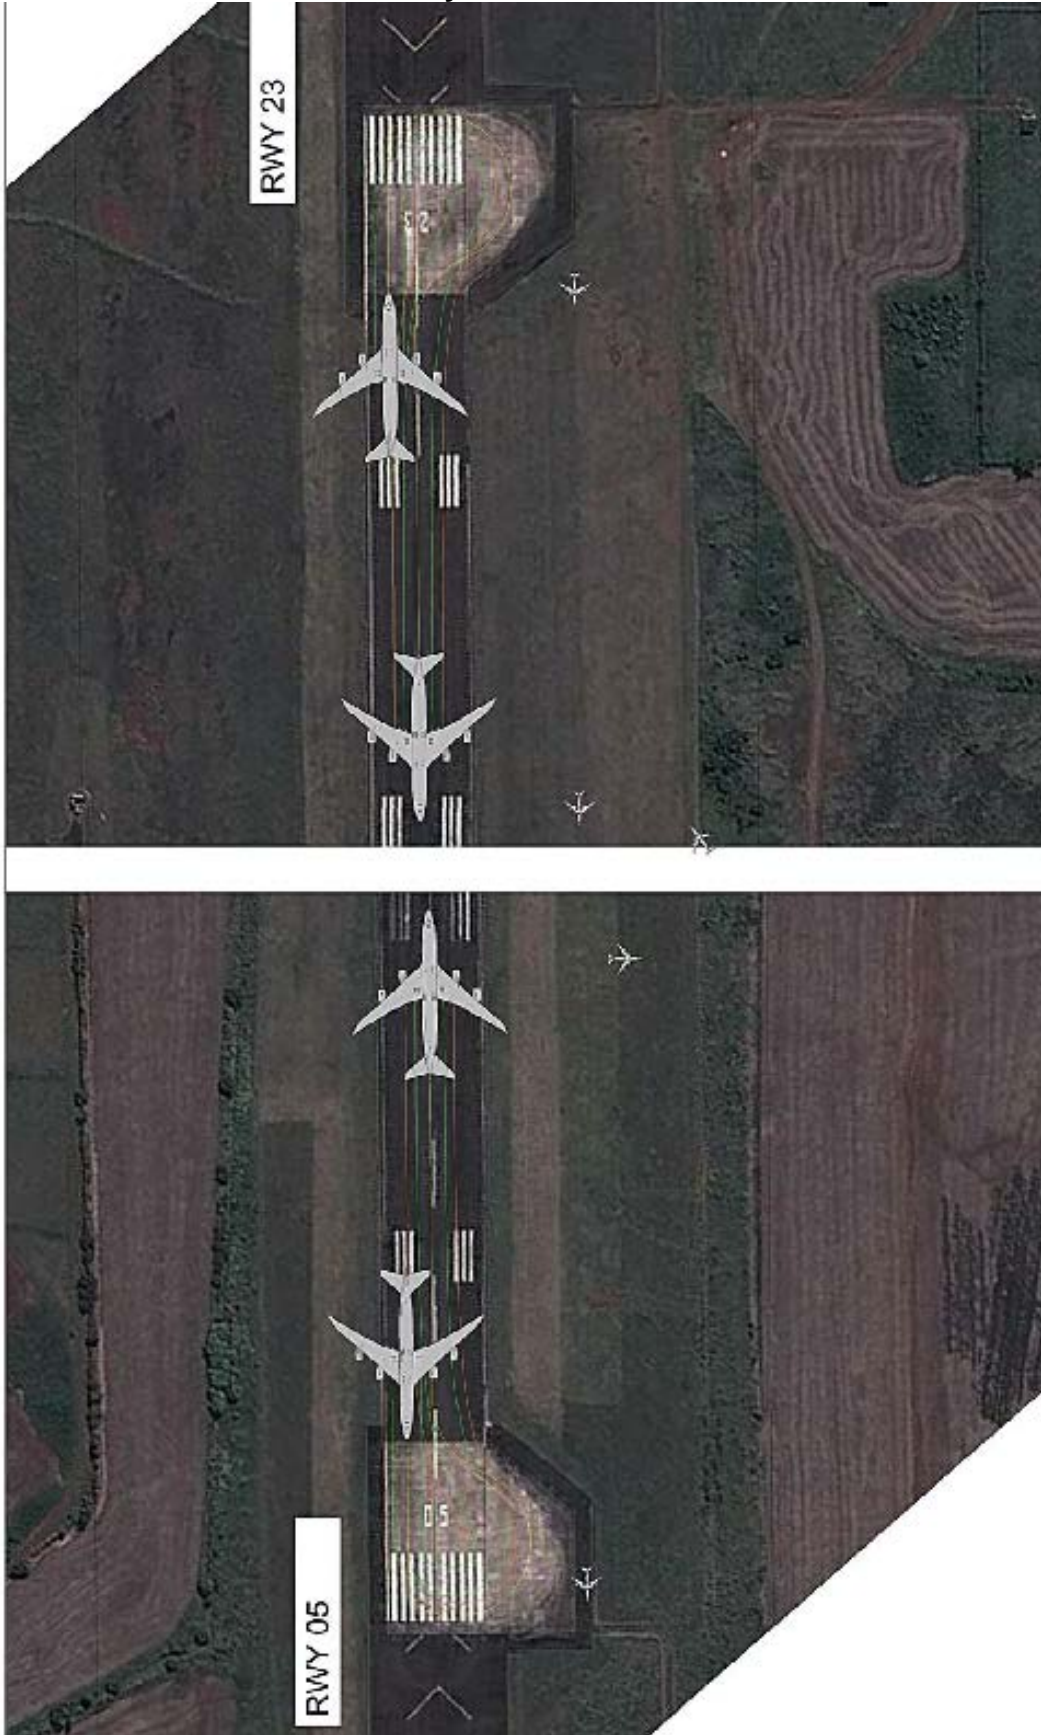
Chart VII: 747-8F U-Turn Analysis – RWY 05 and RWY 23 Turn Pads

- 1. TAXIWAY WING TIP CLEARANCE 7.6M
- 2. WING PATH
- 3. FLIGHT PATH - JUDGEMENTAL OVERSTEERING
- 4. 10% DEGR. STEERING
- 5. EDGE SAFETY MARGIN 4.5M
- 6. TRANSITIONAL SURFACE 1:1 SLOPE
- 7. STRIP WIDTH
- 8. JETBLAST CONTOUR
