# Chet Collett – Director Flight Ops Engineering Alaska Airlines

FLIGHT OPS ENGINEERING

### **Agenda**

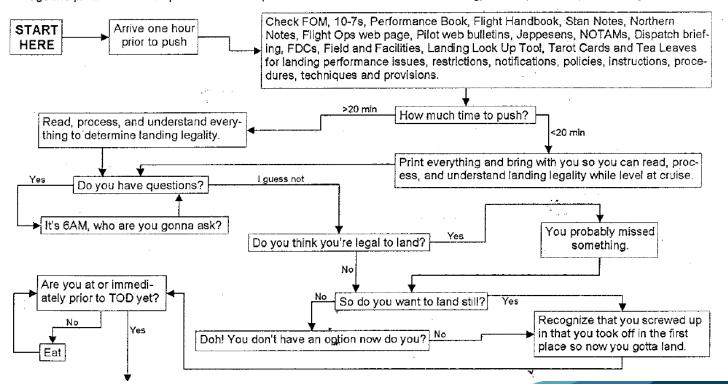
CUD (Can U lanD?)

The decision process to land Alaska Airlines jets can be very confusing. This landing flowchart is presented for the benefit of Anchorage line pilots and is to be provided for each pilot. If ever there is a doubt about landing, sit back, ruminate, and chew your CUD.

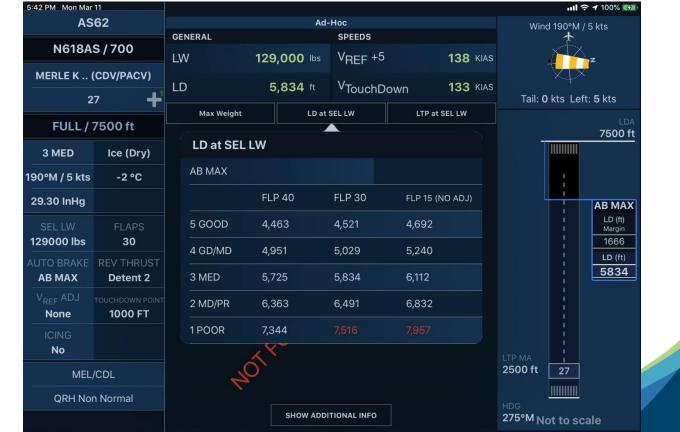
### An Example of our Experience

CDV 01/265 Aerodrome 01/14/2019 2346 01/15/2019 2346 RWY 09 FICON 3/3/3 30 PCT ICE SANDED 80FT WID AND DEICED SOLID 80FT WID OBS AT 1901142346. (1546 PST)

CDV 01/260 Aerodrome 01/14/2019 2037 01/15/2019 2037 RWY 09 FICON 3/3/3 100 PCT ICE SANDED 80FT WID AND DEICED SOLID 80FT WID OBS AT 1901142037. (1237 PST)

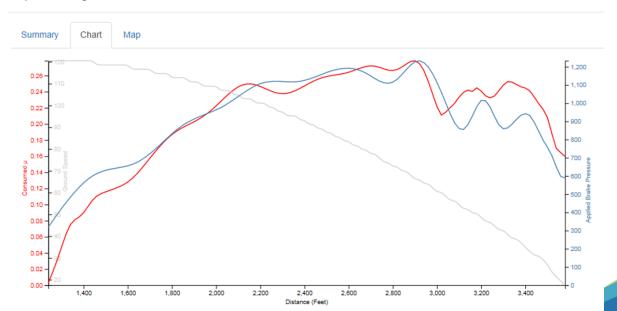
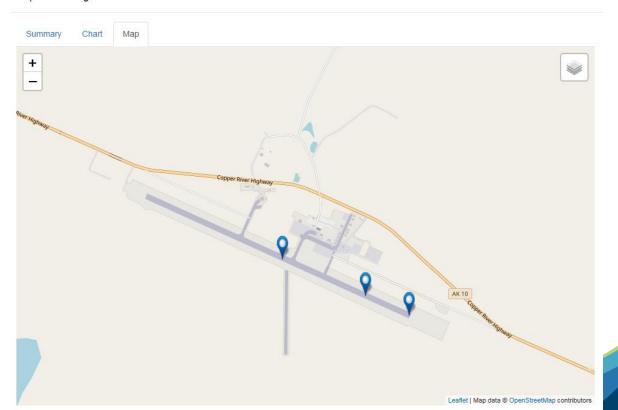
### **Aviation Safety Technology (AST)**

Airport Landing Detail Data

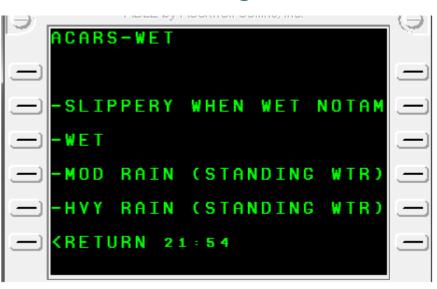
### **ACARS Page for WET**

- If it is WET (Damp or more) Request Data based on RWYCC 5 – GOOD vs WET
- (Or) Less than Good Calculate Latest Touchdown Point (LTP)
- (And) Less than Good Use Max Auto-Brakes with Max Manual Braking until stopping is assured
