## Airport Challenges and Runway *Incursions*

### Geometries!!!

# HOT SPOTS and US Airport Diagrams

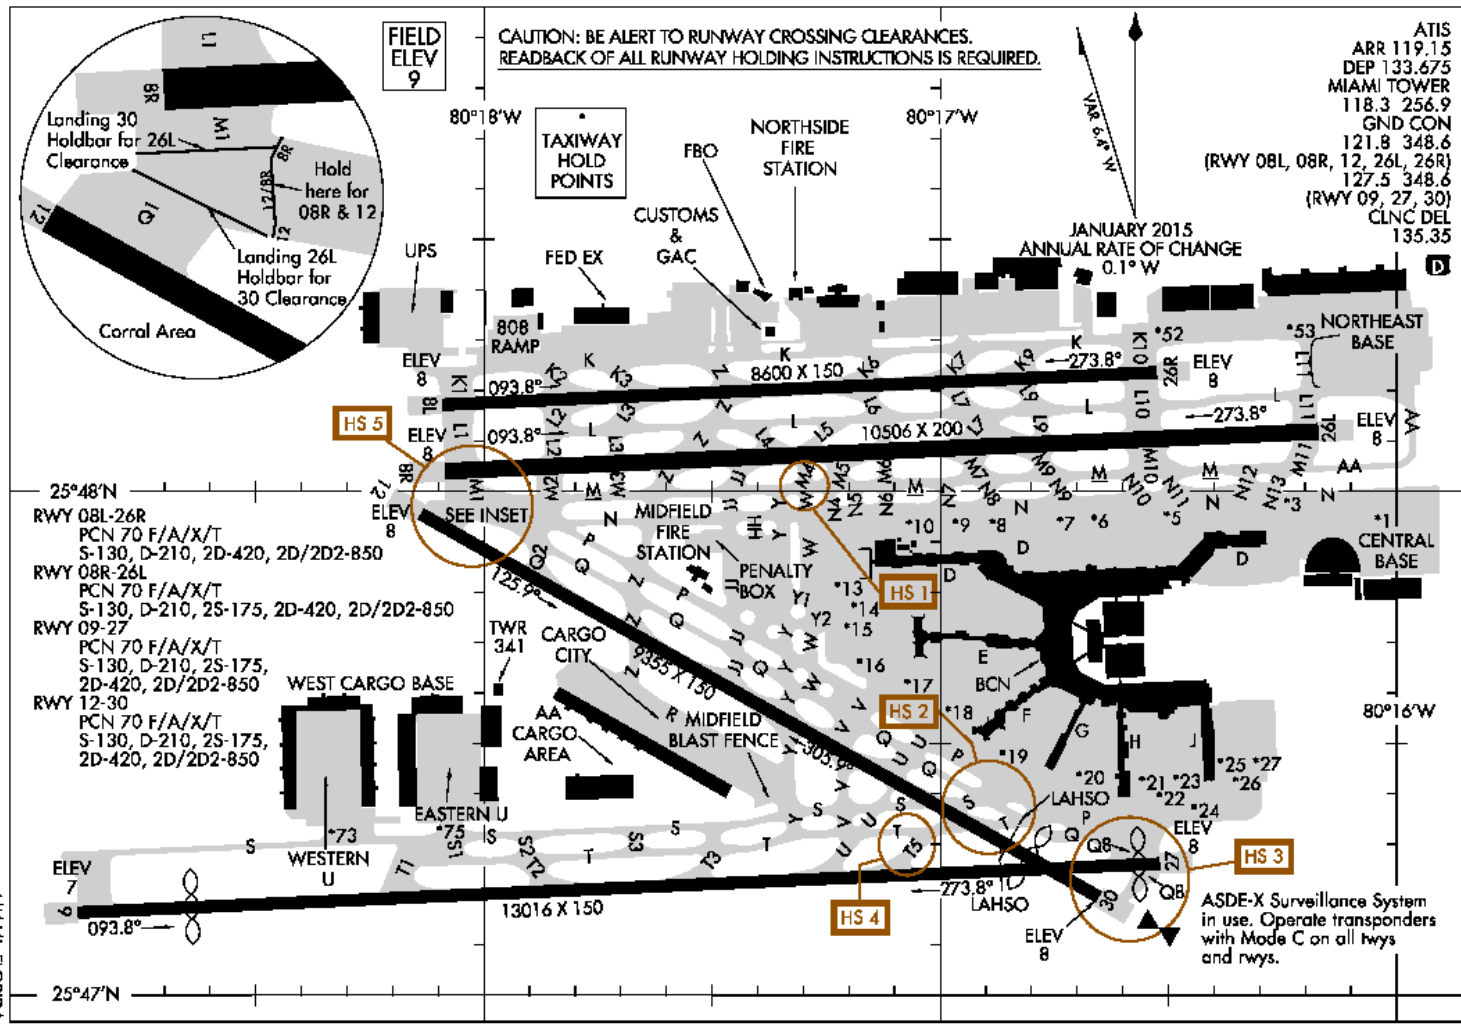
15064  
AIRPORT DIAGRAM

AL-257 (FAA)

MIAMI INTL (MIA)  
MIAMI, FLORIDA

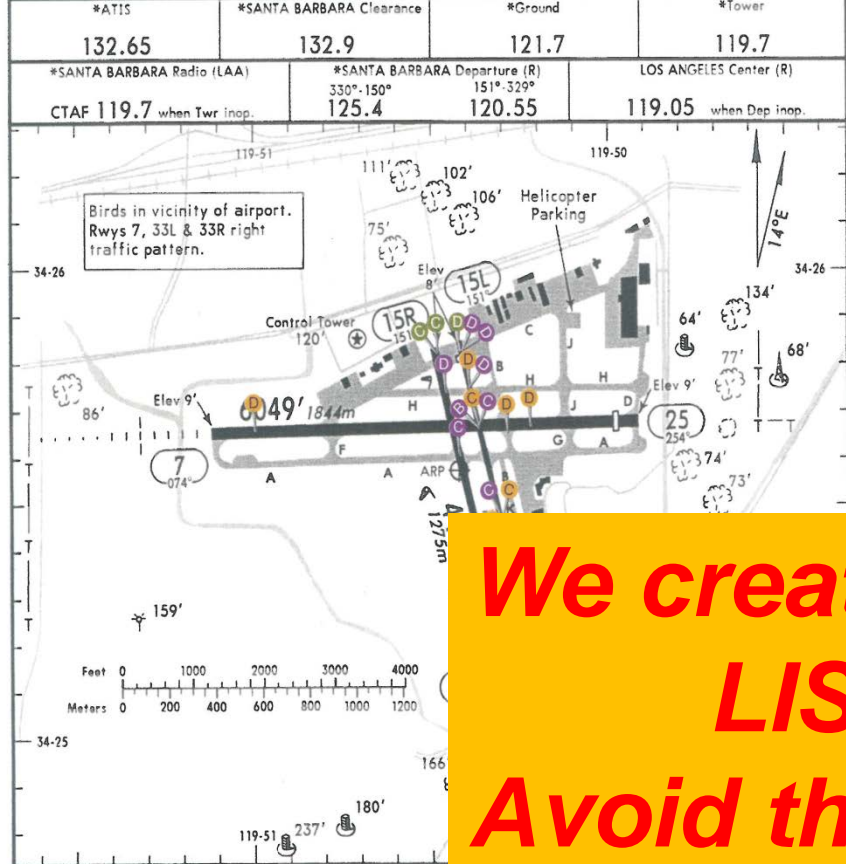
## FY 2000 through FY 2003 Runway Incursions Santa Barbara Municipal Airport

● Operational Errors / Deviations    
 ● Pilot Deviations    
 ● Vehicle / Pedestrian Deviations

**KSBA/SBA**     **JEPPESEN SANTA BARBARA, CALIF**  
 Apt Elev 10'     28 FEB 03 (11-1)     SANTA BARBARA MUN  
 200.6°/6.1 From RZS 114.9     N34 25.6 W119 50.4

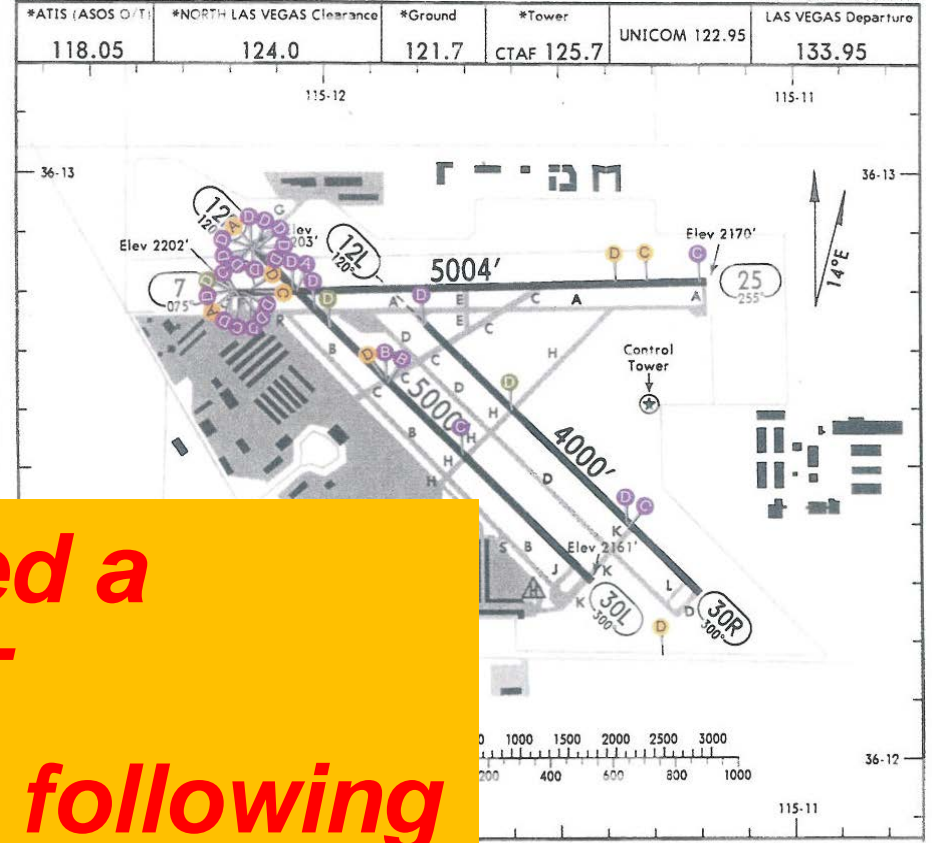
## FY 2000 through FY 2003 Runway Incursions North Las Vegas Airport

● Operational Errors / Deviations    
 ● Pilot Deviations    
 ● Vehicle / Pedestrian Deviations

**KVGT/VGT**     **JEPPESEN**     **LAS VEGAS, NEV**  
 Apt Elev 2205'     28 MAR 03 (28-1)     NORTH LAS VEGAS  
 332.6°/8.1 From LAS 116.9     N36 12.7 W115 11.7

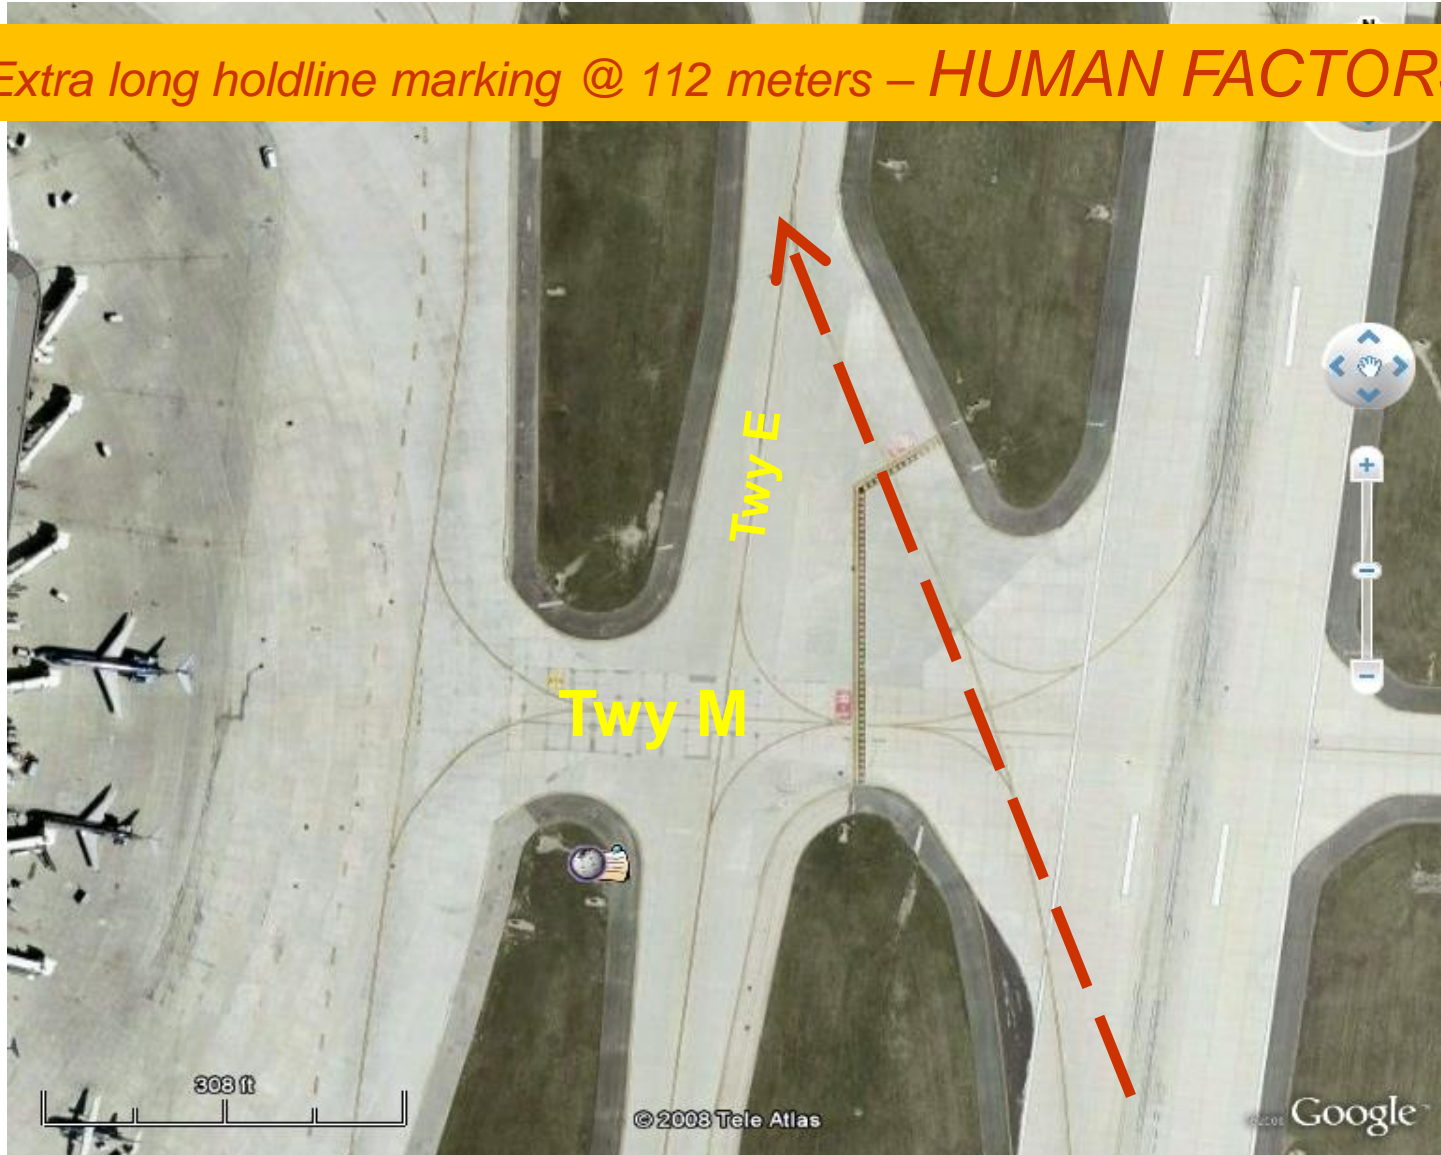
# MKE: 3-PDs

Extra long holdline marking @ 112 meters – HUMAN FACTORS

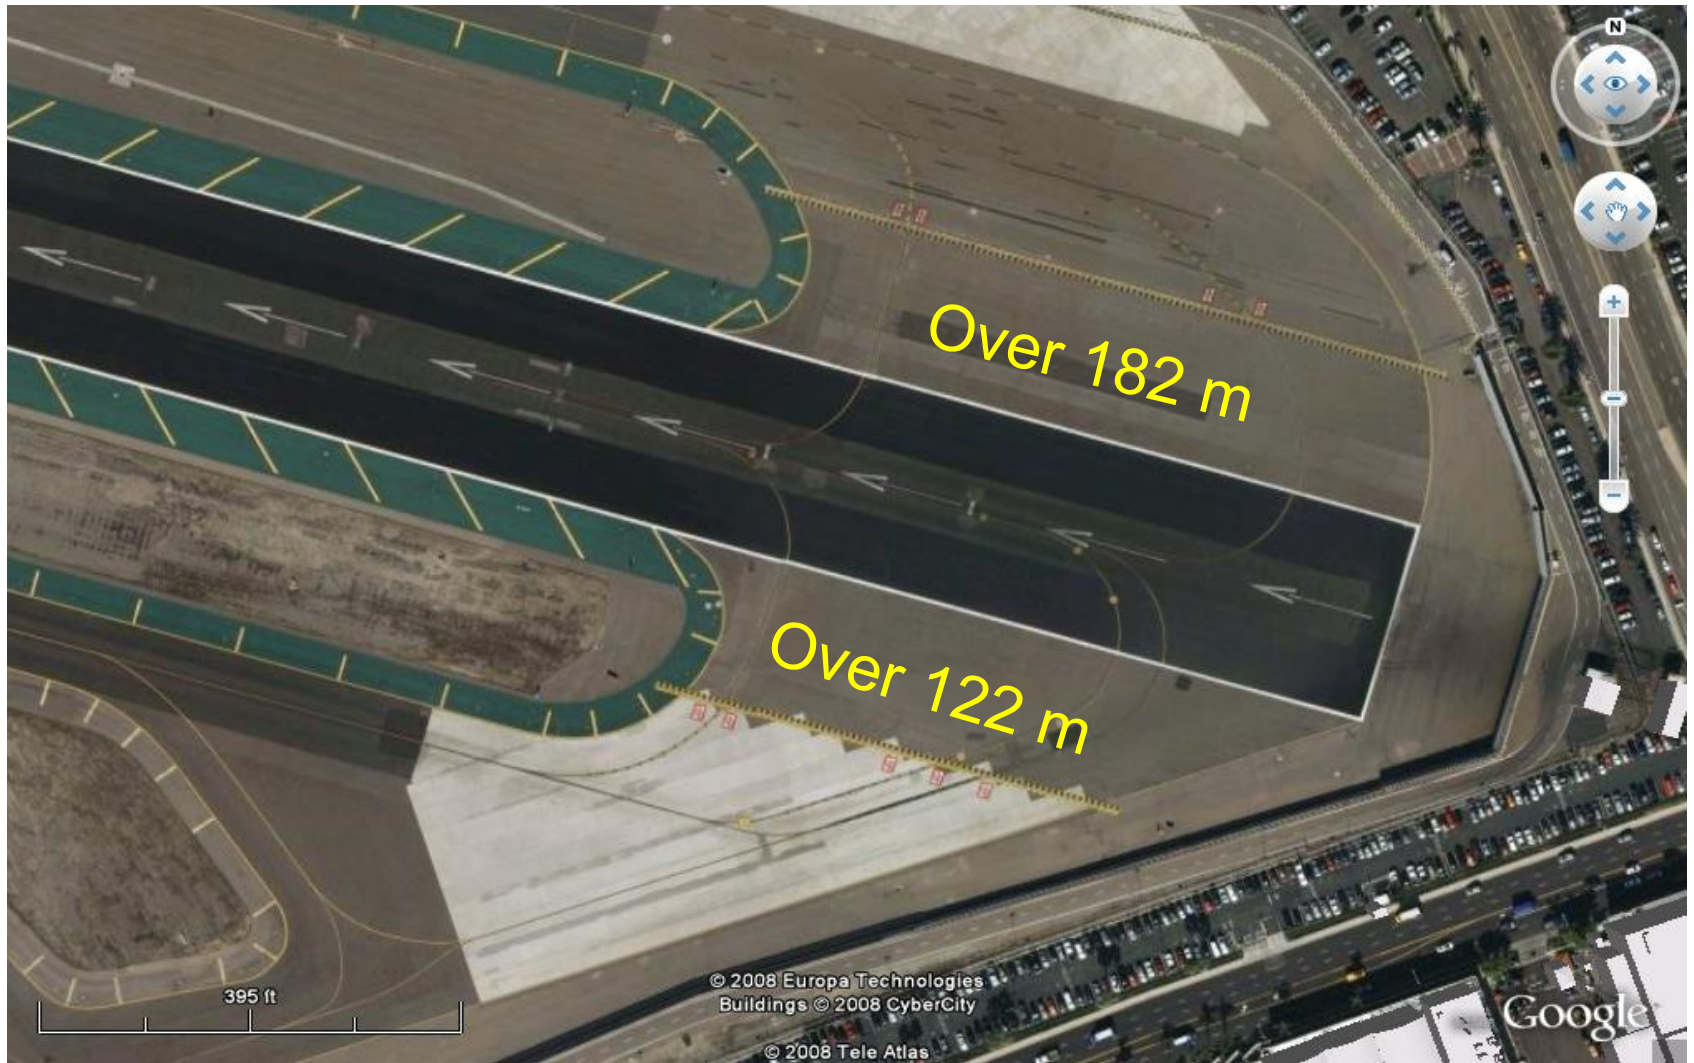
# San Diego Intl Airport (SAN): 2-PDS, 1-OE

**Lack of "GRASS ISLANDS" - Missing Vertical Sign**

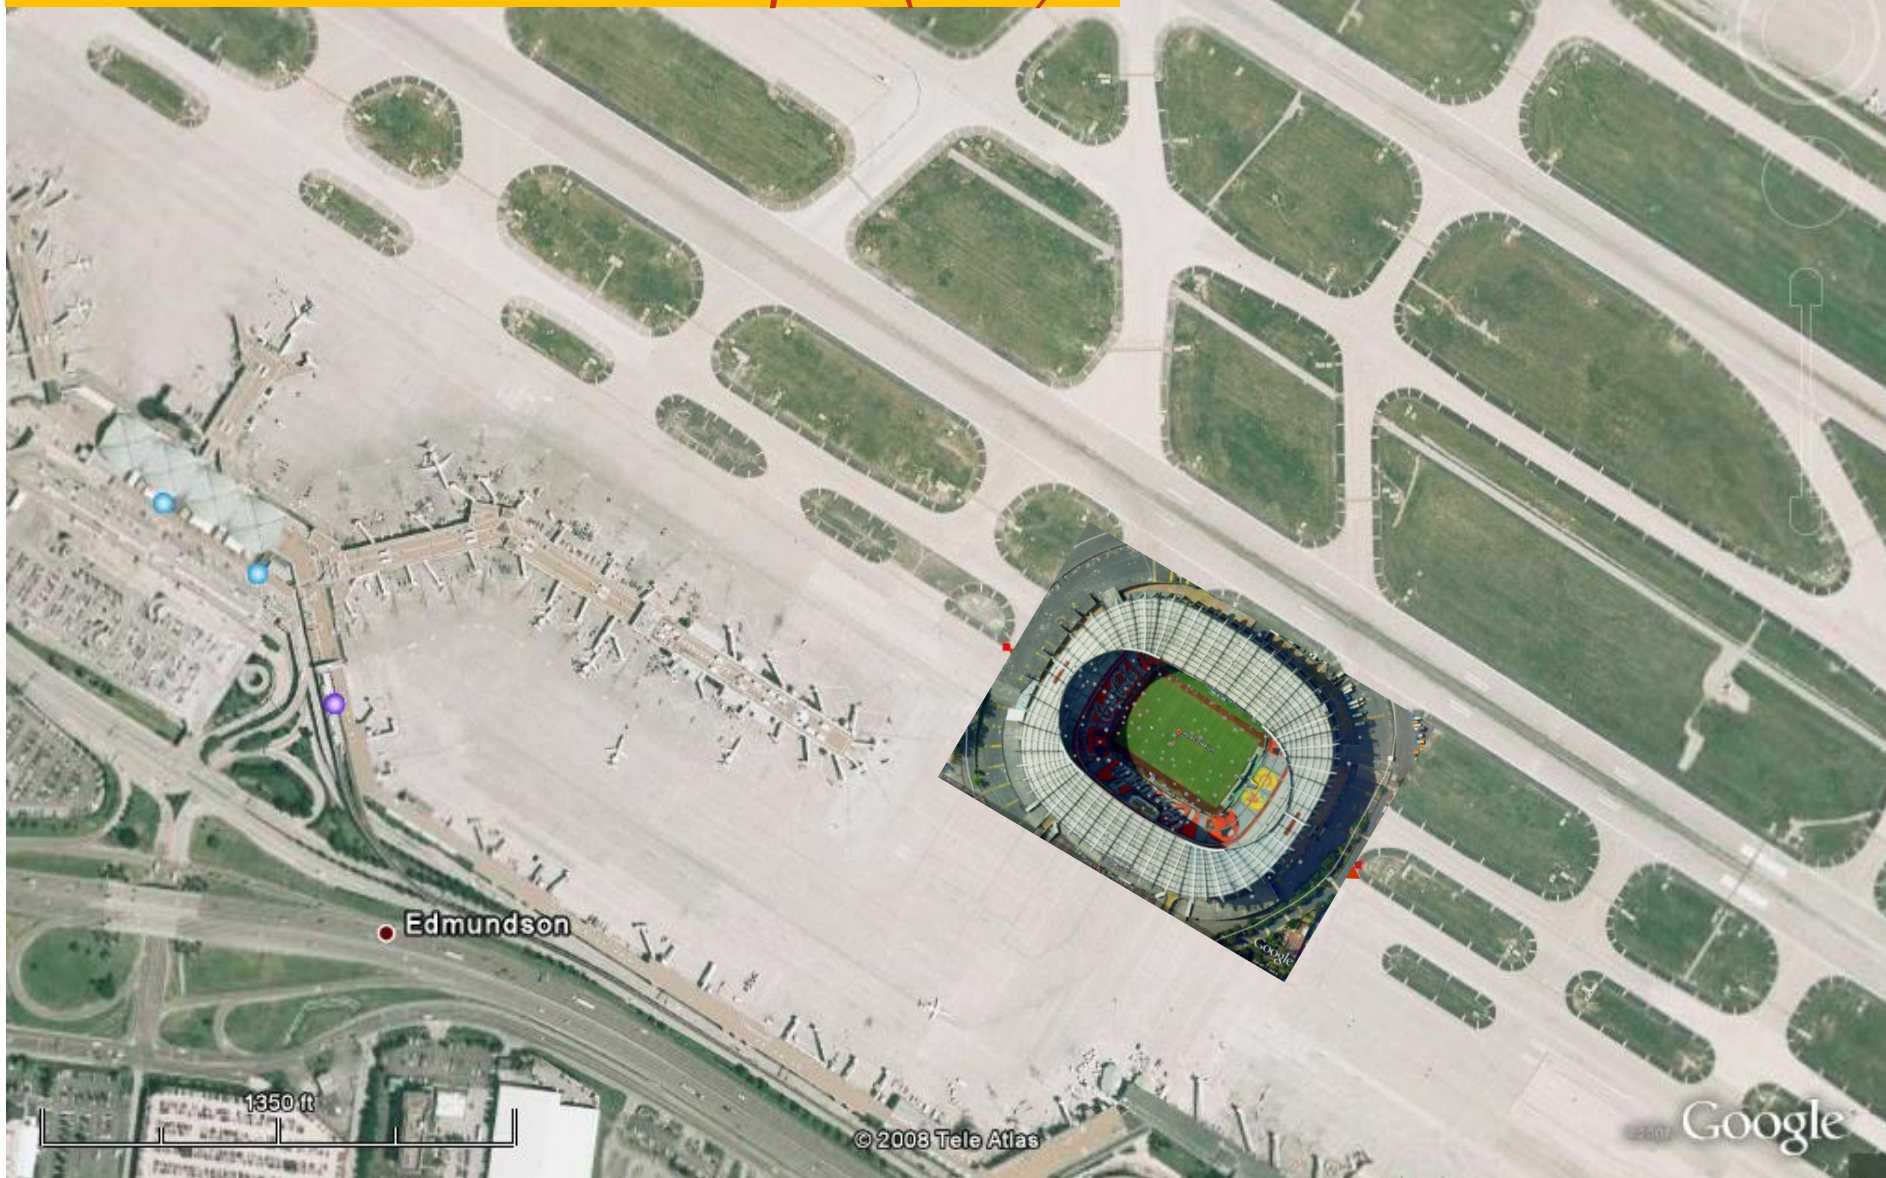
# St. Louis Lambert Intl Airport (STL)

*Extra Width of Entrance Approx. 365 meters*

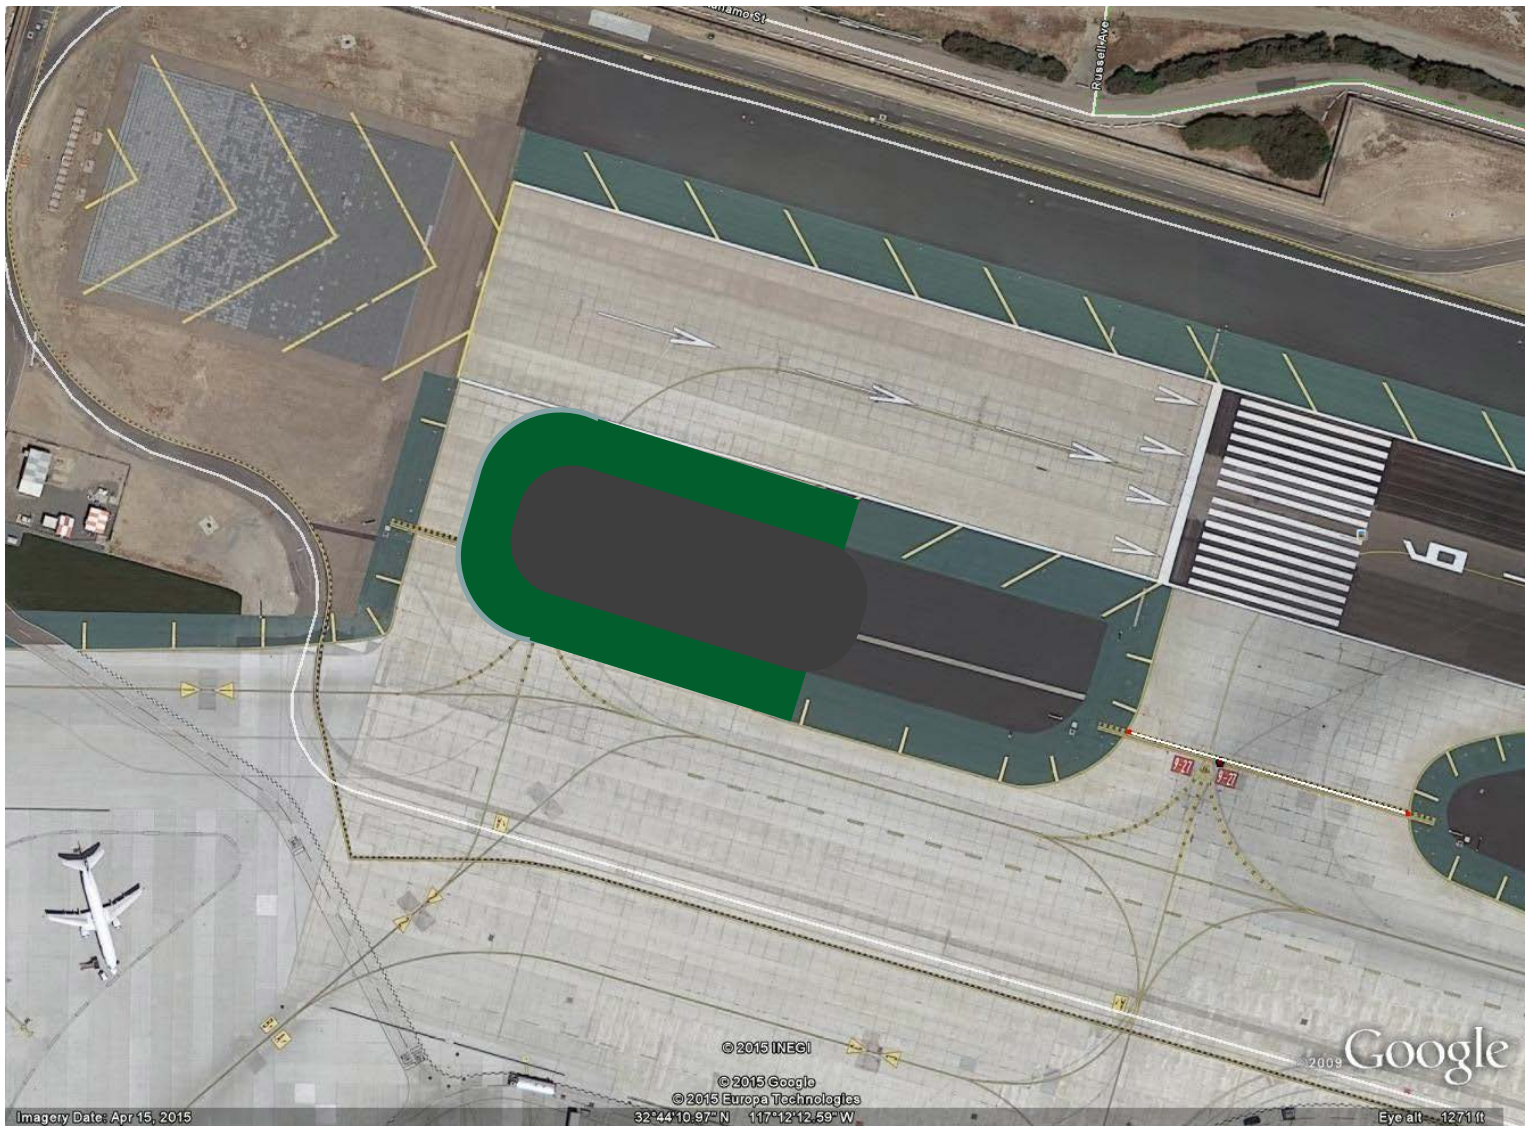
Vertical Signs are 307 m apart

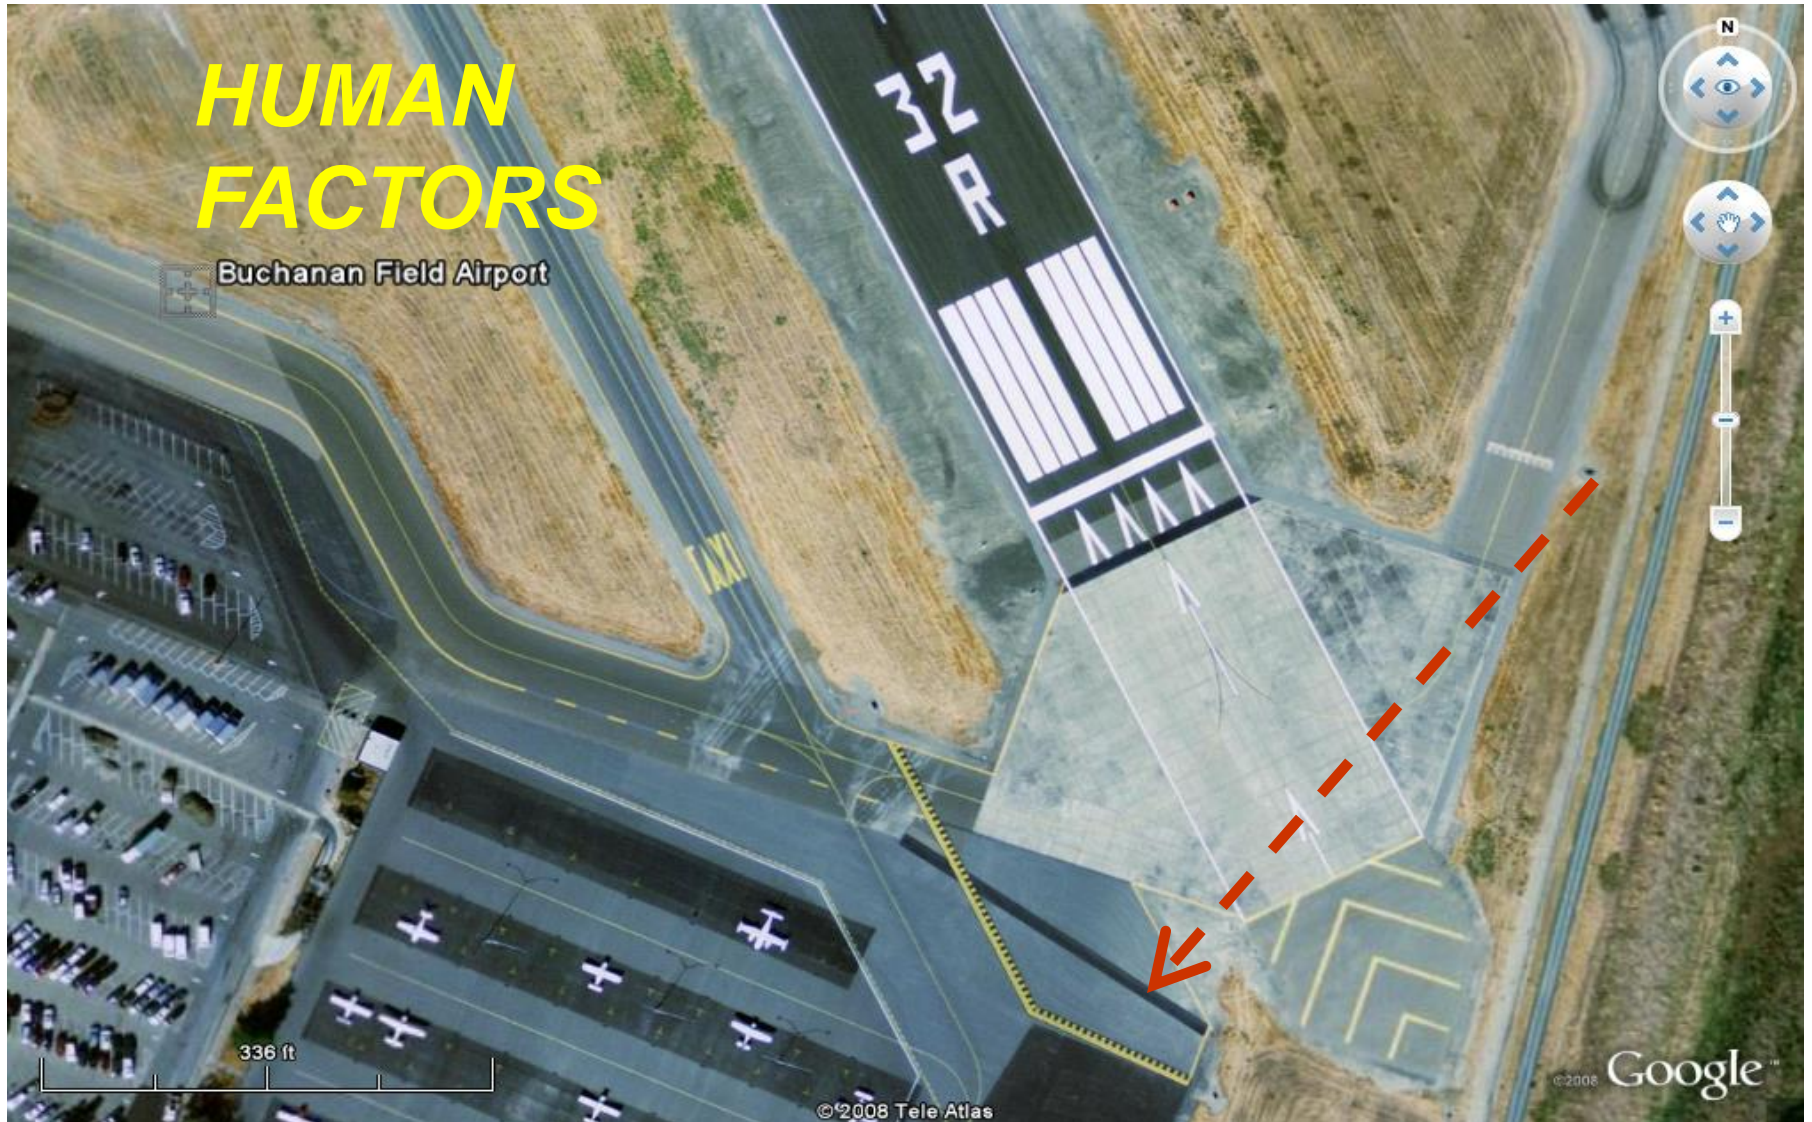
# Concord-Buchanan Field (CCR): 5-PDs, 2-OEs (1997 -2000)

Buchanan Field Airport

*Asphalt vs Concrete vs Asphalt*

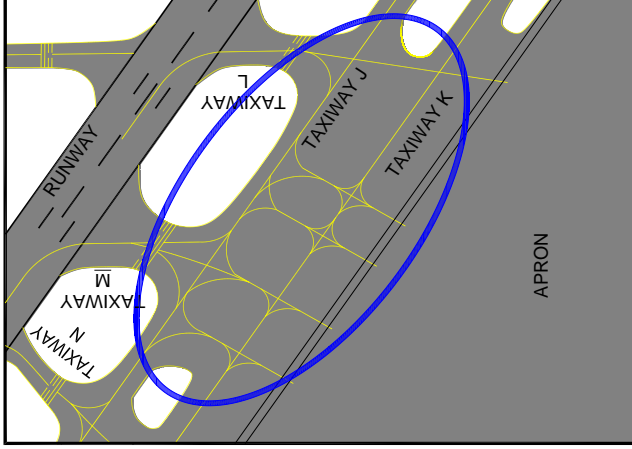
(b) Extra-wide throated taxiway leading from the apron directly to parallel taxiways and runways

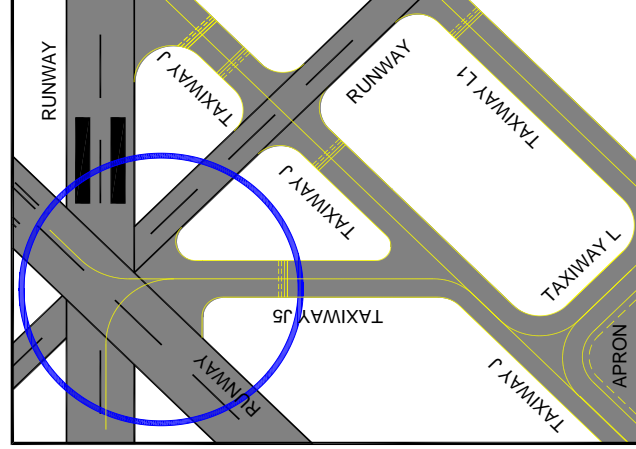
(d) Taxiway intersecting multiple runways

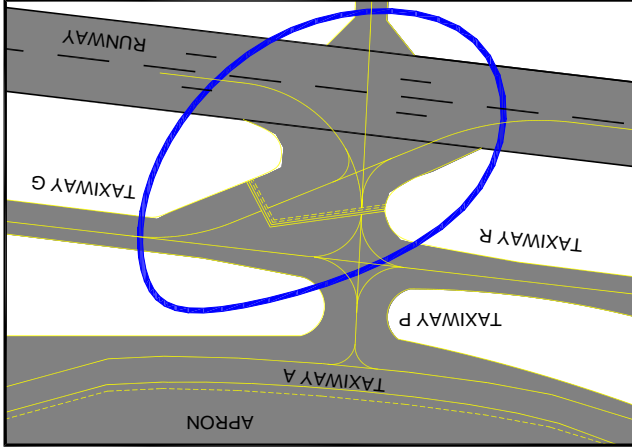
(a) Taxiway crossing high-speed exit and wide throated runway entrance

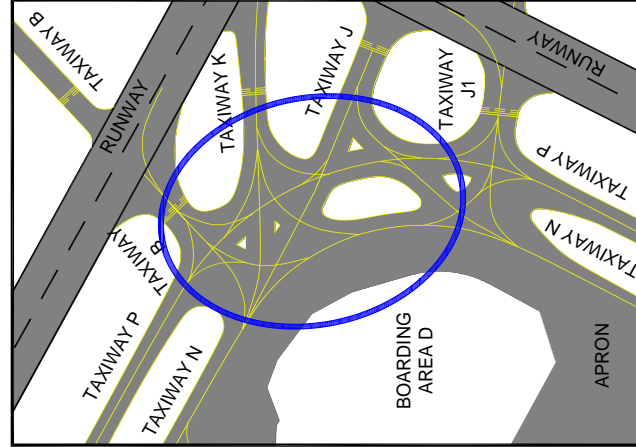
(c) Taxiway intersection exceeds "3-node" concept

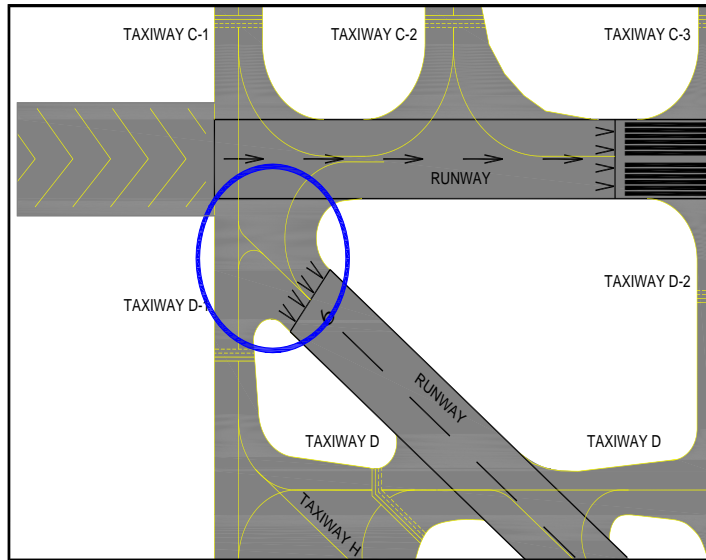
(e) Aligned taxiway between two closely spaced runway ends

***PROHIBITED***  
***Aligned Taxiway***

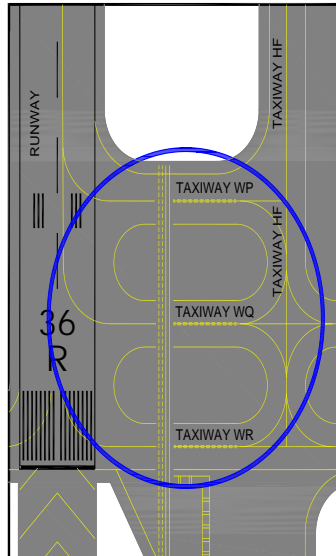
(f) Two or more taxiway entrances lacking "No Taxi" islands

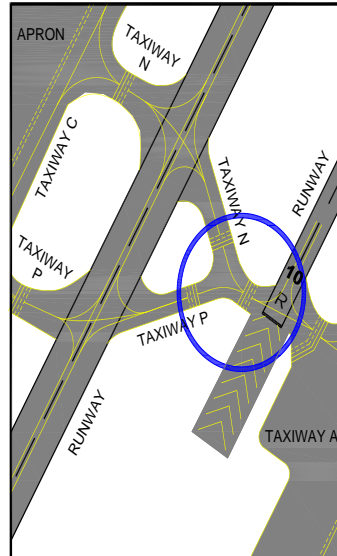
(g) "Y" Shaped taxiway crossing a runway

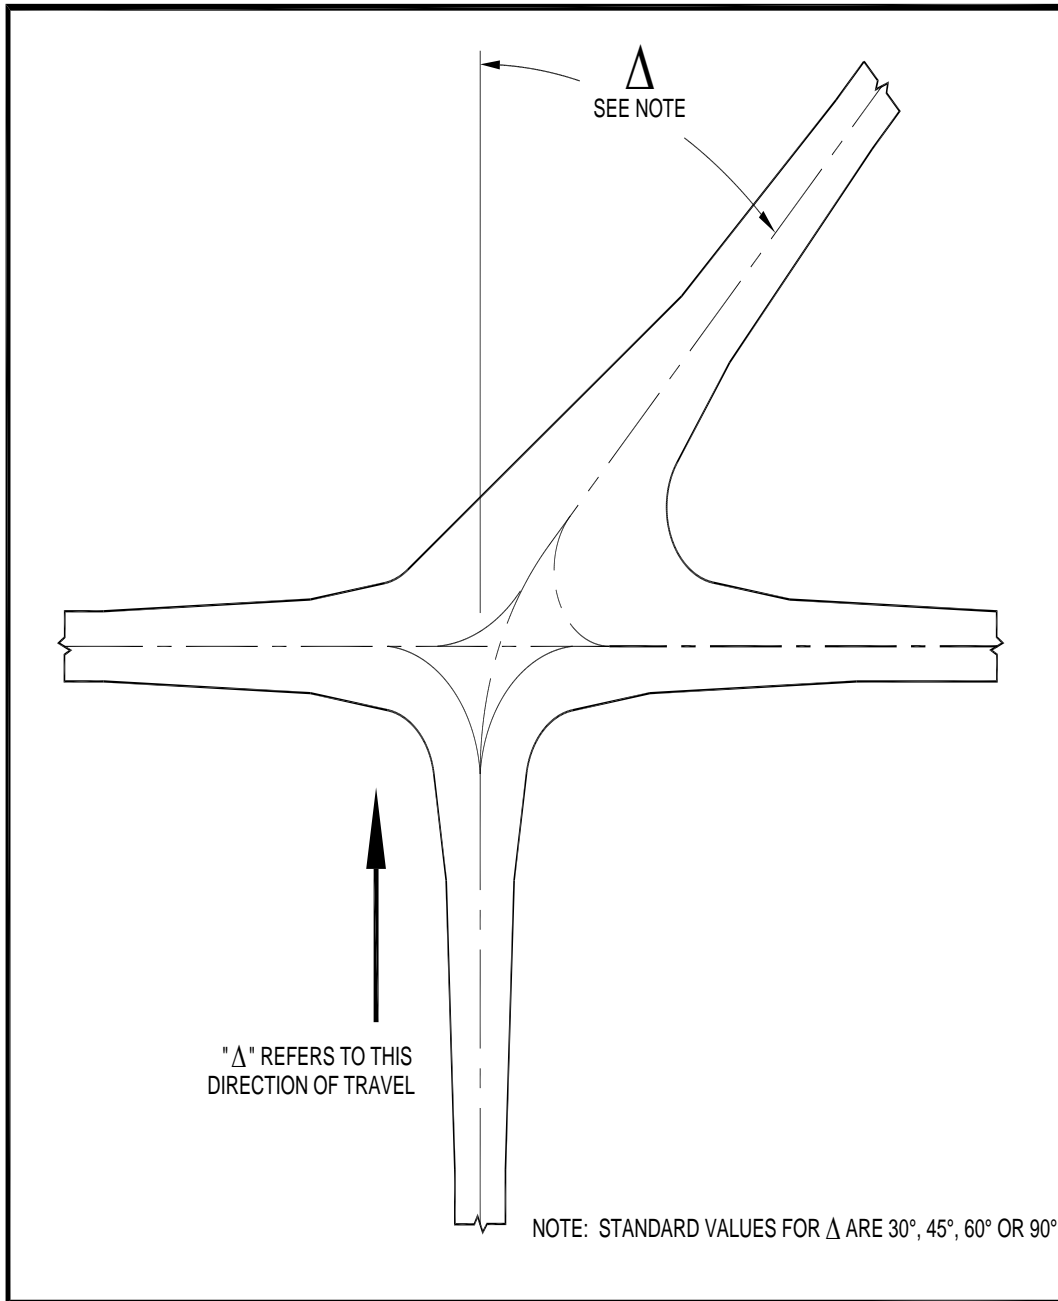
**3-NODE  
Principle  
Plus  
Angles**

**30-45-  
60-90  
degrees**

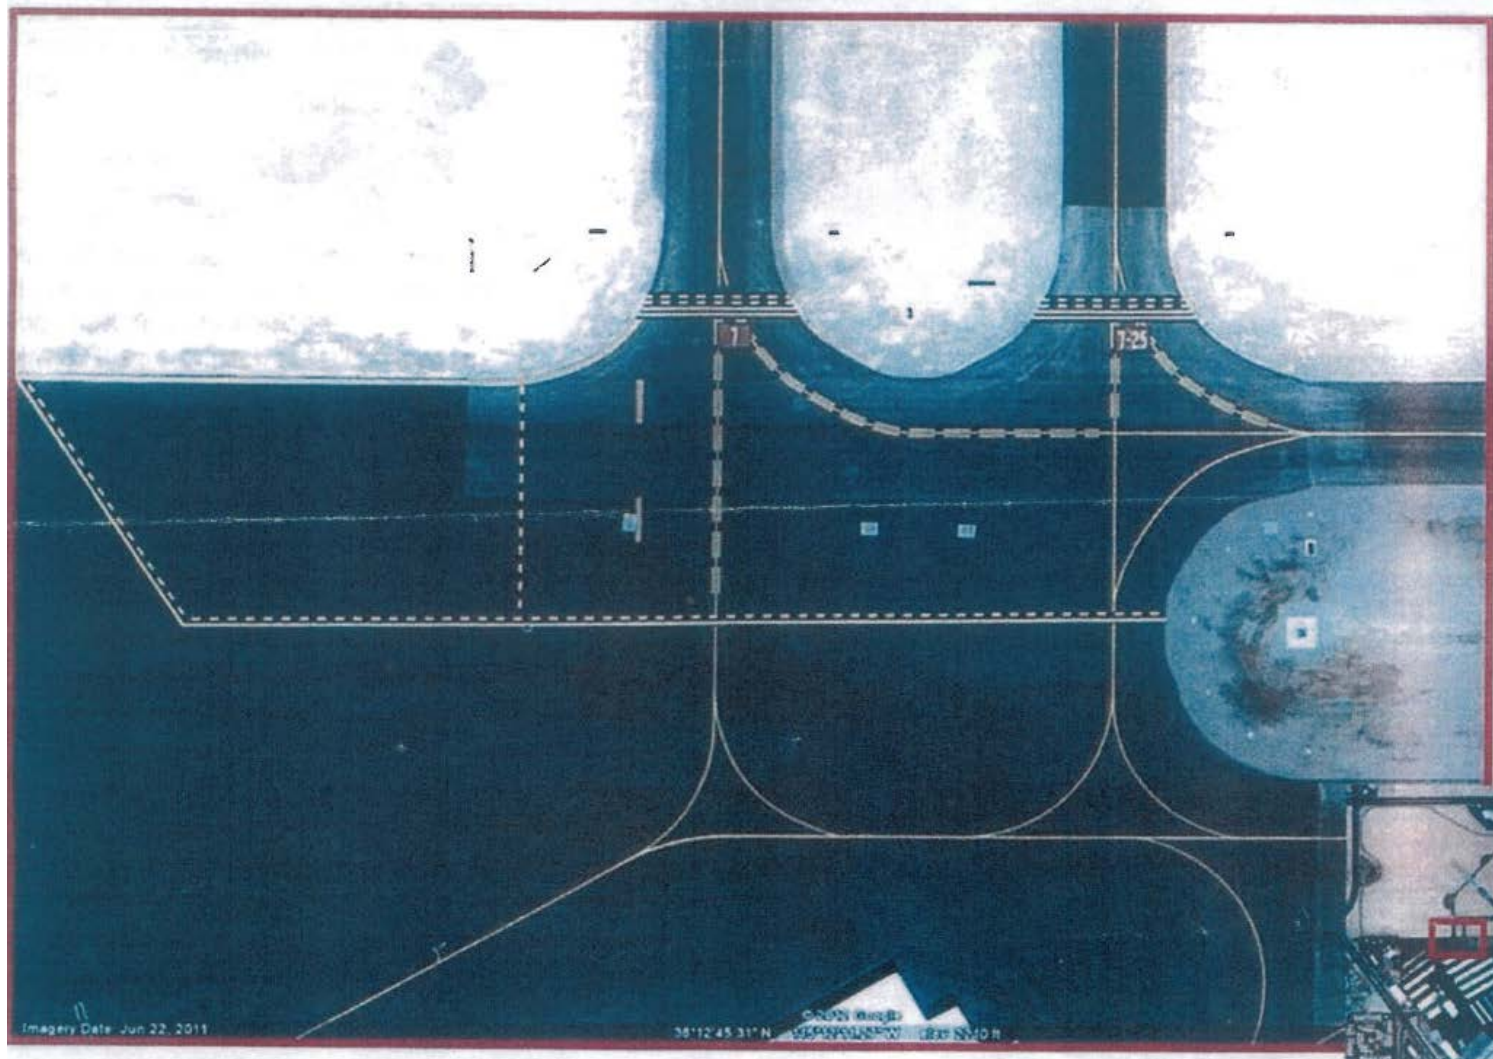
*Nov 18, 2010*  
*NO-TAXI Islands Removed*

## *Result of Removal ?*

- *2010*
  - *1 RI (Nov 26 – Dec 31, 2010)*
- *2011*
  - *12 RIs*
- *2012*
  - *10 RIs*
- *2013 (Thru October)*
  - *8 RIs*
- ***TOTAL***
  - ***31 IRs at Twy G/Twy F***

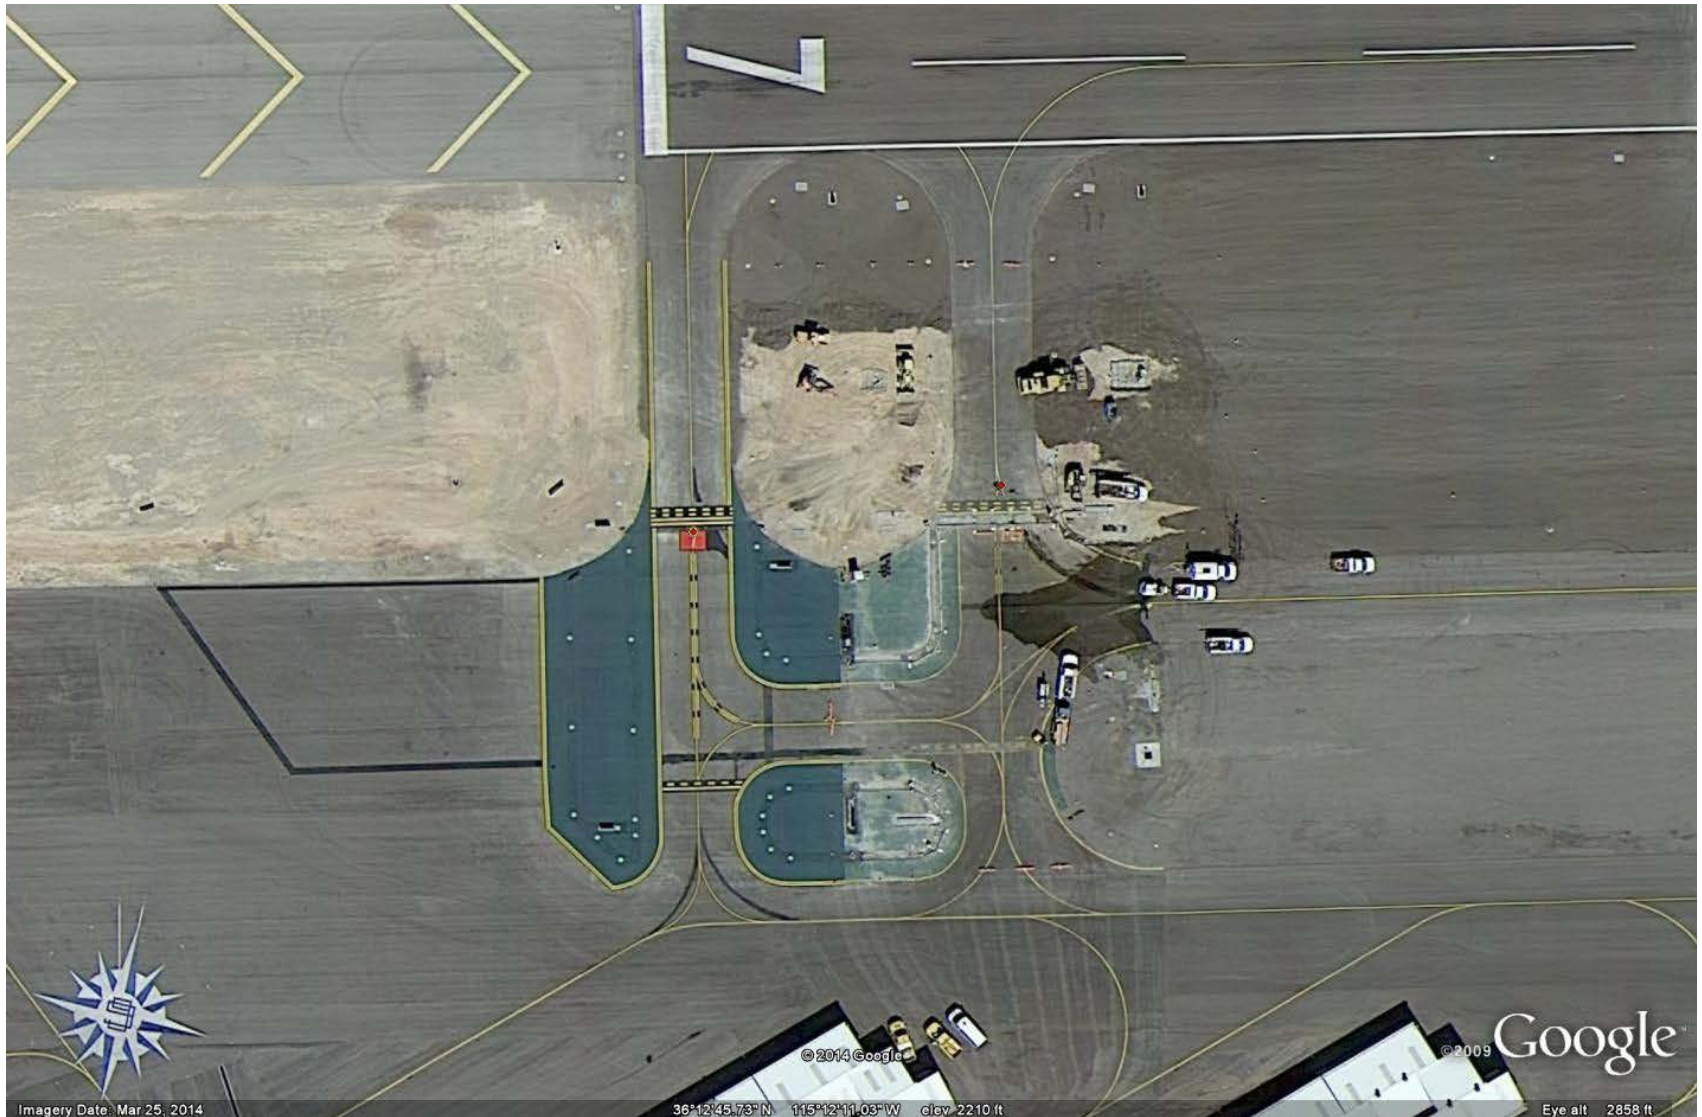
# *RIs Dropped 2014 – 2015*

## *Two Events*

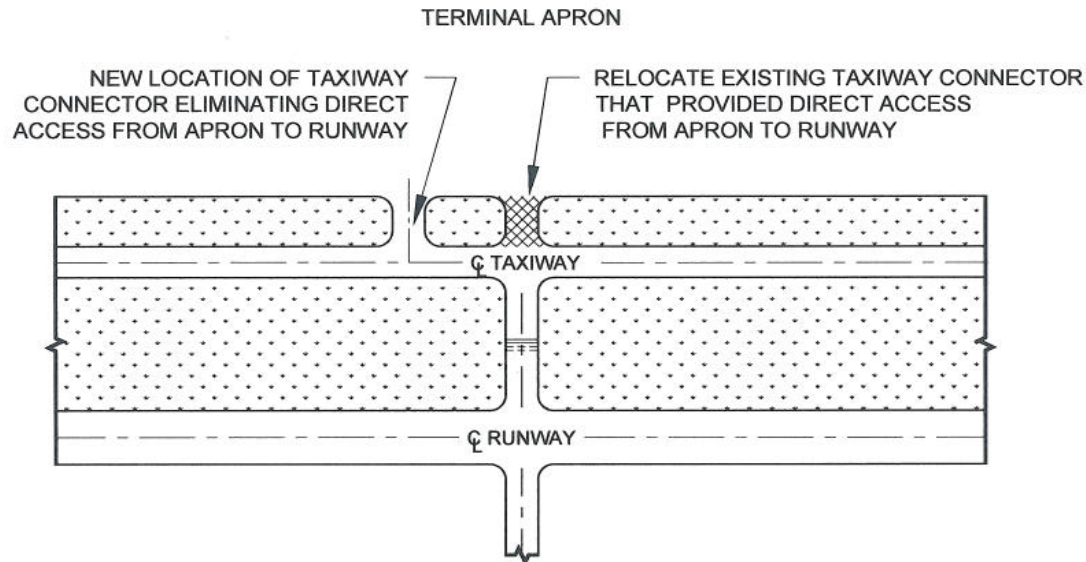
# Design Standard – Apron Access to Runways

- Do **not design** entrance taxiways that provide direct access from an apron to a runway, especially extra wide entrances
- Avoid wide expanses of pavement
- Configure taxiways as shown
