## فريق خبراء البضائع الخطرة

### الاجتماع السادس والعشرون

### أحكام الملصقات على وحدات التحميل

**EXAMPLES IDENTIFIED ON-SITE**

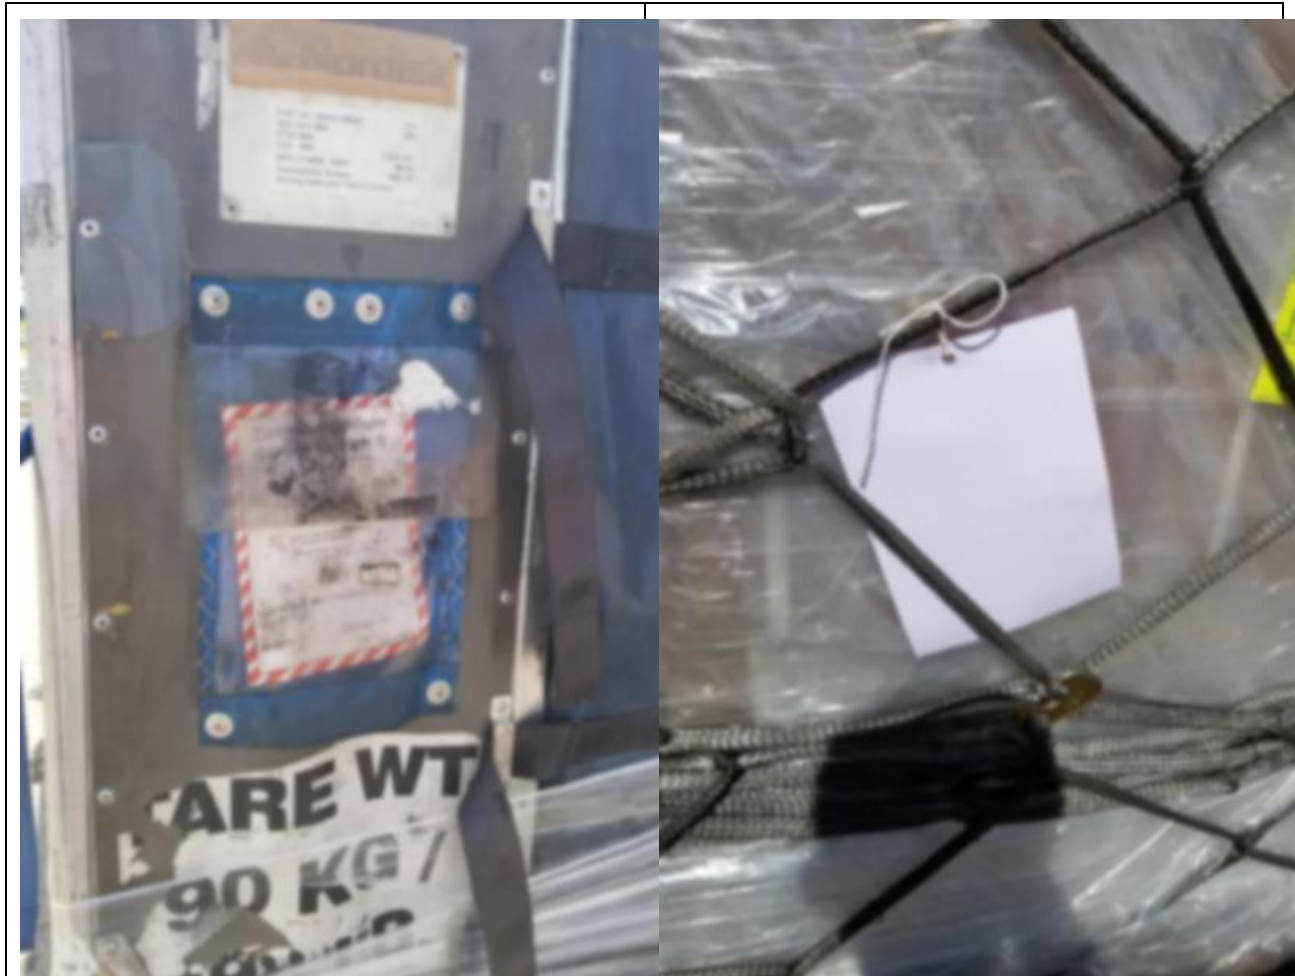
This could be considered clearly as a non-compliance to the TIs 7;2.8.3

The identification tag itself is visible but the information on it is not visible at all times. There is a lack of a clear requirement to avoid that.

1.3 Appendix A shows some examples identified on-site. The second picture shows an identification tag that was visible but the information on it was not visible at all times since the tag kept flipping during transport.
