Sixth Meeting of the Asia/Pacific Aerodrome Assistance
Working Group (AP-AA/WG/6)

Agenda Item 7: Technical Assistance/Cooperation in AGA Field**THE REQUIREMENTS OF RUNWAY SIDE STRIPE MARKINGS &
TAXI SIDE STRIPE MARKINGS**

(Presented by Malaysia)

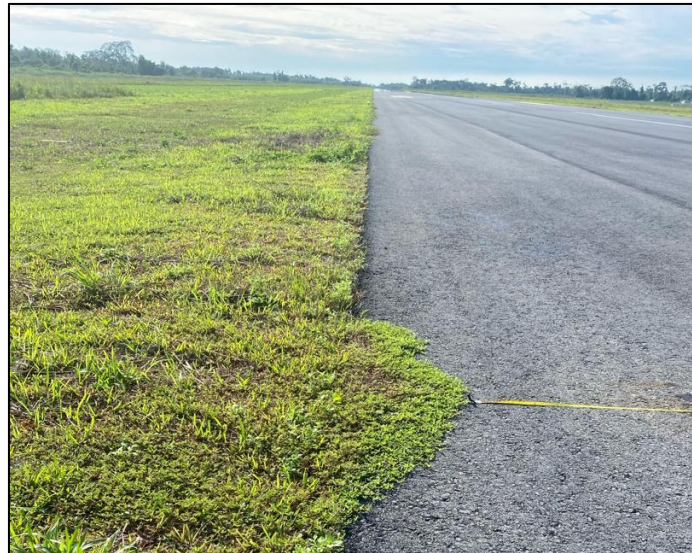
2.2 The absence of runway side stripe markings and taxi side stripe markings at aerodromes often leads to a common issue: inadequate maintenance of grass along runway and taxiway strips, particularly the portions abutting the runway or taxiway surfaces. This neglect can result in the narrowing of the effective width of the runway or taxiway, as illustrated in the figure below.

2.3 With the narrowing of the runway/taxiway due to grass encroachment onto the pavement surface, the affected paved area can no longer be considered as load-bearing area. This presents a significant challenge for aerodrome operators, who must conduct regular surveys to accurately determine the current width of the runway/taxiway.
