The Sixth Meeting of the Asia/Pacific Aerodrome Assistance Working Group (AP-AA/WG/6)

The Requirements of Runway Side Stripe Markings & Taxi Side Stripe Markings

Bangkok, Thailand 2 to 5 April 2024

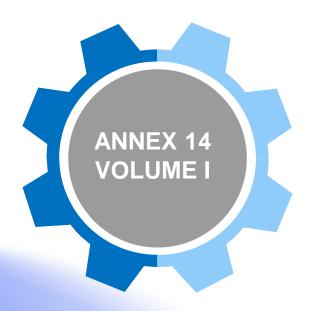
5.2.7.1 A runway side stripe marking shall be provided between the thresholds of a paved runway where there is a lack of contrast between the runway edges and the shoulders or the surrounding terrain

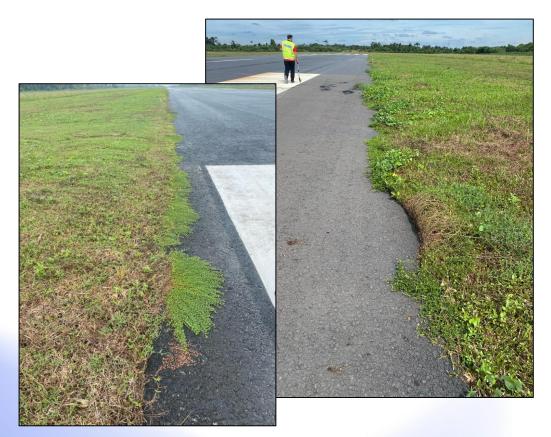
- Poor maintenance of grass at runway and taxiway strip particularly the surface of that portion of a strip that abuts a runway/taxiway.
- May result into the reduction of runway/taxiway width.
- Required to conduct regular surveys to accurately determine the current width of the runway/taxiway

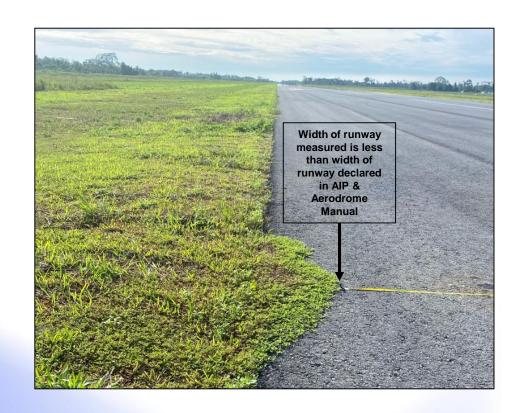
Poor maintenance of grass at runway and taxiway strip particularly the surface of that portion of a strip that abuts a runway/taxiway.

- 2. May result into the reduction of runway/taxiway width.
- Required to conduct regular surveys to accurately determine the current width of the runway/taxiway
