*International Civil Aviation Organization***THE THIRTIETH MEETING OF THE  
COMMUNICATIONS / NAVIGATION AND  
SURVEILLANCE SUB-GROUP (CNS SG/30)  
OF APANPIRG***Bangkok, Thailand, 06 - 10 July 2026***Agenda Item 2: Review outcomes of APANPIRG, APAC ANSP Committee, ATM Sub-group,  
MET Sub-group and other Meetings and global CNS updates****SIGNIFICANCE OF FRANGIBILITY REQUIREMENTS OF NAVIGATIONAL AIDS  
INSTALLED ON THE RUNWAY STRIP AND RESA***(Presented by Nepal on behalf of the SWG for AP-ADO/TF Task 6/4)***SUMMARY**

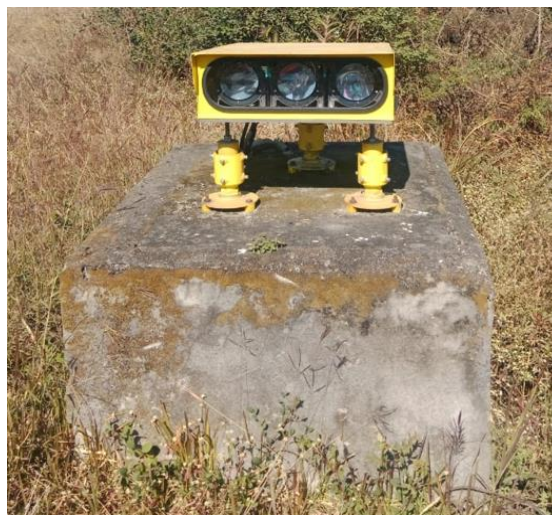
Figure 1: Elevated foundation of PAPI on the runway strip

2.4.1 We often observe a variety of installations that do not adhere to the requirements of Annex 14, Volume I, Attachment A, Section 8.2, such as approach light foundations, PAPI foundations, transformer chambers, and drainage side walls located on the runway/ taxiway strips. These foundations with vertical faces could invite a disastrous outcome in the event of an aircraft overrun or veer off from the runway.

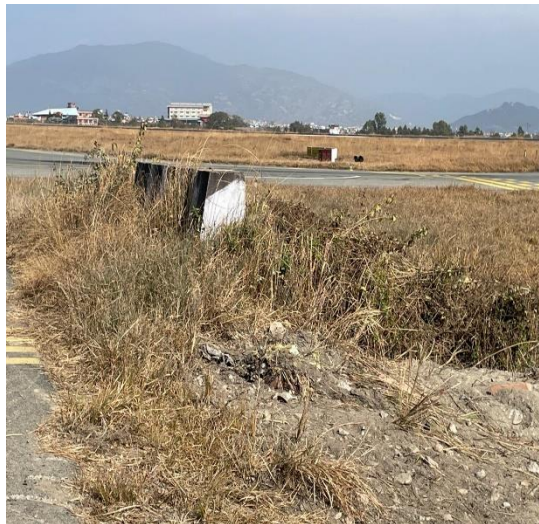
Figure 2: Elevated side wall near taxiway strip

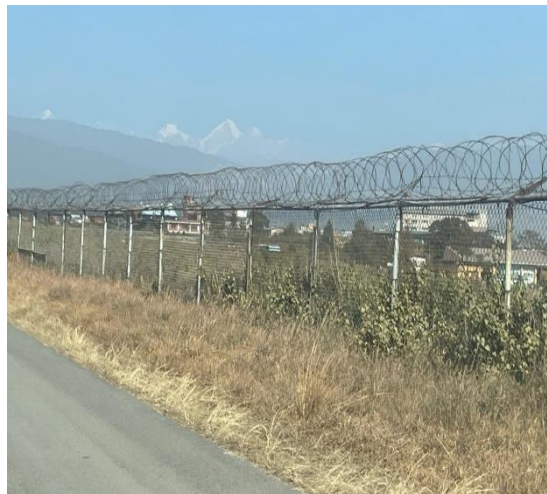
Figure 3: Non-Frangible security fence

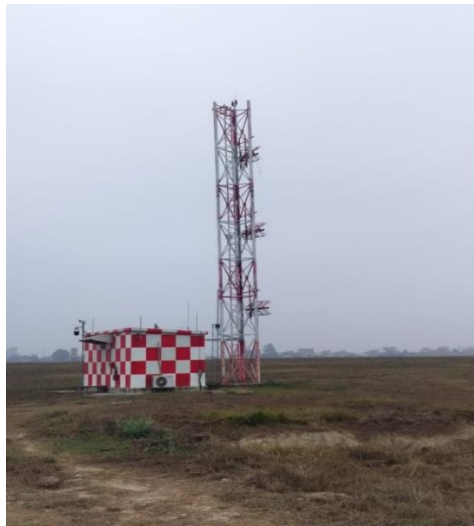
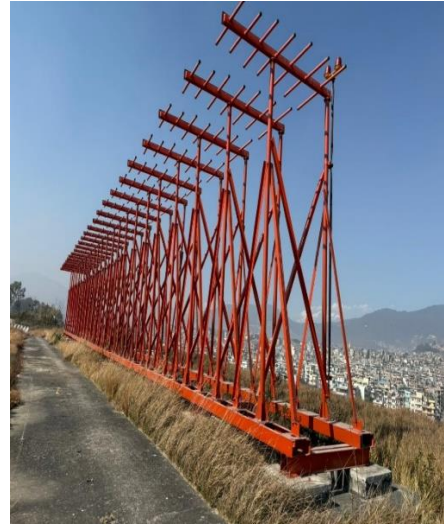
Figure 4: ILS / Glide path antenna and equipment on the runway strip

2.1.8 The lateral displacement of the ILS glide path antenna system should not be less than 120 m with respect to the runway centre line. The longitudinal location should be selected to place the ILS reference datum as close as possible to the recommended nominal value of 15 m above the threshold.

2.7 Due to its heavy mass, the transmitter housing for ILS installations cannot be made frangible. Therefore, when planning for the installation of an ILS, the location of the transmitter housing for the localizer as well as for the glide path should be carefully considered. Where practicable, the transmitter housing for the ILS glide path should be located outside the runway strip and RESA.

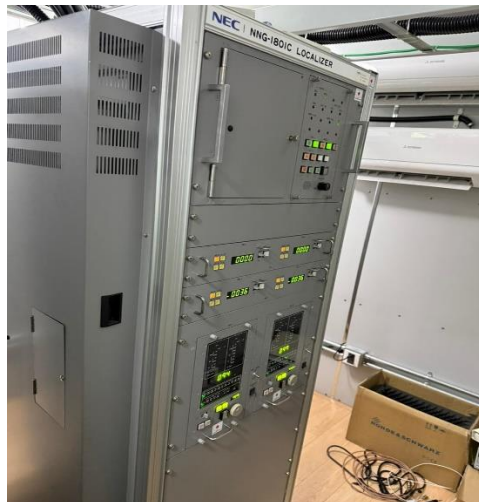
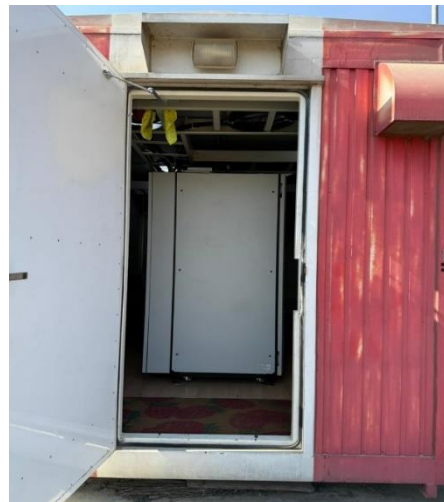
Figure 5: ILS Hut with equipment

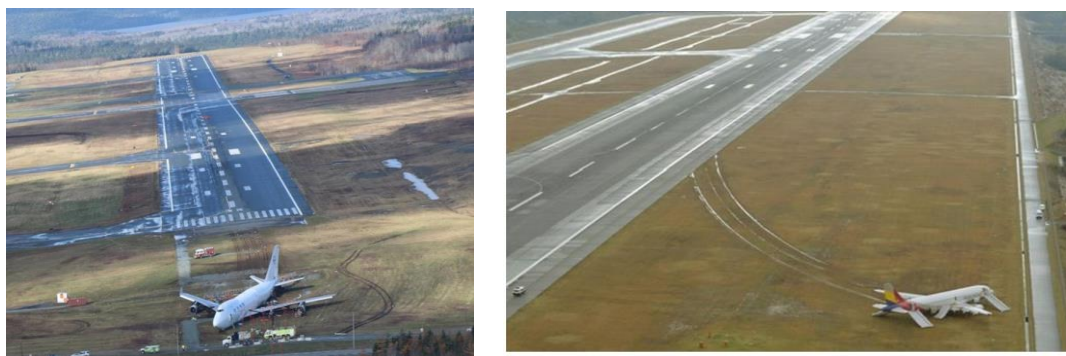
Figure 6: Aeroplane overshoot and veered off from runway
