Seminario Regional SAM sobre Formato Global de
Reporte de Estado de Pista
SAM Regional Seminar on GRF for Runway Conditions
Lima, Peru. 21-22 Agosto 2019

SAM WORKSHOP ON GRF

Workshop cases

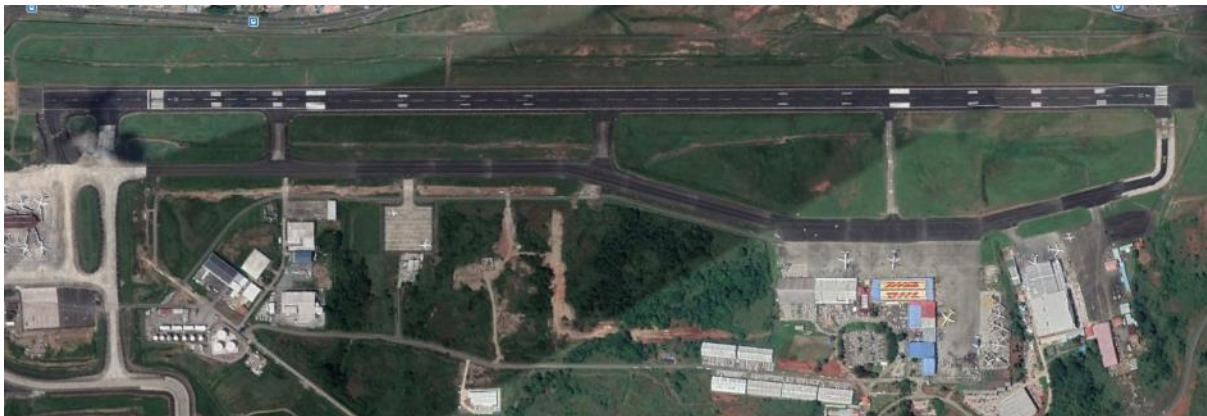
Case # 1.

- Tocumen International Airport (MPTO), Panama. Runway 03L/21R
- 06 July 2018 at 1630UTC
- At present:
 - Beginning to rain;
 - Rain intensity forecasted is Heavy showers For 25 minutes.
 - There is no wind.
- The runway is completely and evenly covered with a thin layer of water less than 3 mm deep. The runway has adequate drainage capabilities.
- No relevant NOTAM issued.
- The runway has some rubber deposits 1st third and 3rd third of the runway.
 - The runway is closely monitored as it has been determined that it is approaching State set or agreed criteria for minimum surface friction characteristics.
 - There is no NOTAM issued declaring the runway to be a 'Slippery when wet' runway.
- One pilot reports Braking Action at 1625 UTC as MEDIUM.
- Outside temperature is 26°C

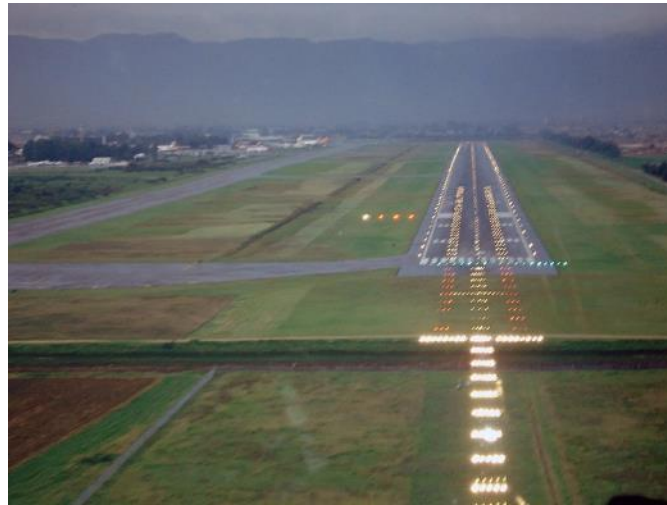
Case # 2

- Runway 13R/31L at Bogota Airport (SKBO), Columbia.
- Date and time: 02 August 2019 at 0005UTC
- Last RCR: 5/5/5
- At present:
 - Rain intensity is heavy rain
 - Rain intensity forecasted is HEAVY in showers for 2 hours
 - There is a crosswind of 5knots
- No relevant NOTAM issued.
- The runway is completely but unevenly covered with water
 - 1st third and 3rd third is covered by water less than 3 mm deep.
 - 2nd third has a 200 m long portion covering the wheel tracks of water in a pond more than 3 mm deep.

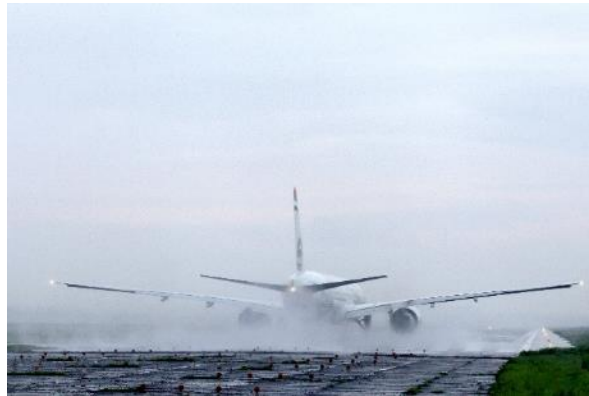
Case # 3

- Runway 18/36 at XYZ International Airport, Fantasyland
- Date and time: 22 November 2019 at 2135 UTC
- A rain is still falling on the airport and surrounding region
- A pilot report to the ATC a runway braking action of MEDIUM TO POOR
- First third of runway has been assess to 26-50 per cent coverage of water of 3 mm or less depth.
- Middle third of runway has been assess to 10 – 25 per cent coverage of water of more than 3 mm depth but not much more than 3 mm.
- Last third of runway has been assessed to 76 – 100 per cent coverage of water of 3 mm or less.
- Which actions should be taken?

- A new assessment revealed that the first and last runway thirds are still covered by 3 mm or less of water and at the second runway third water is accumulating but less than 3 mm assessed increase in depth.
- Which action will be taken?

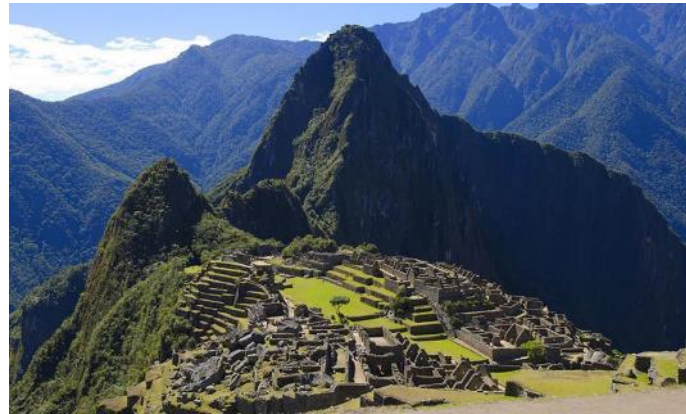
Case # 4

- Runway 10/28 at Alejandro Velasco Astete International Airport , Peru
- 18 April 2019 at 0920 UTC
- Latest RCR 3/3/3. NOTAM published with Slippery Wet situation.
- Latest AIREP reported by pilot to ATC rwy braking action of MEDIUM
- A rain has fallen on the airport and surrounding region but already stopped and no forecasted rain for the next 8 hrs.
- The runway has been assessed to be DRY on all three runway thirds

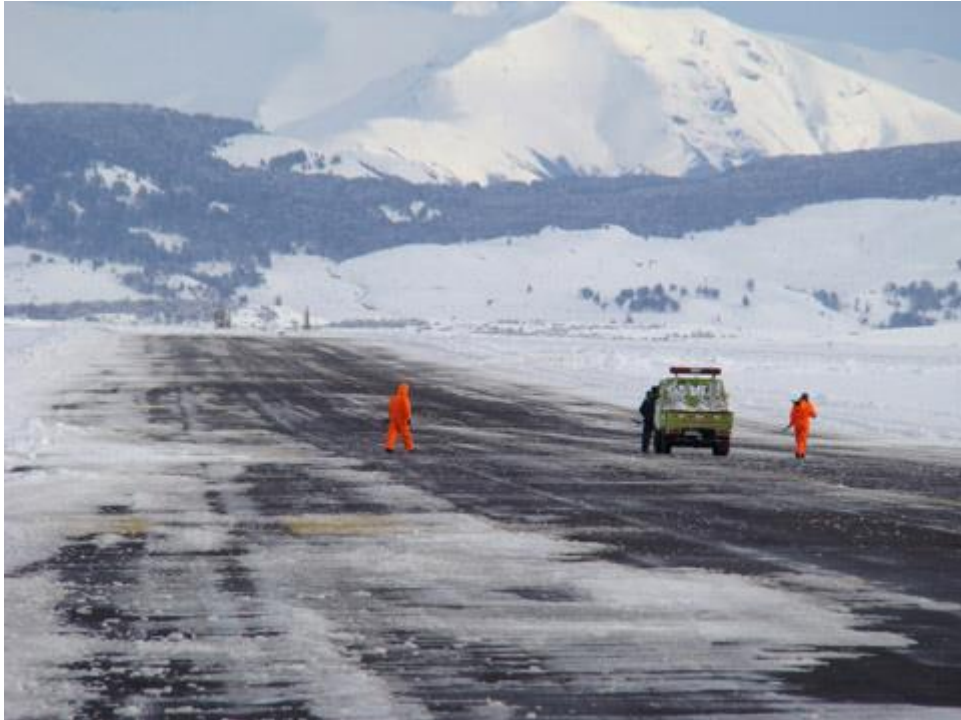
Case # 5

- Runway 15/33 at “Punta Arenas” Airport, Chile. Code: SCCI
- 24 December 2019 – 05:00UTC
- Runway coverage 100% Compacted Snow.
- Runway in good conditions
- OAT -16°C
- Pilot reporting braking action as GOOD at 04:35UTC
