Federal Aviation
Administration

Hazardous Material Safety Program

Lithium Battery History and Testing

March 2015

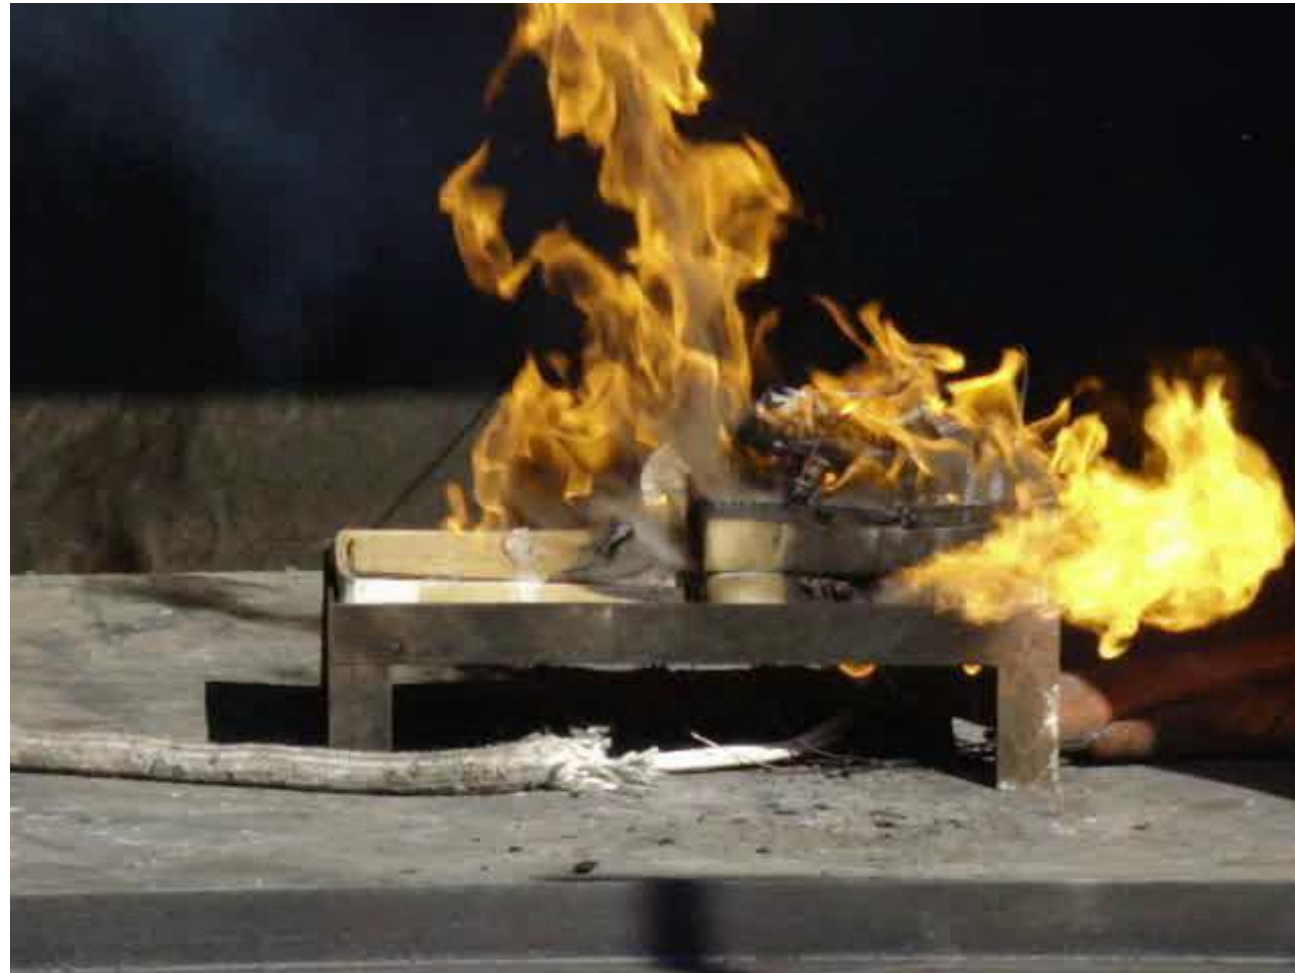
Develop Practical and Cost Effective Fire Resistant Packaging

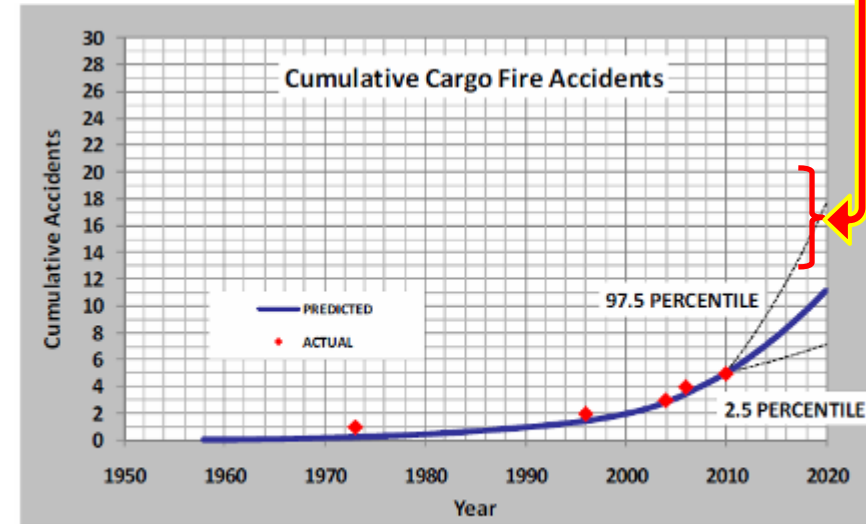
**6 ACCIDENTS
OVER NEXT 10
YEARS**

Figure 6 Predicted Number of Freighter Airplane Cargo Fire Accidents through to 2020

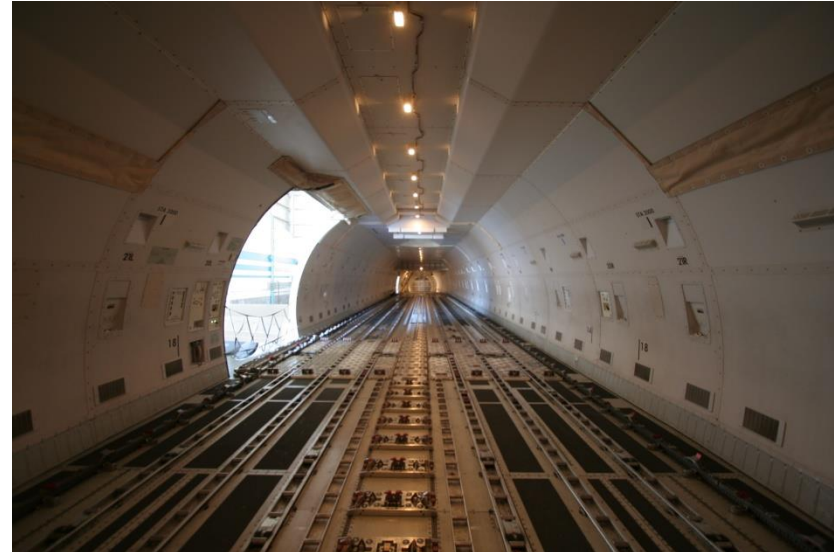
Class E Cargo Compartment

- Upper deck compartment on most freighters
 - Has Fire detection system
 - Means to shut off ventilation flow to the compartment
 - Means to exclude hazardous quantities of smoke, flames, or noxious gases, from the flight crew compartment

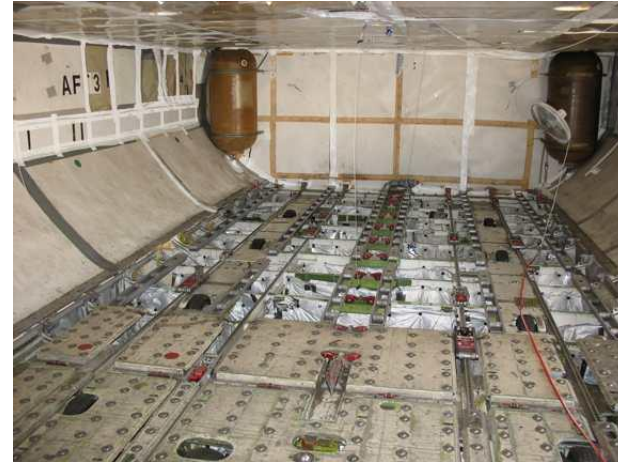
Class C Cargo Compartment

- Passenger aircraft under floor cargo compartments
 - smoke detector or fire detector system
 - built-in fire extinguishing or suppression system controllable from the cockpit
 - means to exclude hazardous quantities of smoke, flames, or extinguishing agent, from any compartment occupied by the crew or passengers
 - means to control ventilation and drafts within the compartment

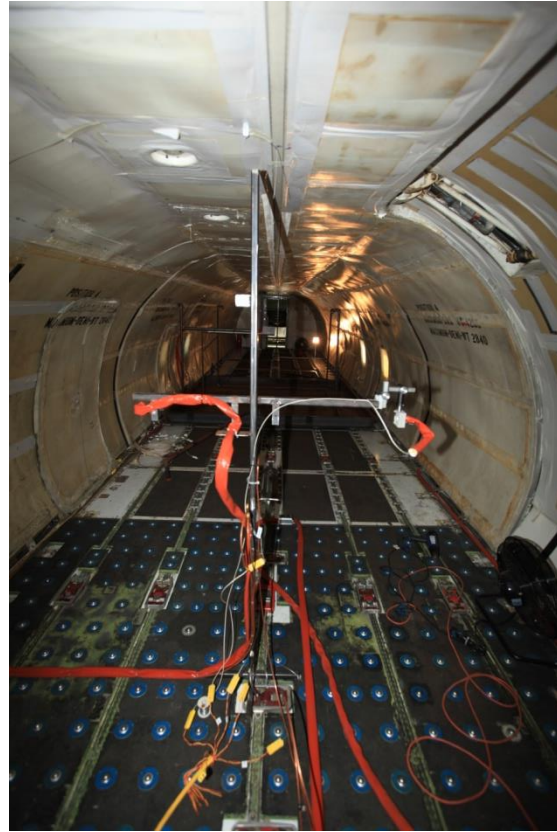
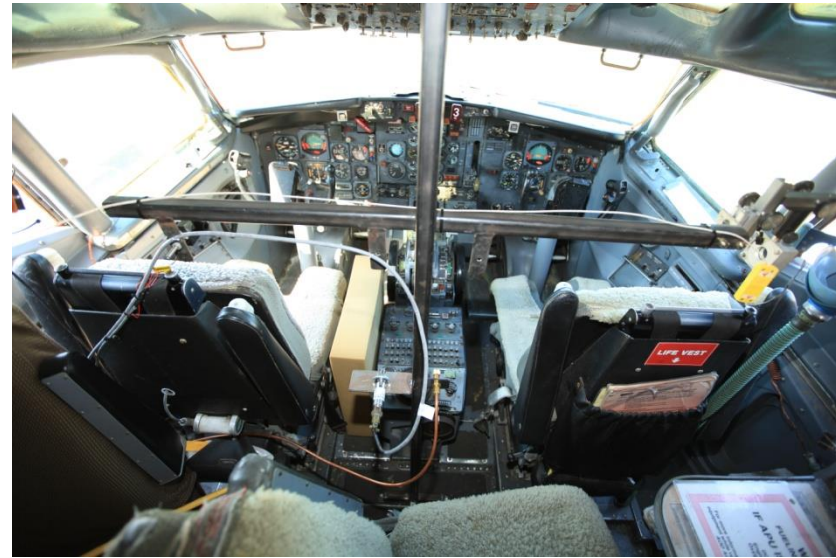
Instrumented 727 Test Article

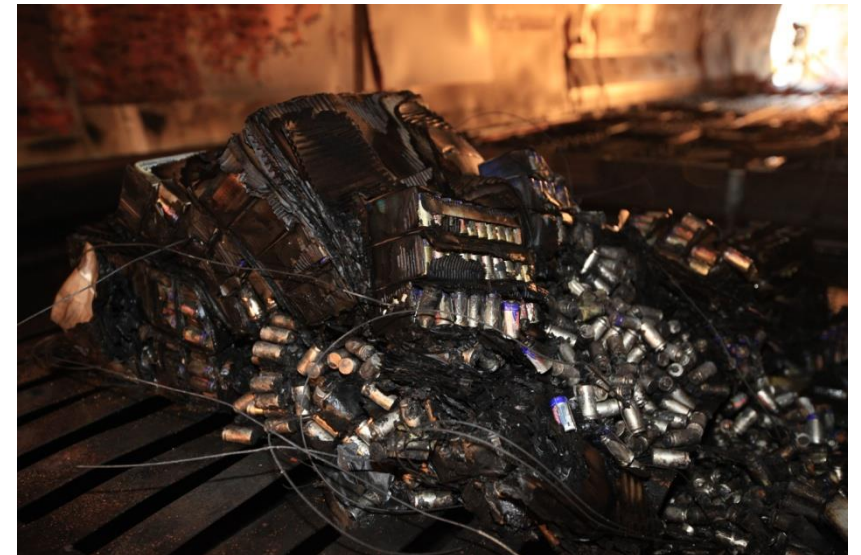
Results Lithium Metal Class E

- Test terminated at 16 minutes with water
- Approximately half of the cells were consumed
- Very high ceiling temp: 1700 DegF @ 16 min
- Very high battery fire temp: 2250 DegF @ 12 min.
- Oxygen starvation had little or no effect on fire intensity
- Smoke on flight deck in less than 4 minutes
from first observable fire, obscured in less than 6 minutes.
- Significant cargo liner damage

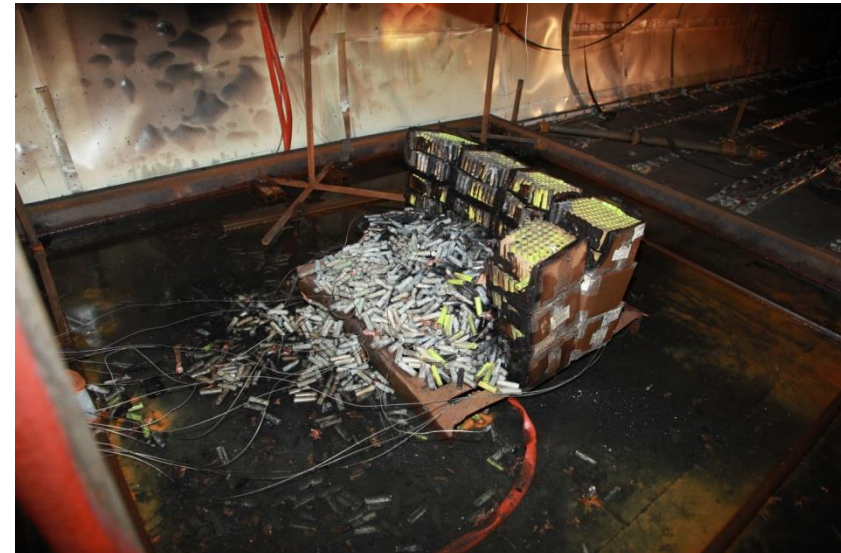
Results Lithium-ion Class E

- Test terminated at 57 minutes with water
- More than half of the cells consumed
- High ceiling temp: 1490 DegF @ 49 min
- High battery fire temp: 1300 DegF @ 55 min.
- Oxygen depletion slowed fire progress
- Some light smoke on the flight deck
- Significant damage to cargo liner

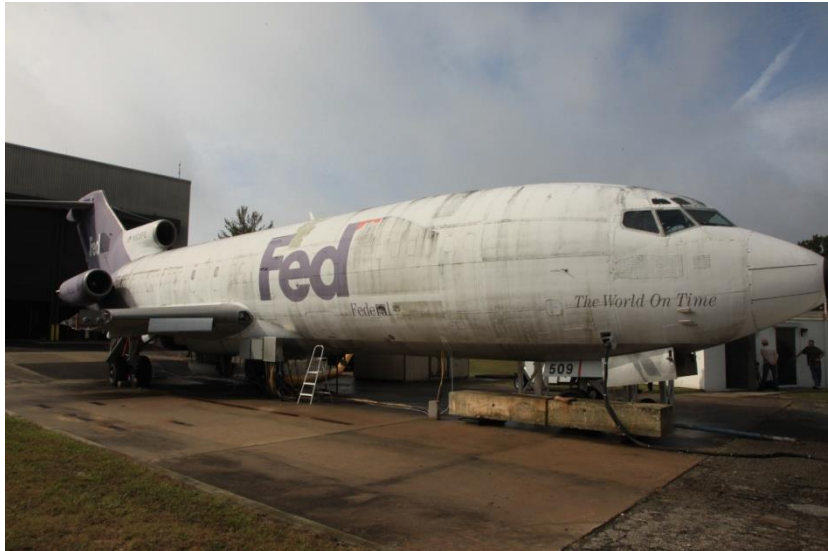
Class C Tests

- Ventilation configured for fire in lower cargo compartment
- Halon discharged one minute after initial smoke observation

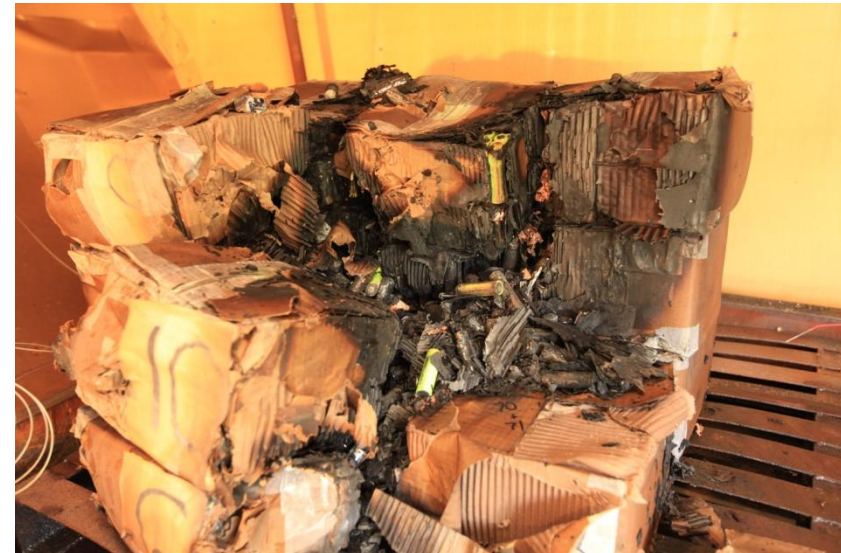
Results Lithium-ion Class C

- Halon suppressed surface fire and the electrolyte fire
- Thermal runaway propagated between boxes
- Approximately 1200 cells were consumed
- Low to moderate ceiling temperatures
- Smoke contained within the compartment
- Little damage to cargo liner

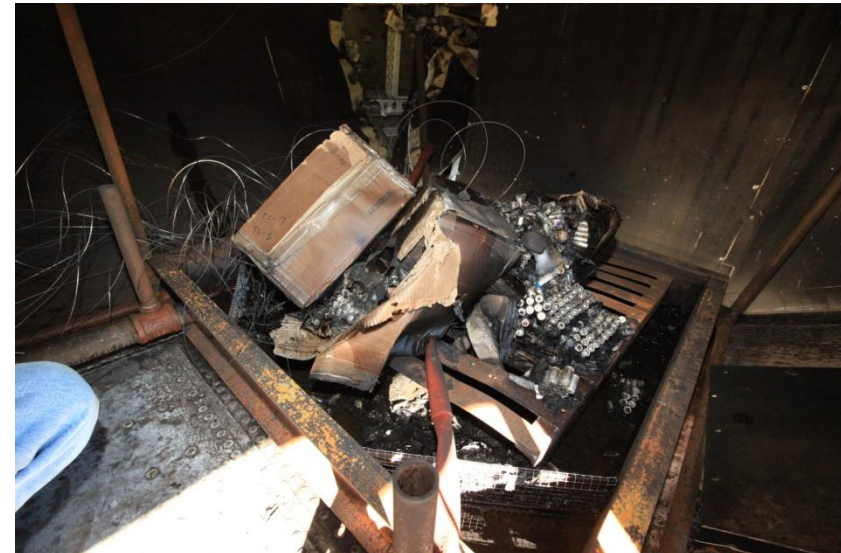
Results Lithium Metal Class C

- Halon suppressed the cardboard and electrolyte fire
- Thermal runaway propagated rapidly between boxes, despite Halon and extremely low oxygen levels
- 3450 cells consumed
- Smoke penetrated the mix bay and main deck
- Rapid reduction in Halon concentration
- Test was terminated due to high ceiling temperatures
- Post test event

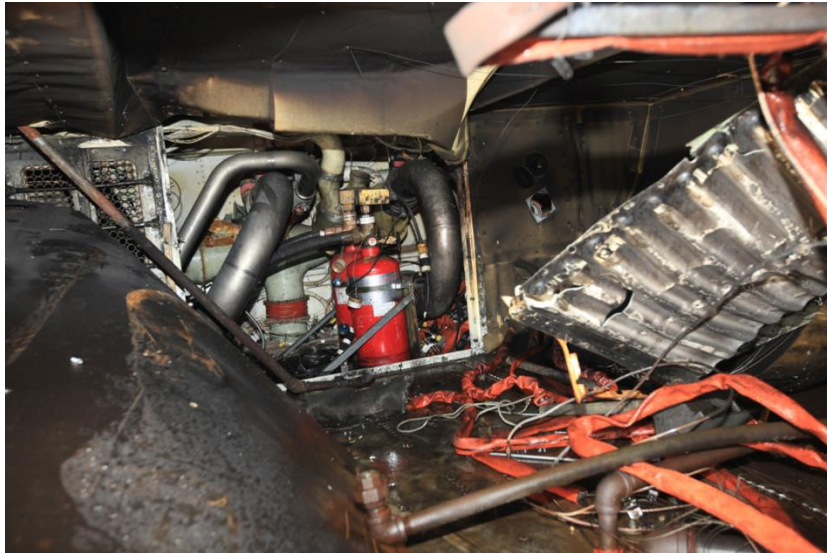
Post Test Explosion

- Post test, the oxygen levels in the cargo compartment increased, while the Halon neared zero.
- A single cell in thermal runaway caused a flash fire in the cargo compartment.
- The flash fire forced open the blow out panel into the mix bay.
- This ignited the fumes in the mix bay causing an explosion

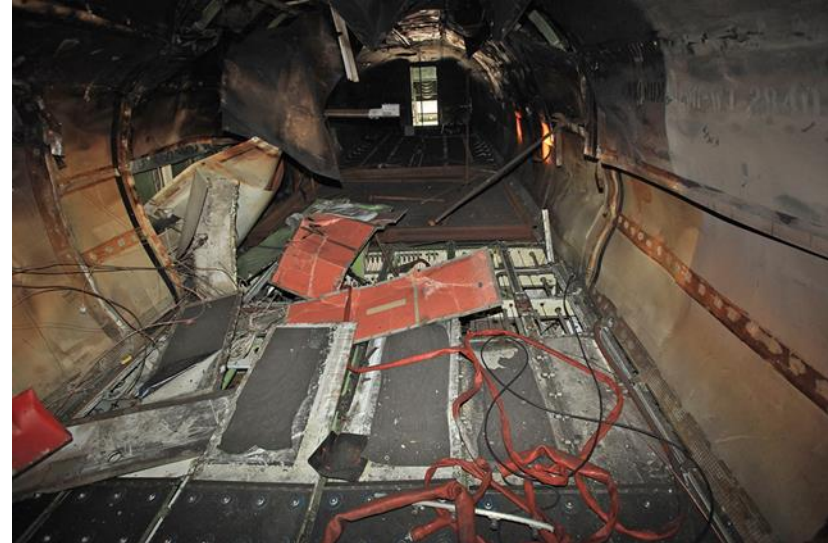
Post Test Explosion

- The explosion blew the aft cargo access panel into the cargo compartment, as well as the forward cargo bulkhead into the EE bay.
- The floor boards in the main cabin above the mix bay were blown upward.
- The door to the flight deck was blown off the hinges and into the flight deck

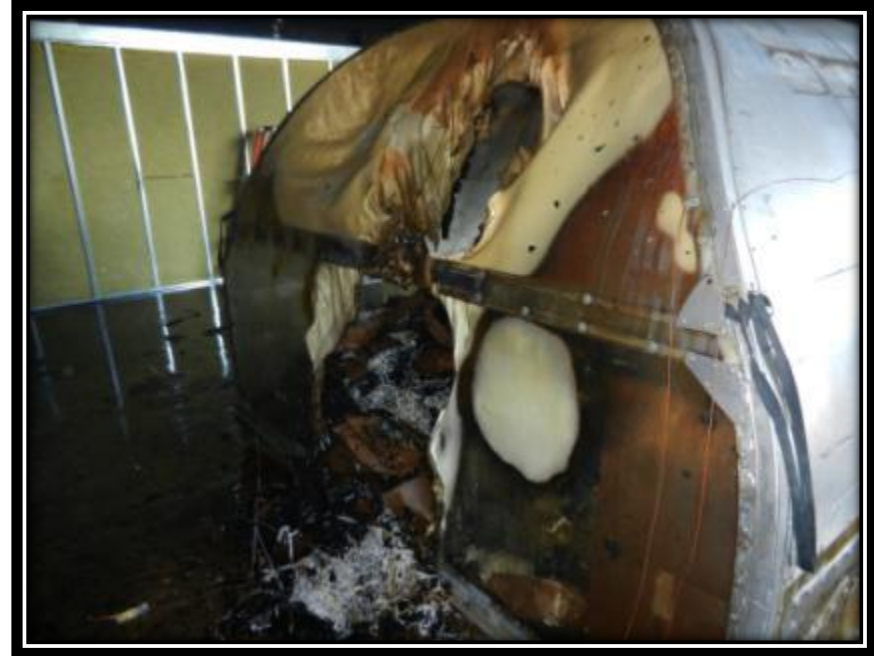
ULDs

- Currently used ULDs can not contain deep seated fires even with the discharge of an aerosol based fire suppression agent.
- The agent escapes from the door which allows for fresh air to enter the container.

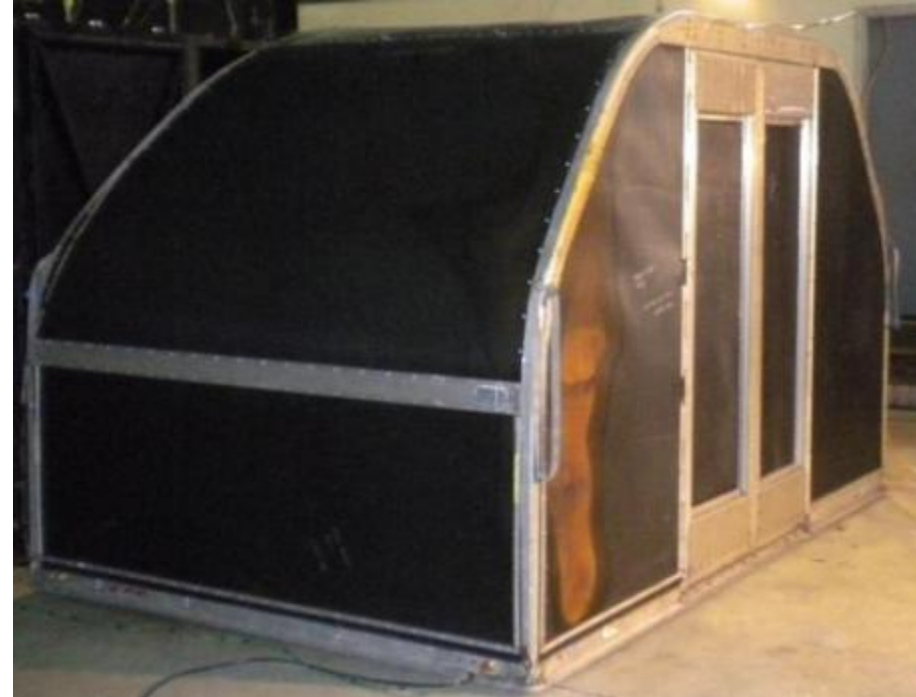
Oxygen Starvation

- Develop materials that can withstand fires within the container.
- Reduce the air exchange rate to
 - Reduce oxygen
 - Retain fire suppression agent
- Reduce weight

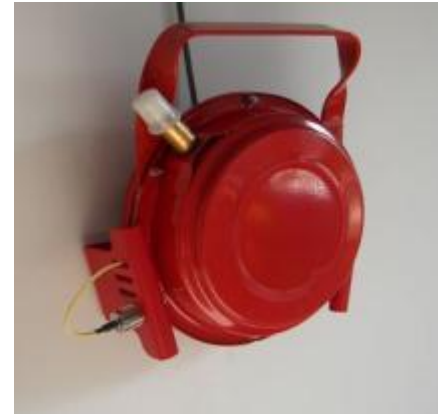
Secondary Fire Suppression Agent

- Detects and activates from fires within the container.
- Extinguishes or suppresses the fire within the container.
- Maintains a low oxygen concentration environment.

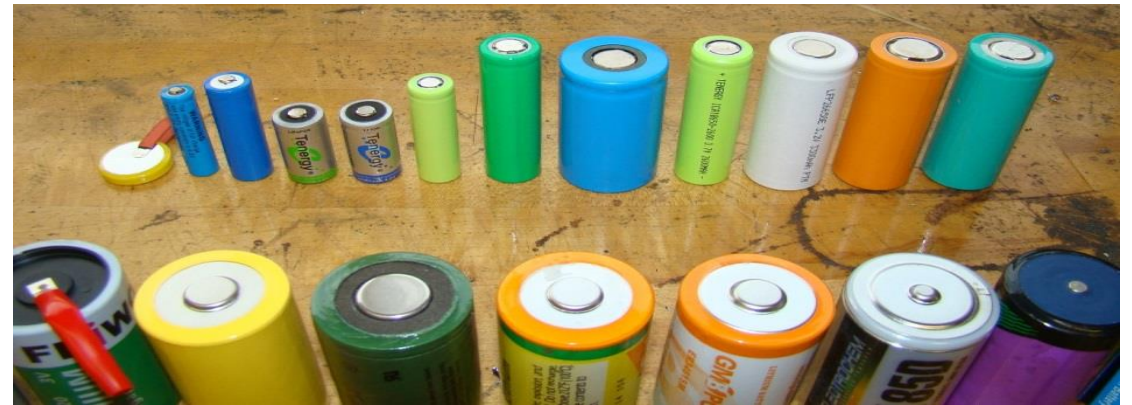
Cell types

- Cells come in various sizes and chemistries
- Cell hazard varies by chemistry, size and cell construction and manufacturer

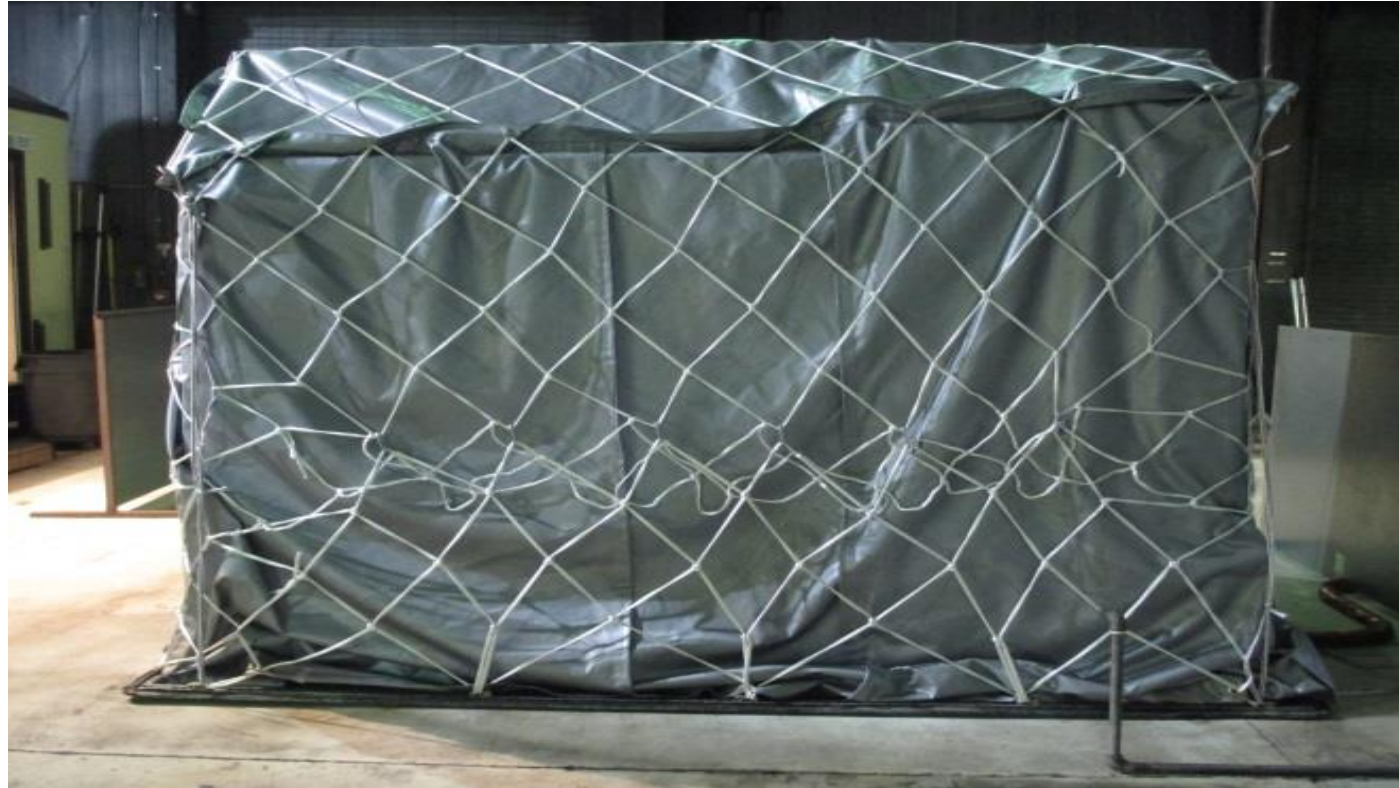
Fire Containment Tests

- Test conducted on March 2014
 - Setup involved a metal frame that supported the FCC and backup water suppression systems.
 - Batteries were placed in a steel pan. Balance of cargo cardboard boxes filled with shredded paper.
 - Thermal runaway initiated with a cartridge heater.
 - FCC contained the battery fire for the period of 4 hours.
- Repeated test without metal frames

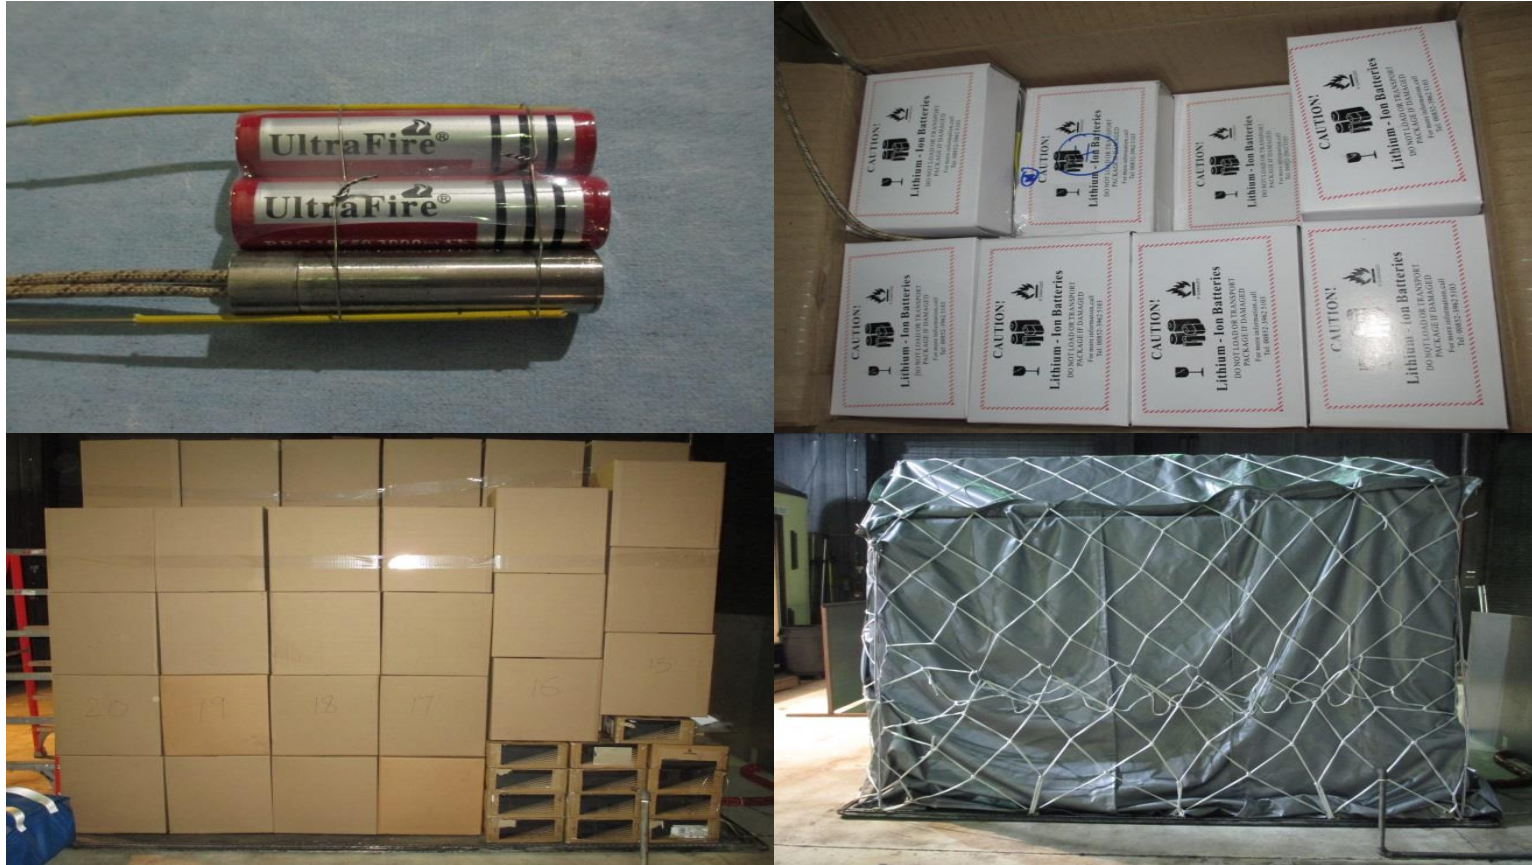
5000 Lithium-ion Batteries in a FCC

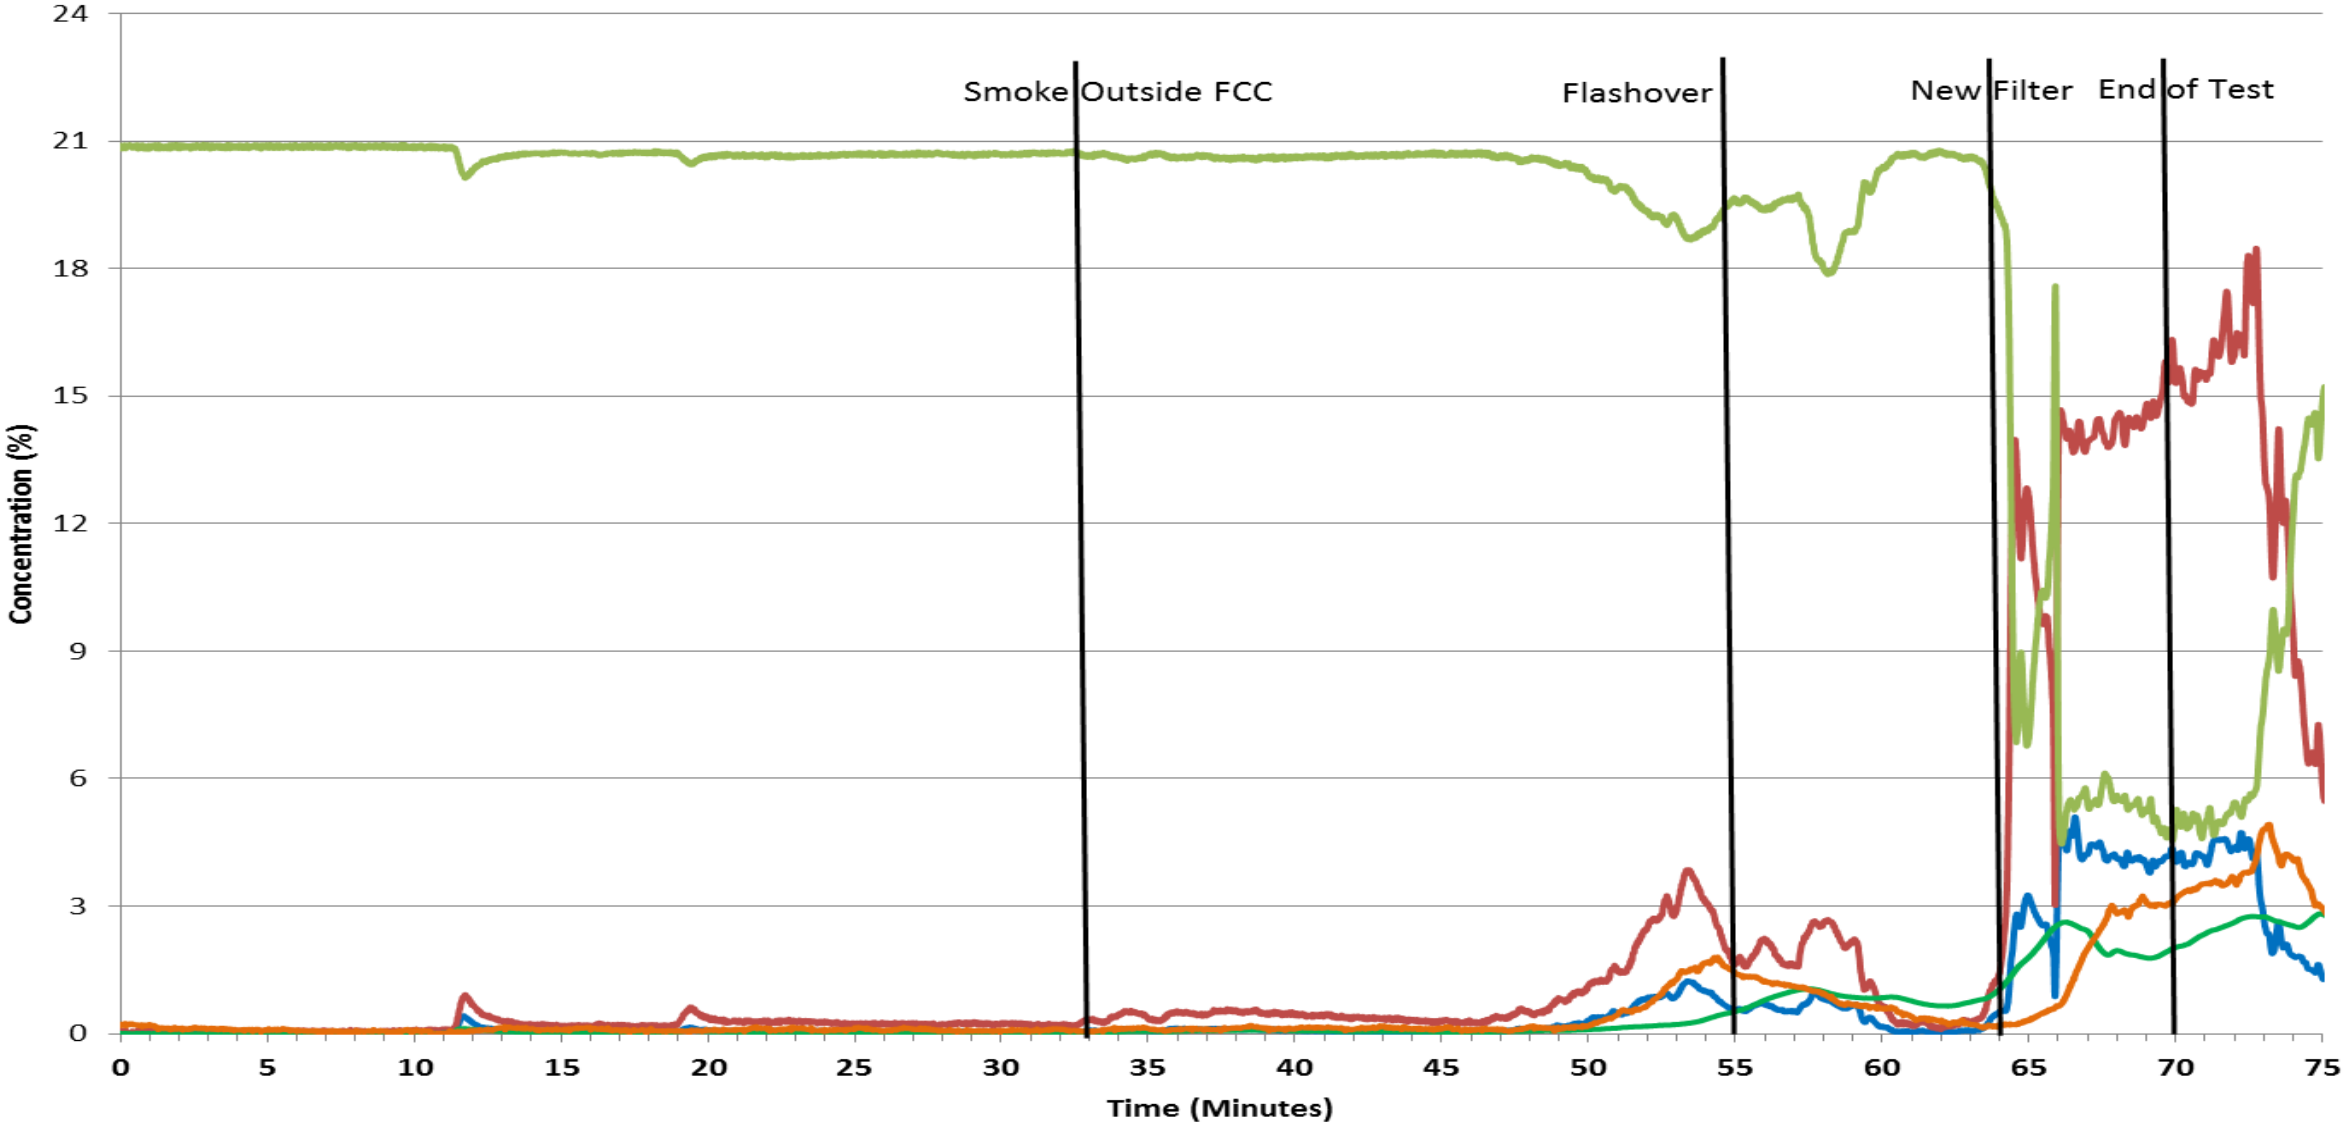
Gas Analysis for 5000 Lithium-ion Batteries in a FCC

CO CO2 Oxygen HC Conc Hydrogen Analyzer

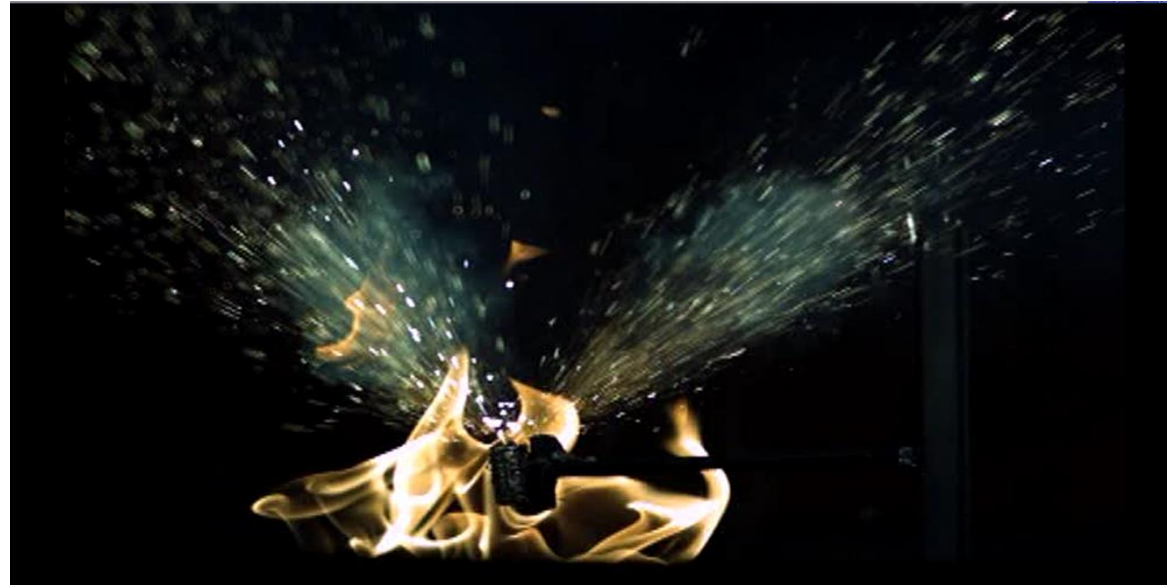
Lithium Battery Thermal Runaway Vent Gas Analysis

- Three test Setups.
 1. **Small Scale** tests with multiple cell chemistries and SOC to analyze hazard.
 2. **Small Scale** tests with LiCoO₂ chemistry to determine pressure rise vs. concentration of vent gas.
 3. **Large scale** tests with lithium-ion cells to verify the hazard on a full scale and evaluate the effectiveness of Halon 1301 at suppressing combustion.

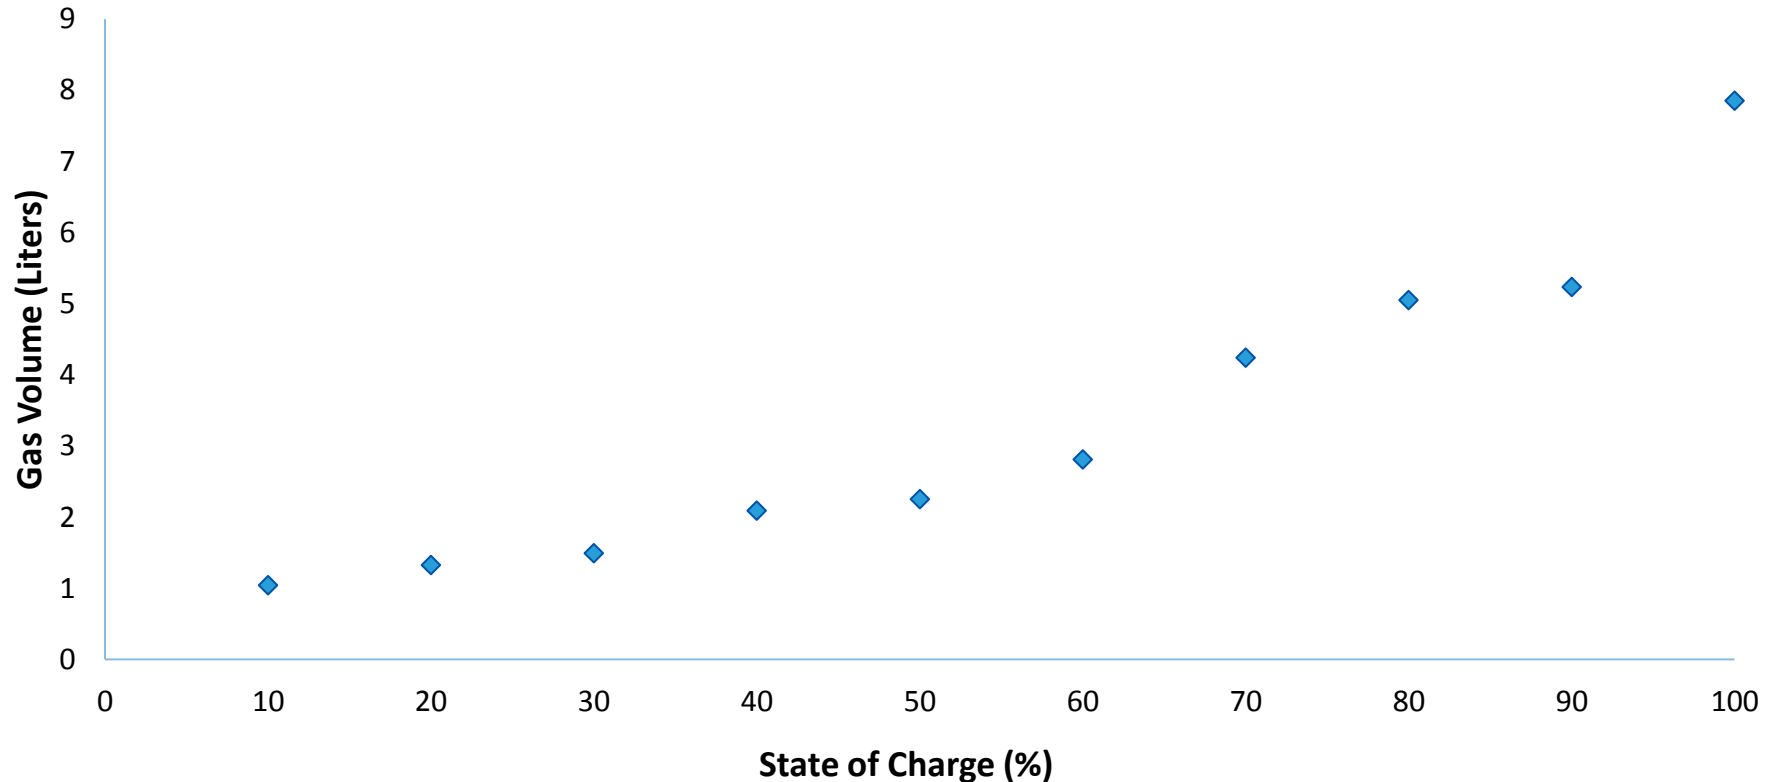
Results: State of Charge (LiCoO_2)

Gas volume emitted increases as SOC increases.

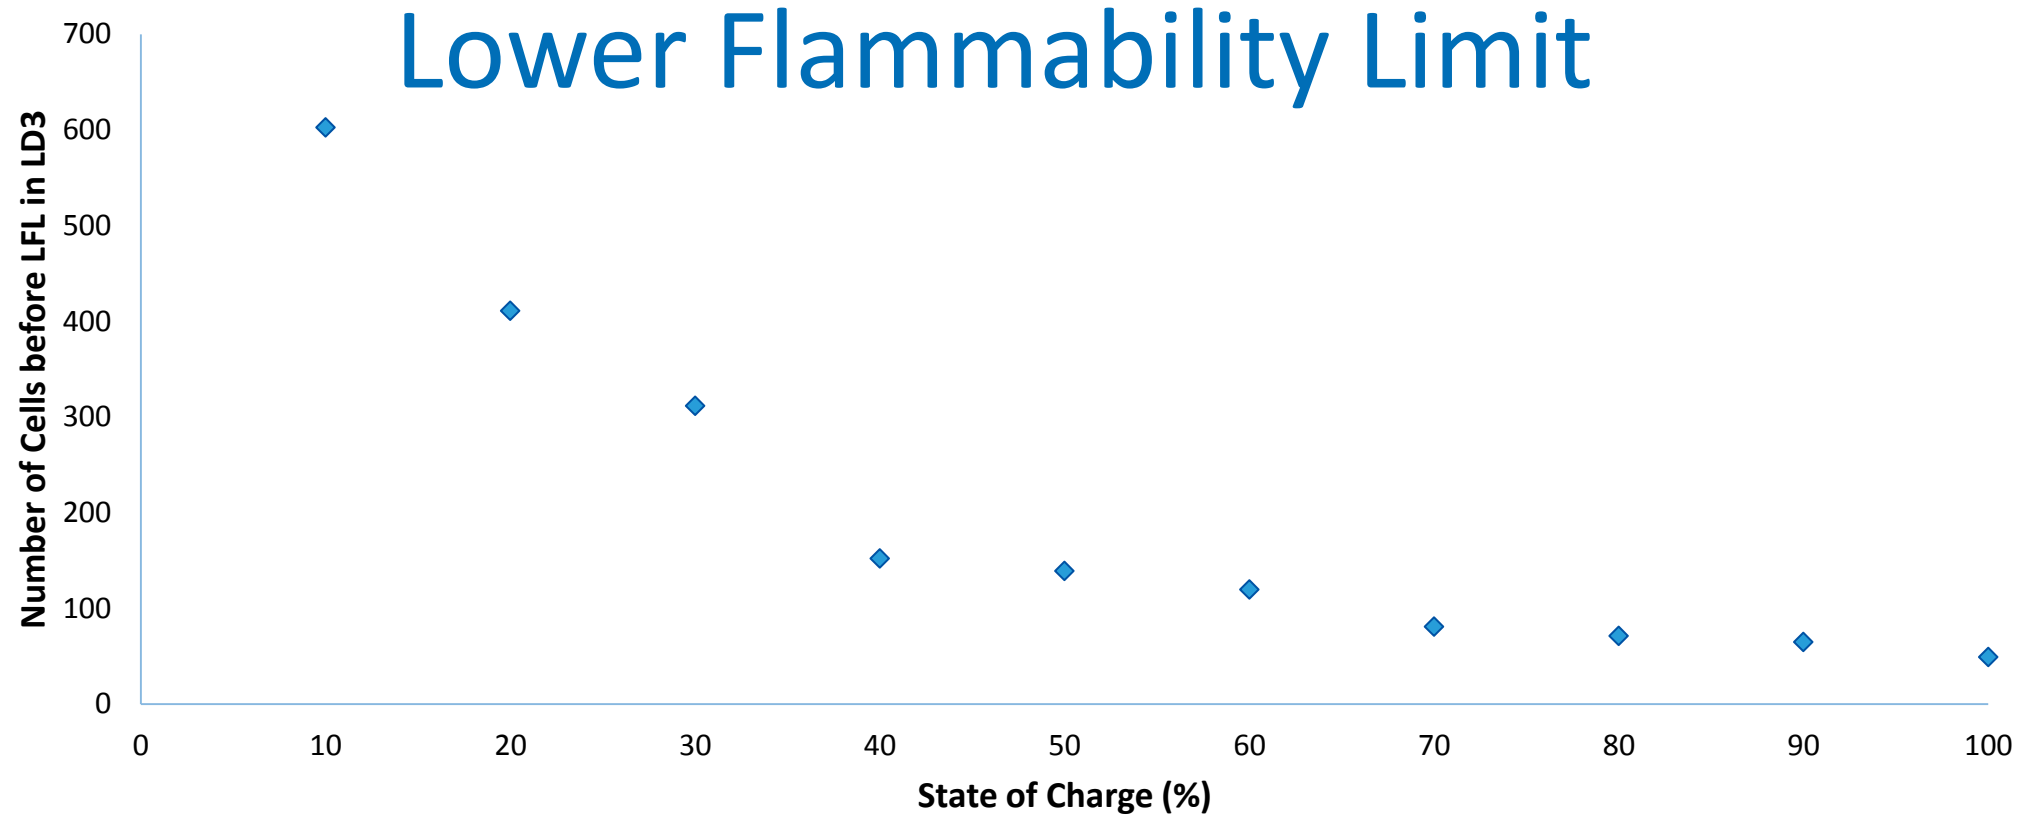
The calculated number of cells required for an explosive mixture in an LD3 (150ft³) decreases as SOC increased.

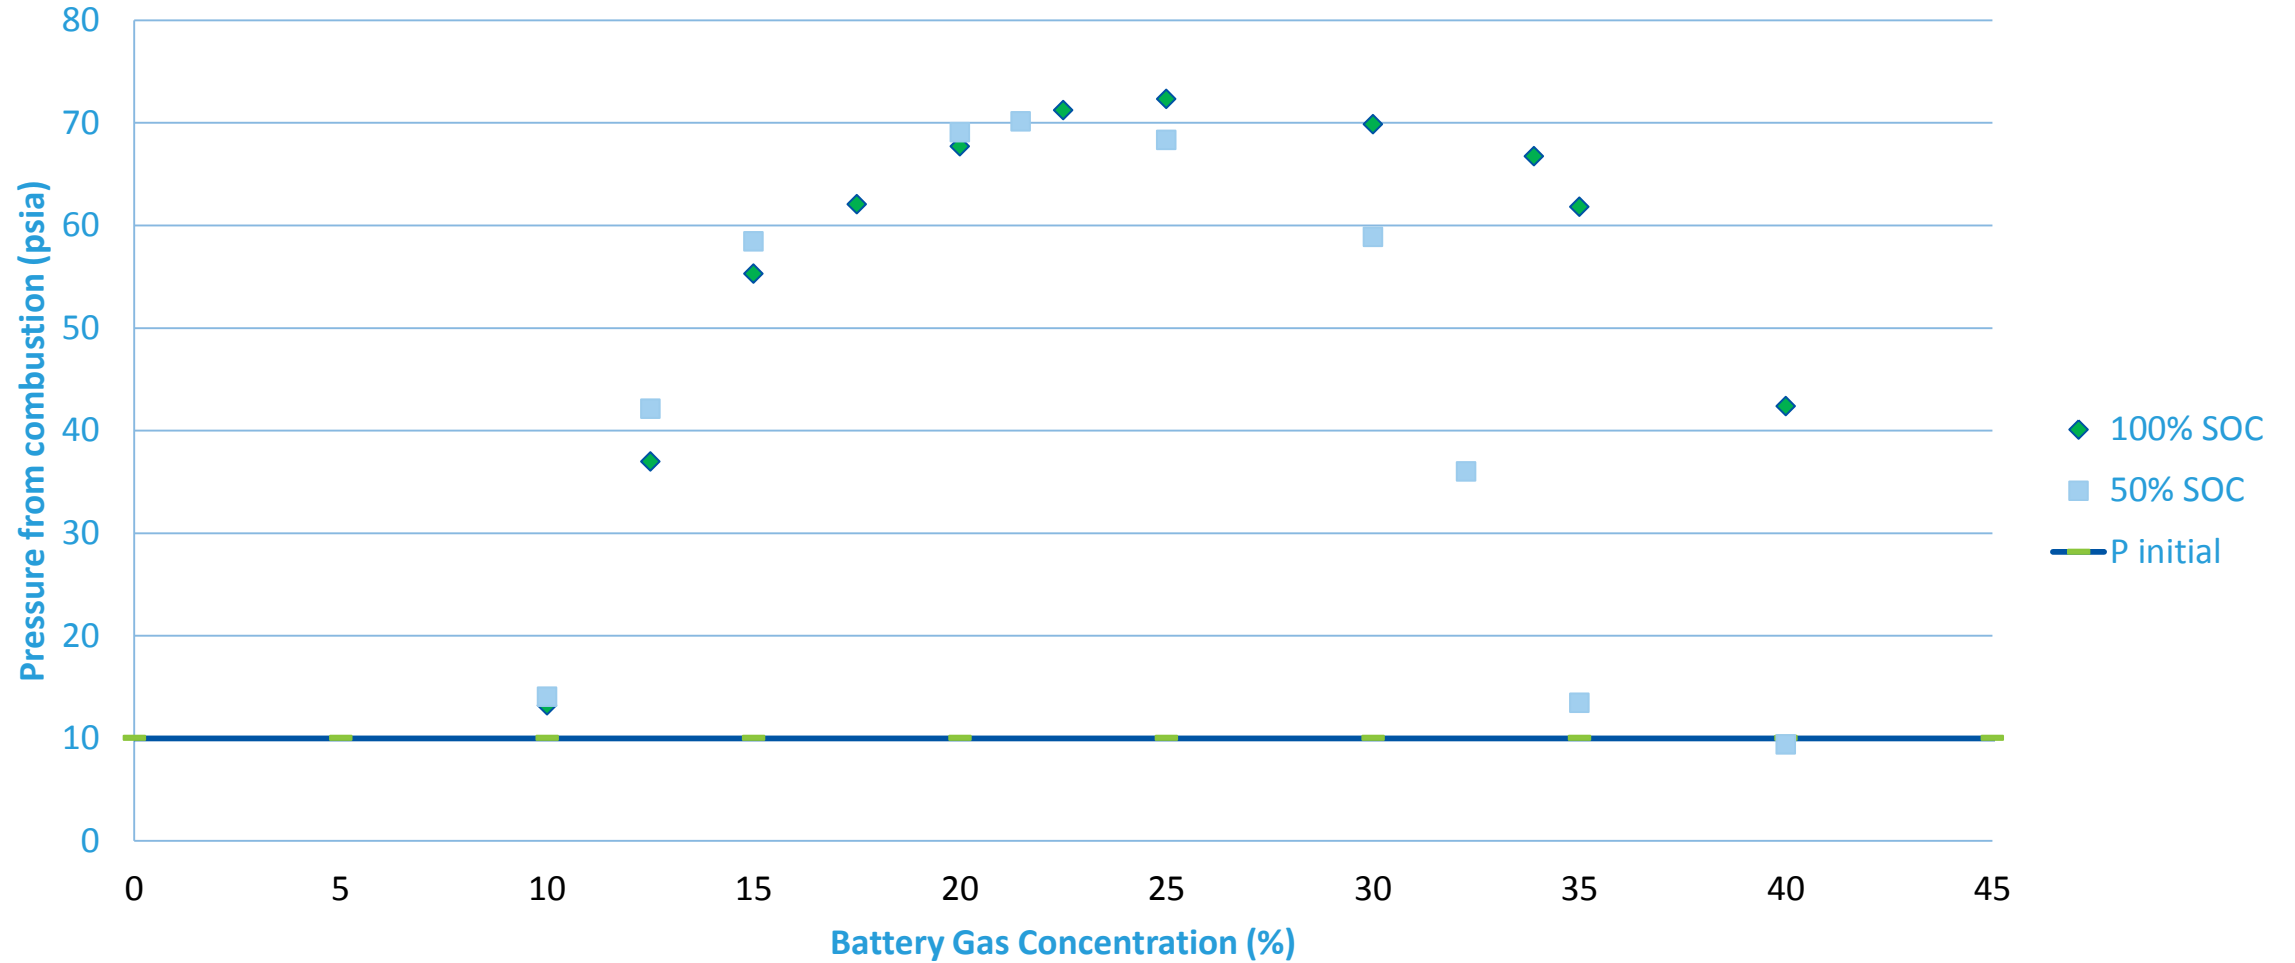
Pressure Rise (small scale)

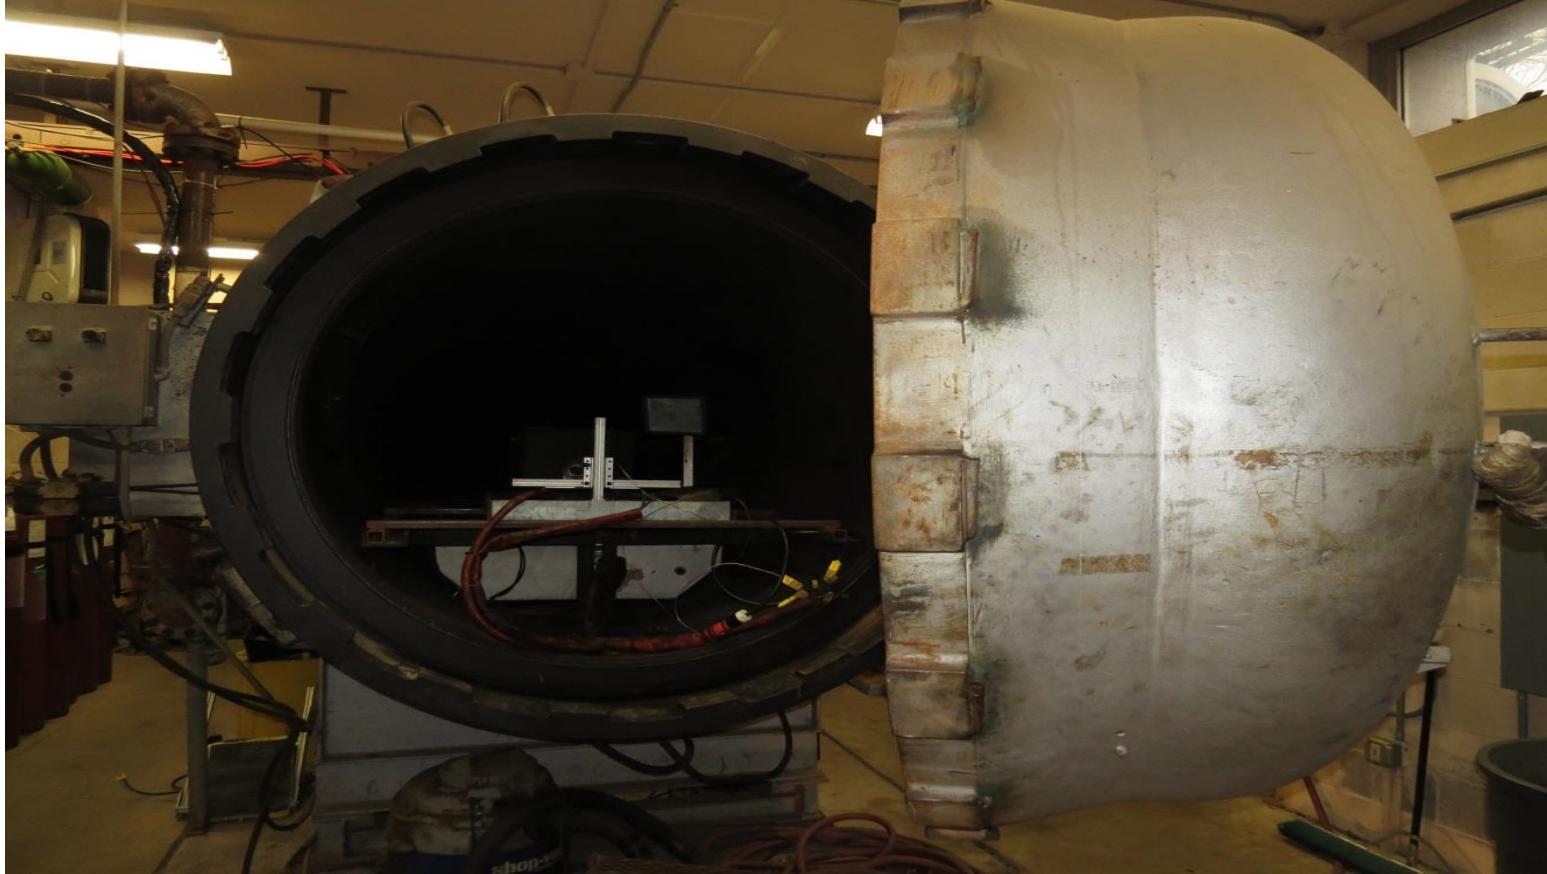
Pressure Chamber (Large Scale Tests)

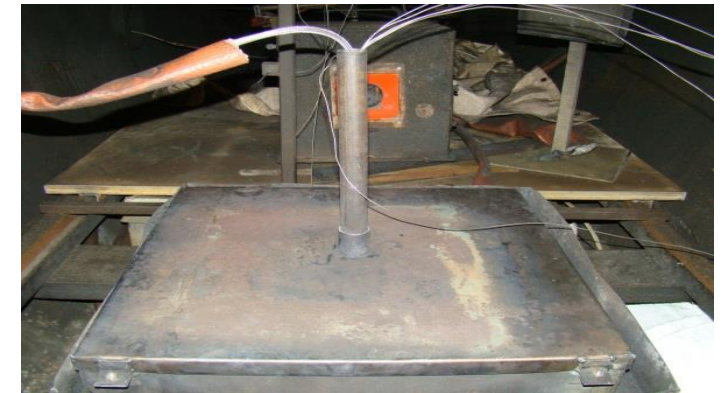
Setup of Large Scale Tests

- A cartridge heater was placed in the center of a 550 cell array.
- Type-k thermocouples were attached to cells at each of the 4 corners and one was attached adjacent to the cartridge heater.
- The array of cells was enclosed in a steel container with a chimney to create a rich fuel mixture and prevent premature ignition.
- A spark igniter was installed in the center of the chamber.
- Additional instrumentation:
 - 2 THC analyzers at different heights to check for stratification.
 - An H₂ analyzer.
 - A CO, CO₂, O₂, Halon 1301 analyzer
 - An LFL analyzer.

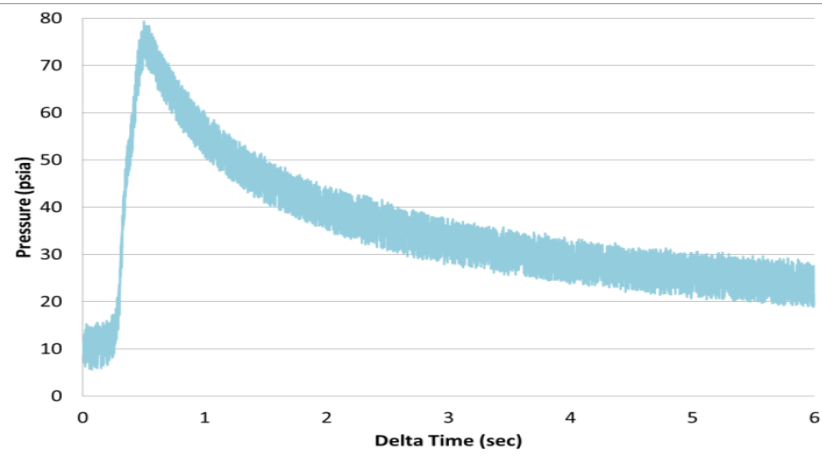
Test without suppression
