Federal Aviation
Administration

Hazardous Material Safety Program

Lithium Battery History and Testing

March 2015

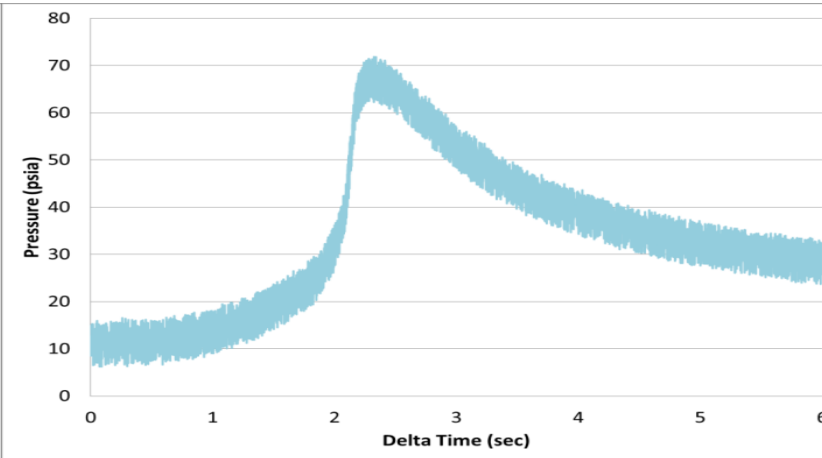
Test with 5.28% Halon

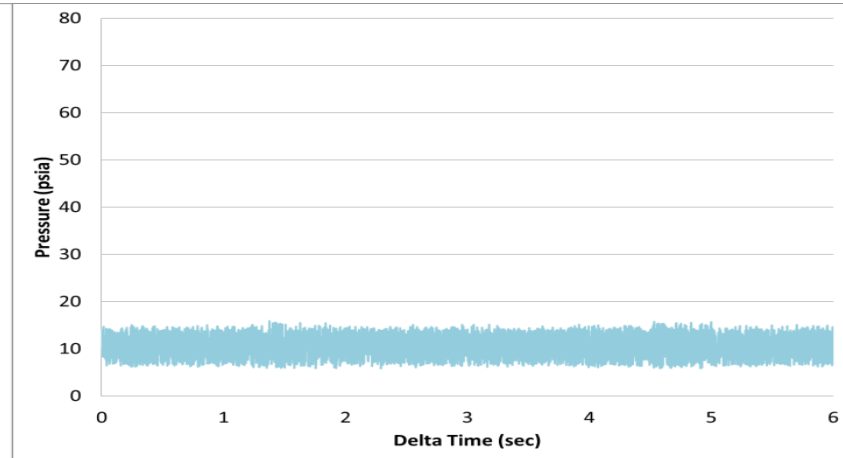
Test with 10.43% Halon

Elapsed time from spark ignition
